# Comparison of the vernacular earthen architecture in Goa (past Portuguese colony in India) and Alentejo (Portugal): local building cultures and conservation approaches

Mémoire du  
Diplôme de Spécialisation et d'Approfondissement — Architecture de Terre et Patrimoine,  
DSA-Terre 2016 - 2018

**Comparison of the vernacular earthen architecture in  
Goa (past Portuguese colony in India) and Alentejo (Portugal):  
Local building cultures and conservation approaches**

**RODRIGUES Chenelle Fatima**

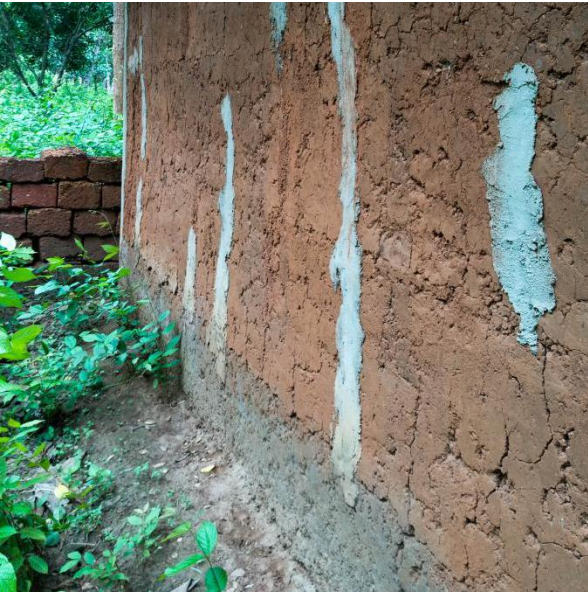
Observations: Base-course is greyish along the one facade.  
Repairs: Cracks and other repairs done in cement.

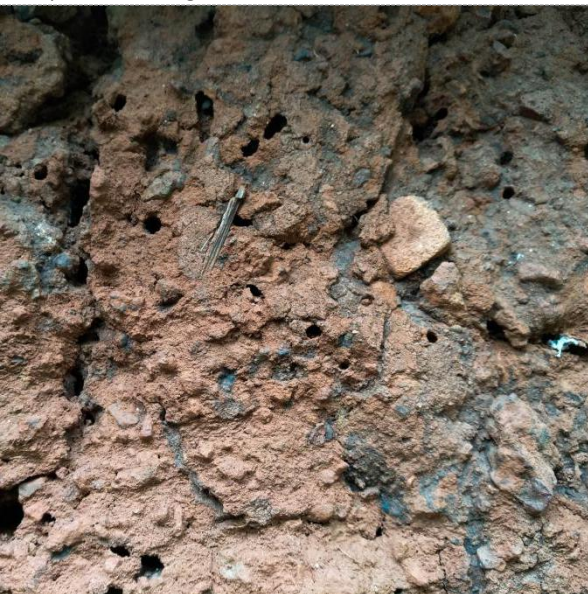
Damages incurred / problems faced: Mason-bee holes

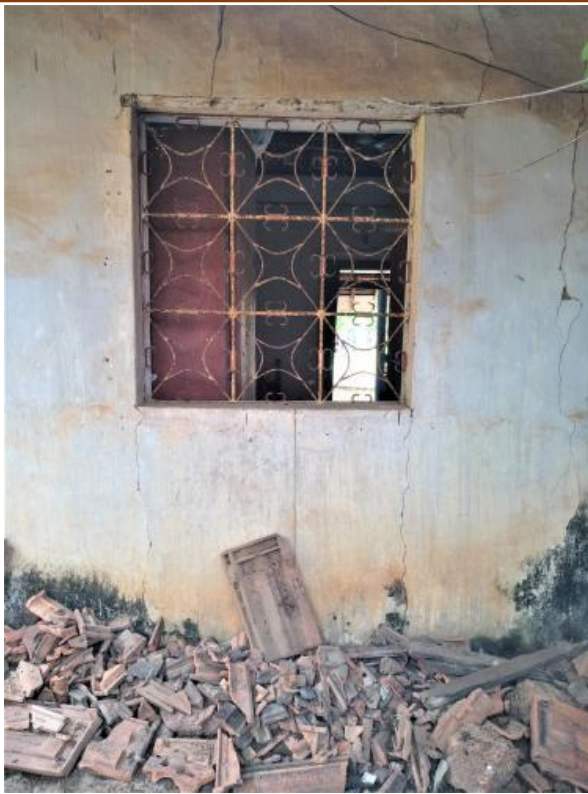
Image 138: The lack of support provided by rotting lintels caused the roof to put pressure on the wall, and created many cracks around the window (Survey no. 7).
