Comparison of the vernacular earthen architecture in Goa (past Portuguese colony in India) and Alentejo (Portugal): local building cultures and conservation approaches

Mémoire du
Diplôme de Spécialisation et d'Approfondissement — Architecture de Terre et Patrimoine,
DSA-Terre 2016 - 2018

RODRIGUES Chenelle Fatima

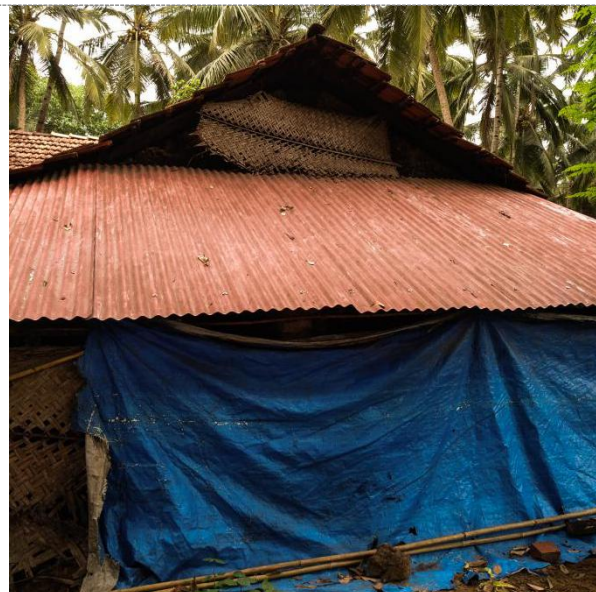
Maintenance and repairs: A woven coconut-frond ('molla') protects the gable from the sprays of rainwater.

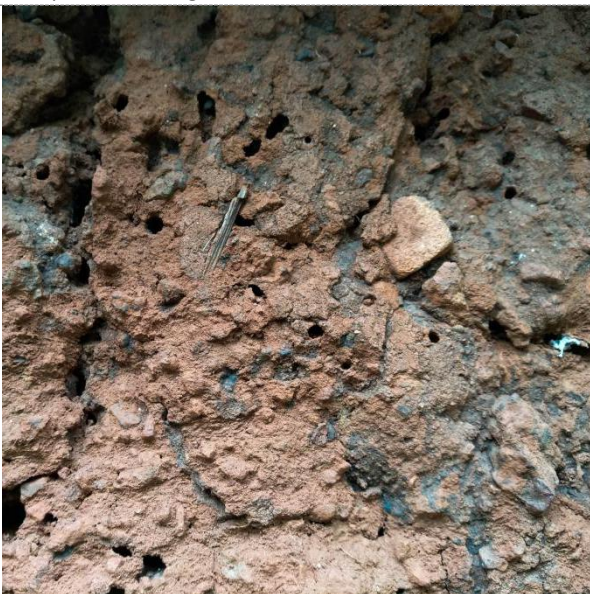
Damages incurred / problems faced: Mason-bee holes

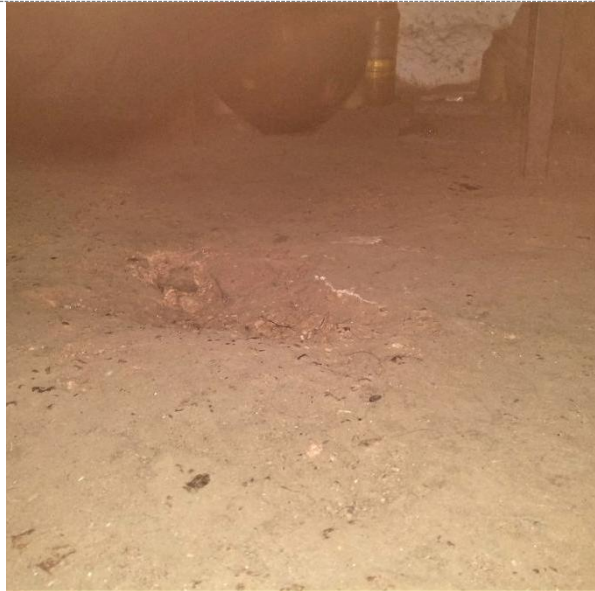
Damages incurred / problems faced: Holes and chipping on flooring.

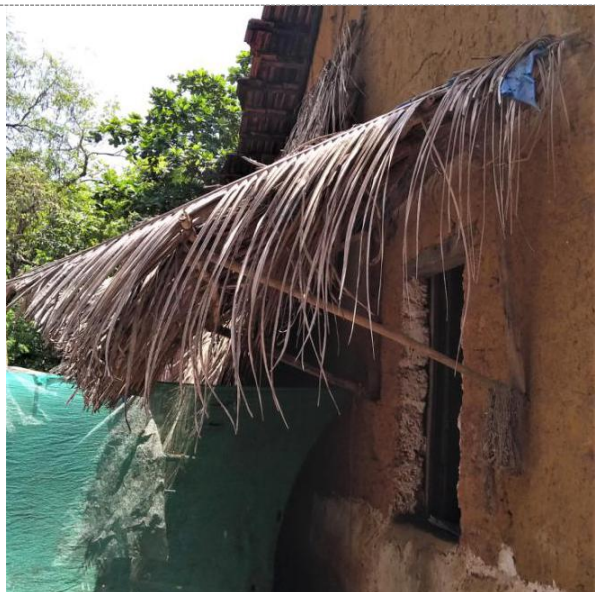
Maintenance and repairs: Every year before the monsoons, old palm-leaf overhangs are replaced with new ones.

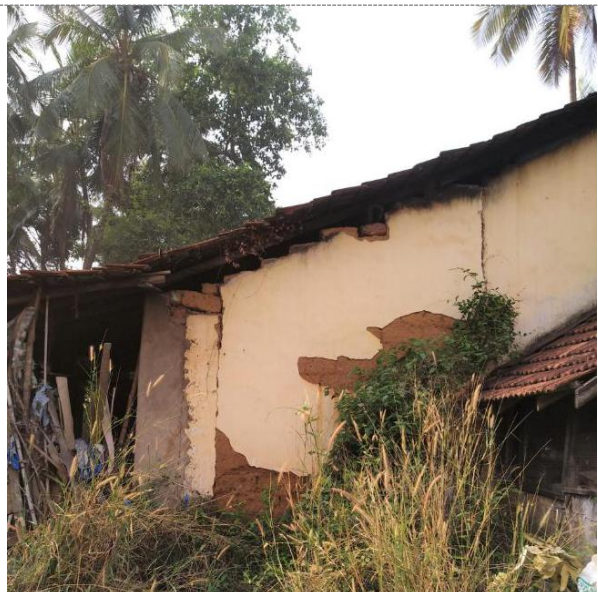
Damages incurred / problems faced: Flaking and falling plasters.

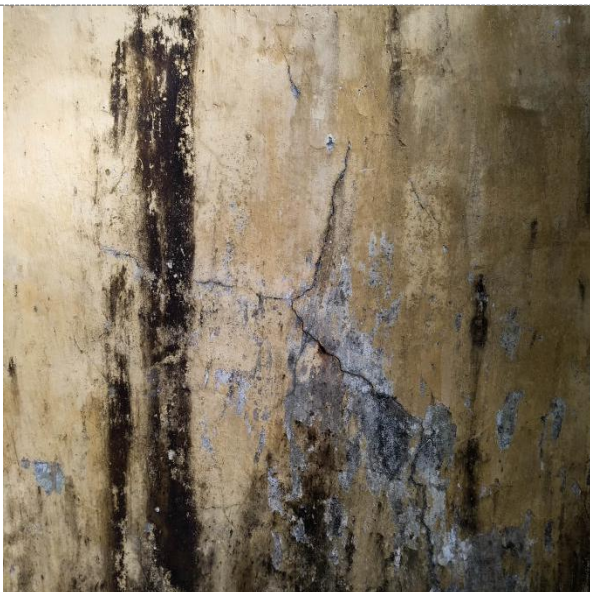
Damages incurred / problems faced: Cracks and dampness

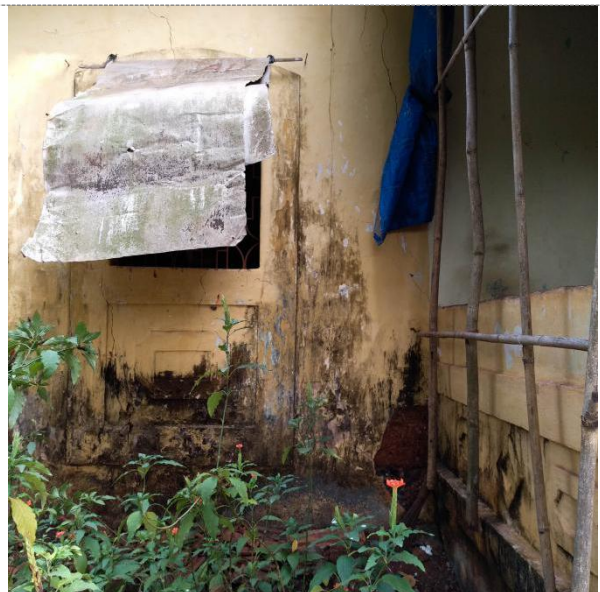
Maintenance and repairs: A make-shift overhang covers the window on the front facade.

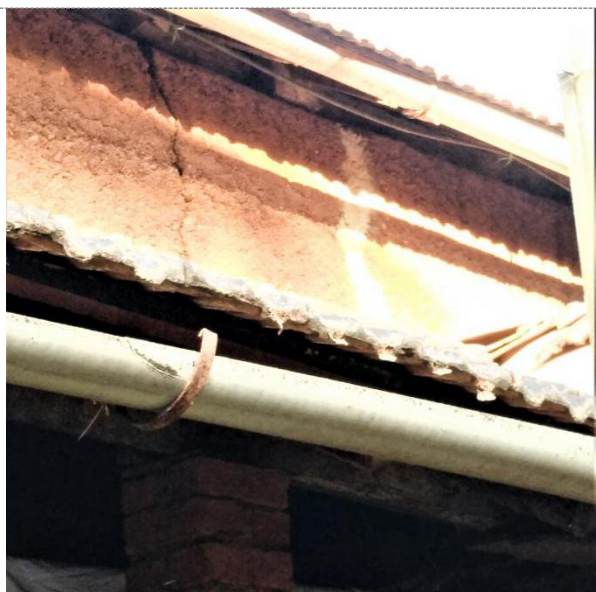
Damages incurred / problems faced: Cracks.
