Comparison of the vernacular earthen architecture in Goa (past Portuguese colony in India) and Alentejo (Portugal): local building cultures and conservation approaches

Mémoire du
Diplôme de Spécialisation et d'Approfondissement — Architecture de Terre et Patrimoine,
DSA-Terre 2016 - 2018

**Comparison of the vernacular earthen architecture in
Goa (past Portuguese colony in India) and Alentejo (Portugal):
Local building cultures and conservation approaches**

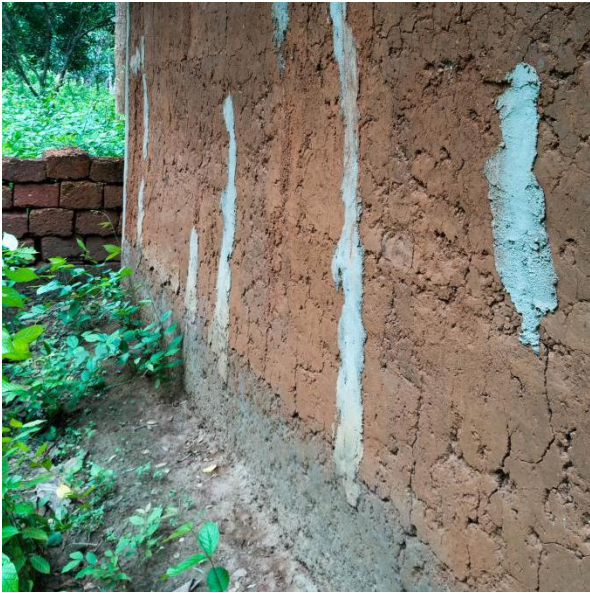
Observations: Base-course is greyish along the one facade.
Repairs: Cracks and other repairs done in cement.

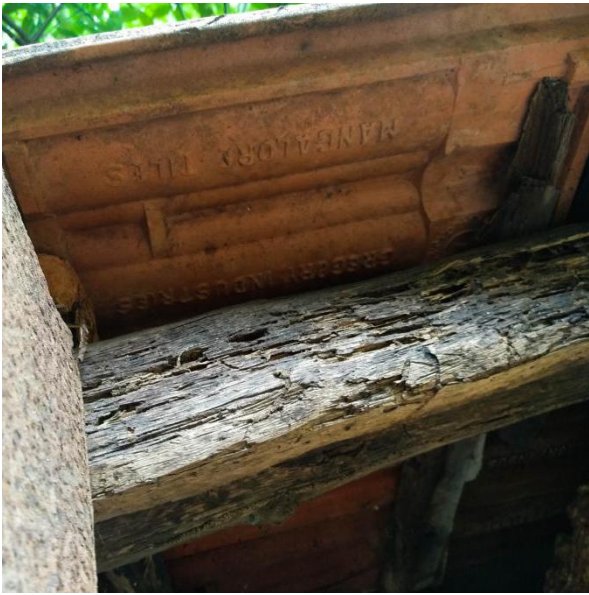
Damages incurred / problems faced: Roof-frame is rotting.

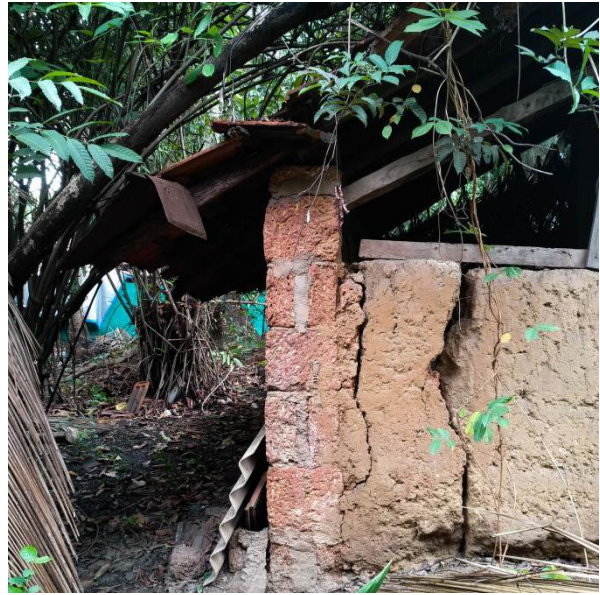
Damages incurred / problems faced: Structural cracks.

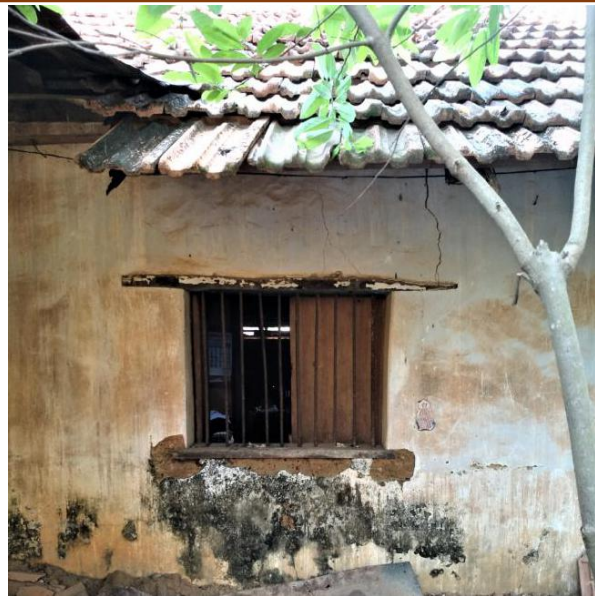
Damages incurred / problems faced: Cracks, especially near lintels.

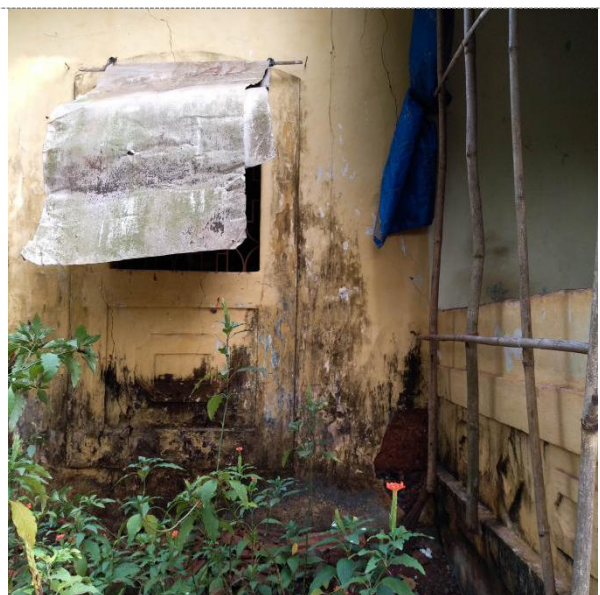
Maintenance and repairs: A make-shift overhang covers the window on the front facade.

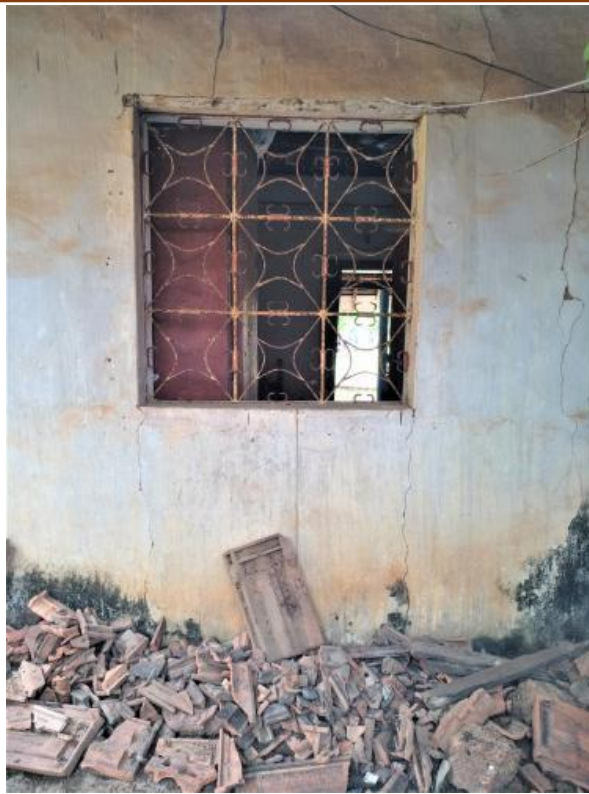
Image 138: The lack of support provided by rotting lintels caused the roof to put pressure on the wall, and created many cracks around the window (Survey no. 7).

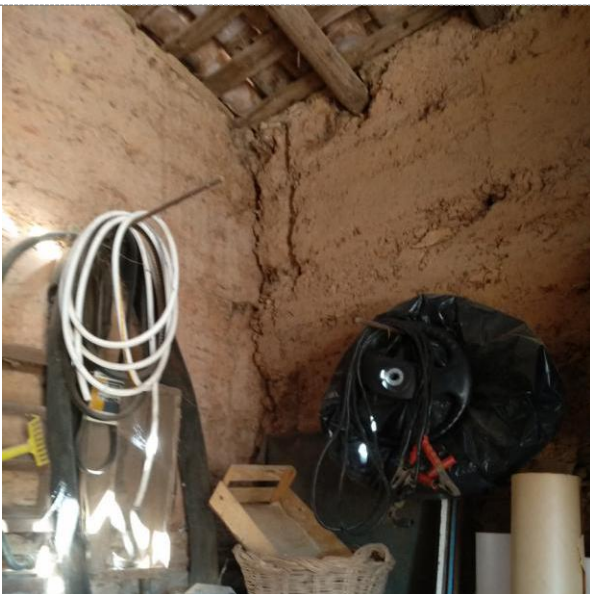
Damages incurred / problems faced: Cracks in corners.

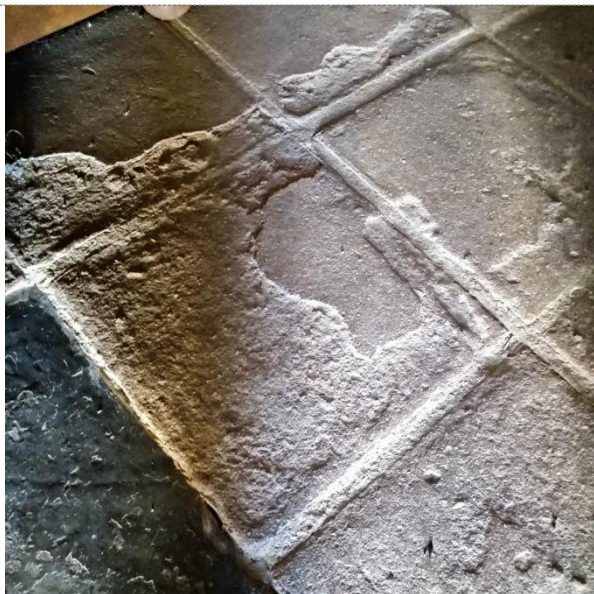
Damages incurred / problems faced: Clay 'baldosa' floor-tiles are chipped-off in some places.

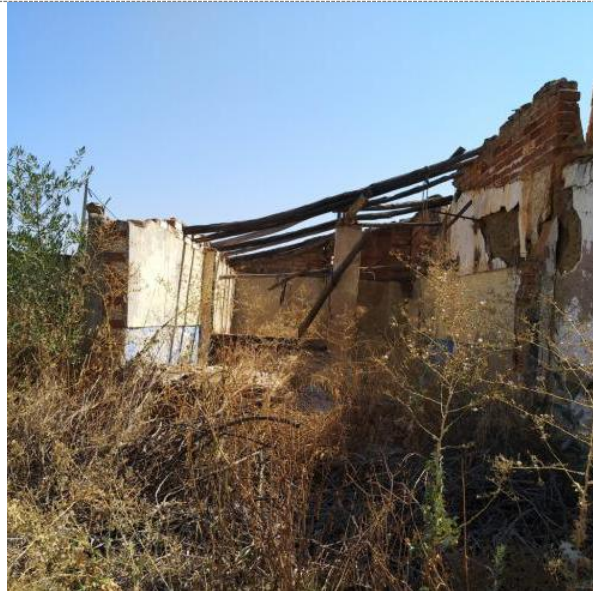
Damages incurred / problems faced: The house is in ruins, and there is vegetation inside and around it.
