Comparison of the vernacular earthen architecture in Goa (past Portuguese colony in India) and Alentejo (Portugal): local building cultures and conservation approaches

Mémoire du
Diplôme de Spécialisation et d'Approfondissement — Architecture de Terre et Patrimoine,
DSA-Terre 2016 - 2018

RODRIGUES Chenelle Fatima

Janvier 2020

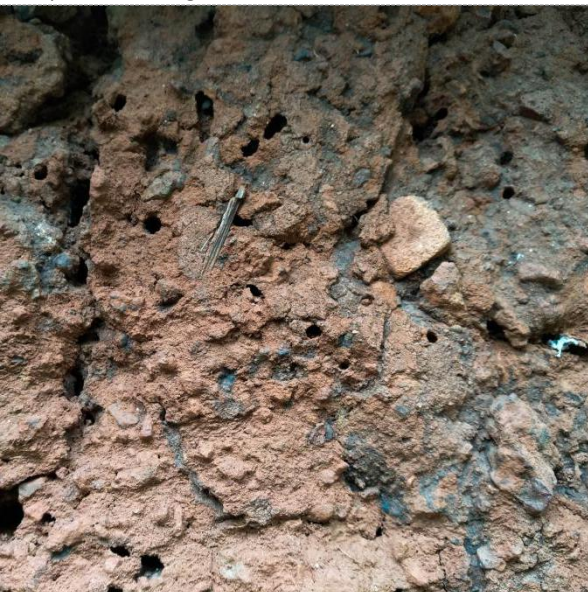
Damages incurred / problems faced: Mason-bee holes

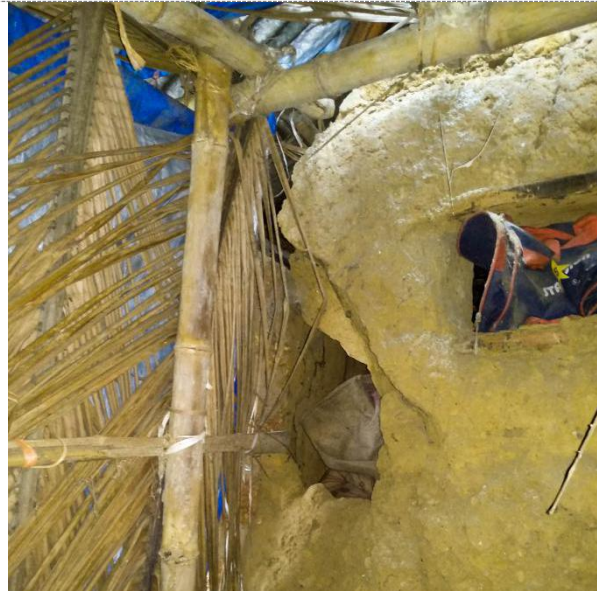
Damages incurred / problems faced: A crack in the roof caused rainwater to seep into the walls and created a hole in the corner.
