# Comparison of the vernacular earthen architecture in Goa (past Portuguese colony in India) and Alentejo (Portugal): local building cultures and conservation approaches

Mémoire du  
Diplôme de Spécialisation et d'Approfondissement — Architecture de Terre et Patrimoine,  
DSA-Terre 2016 - 2018

**RODRIGUES Chenelle Fatima**

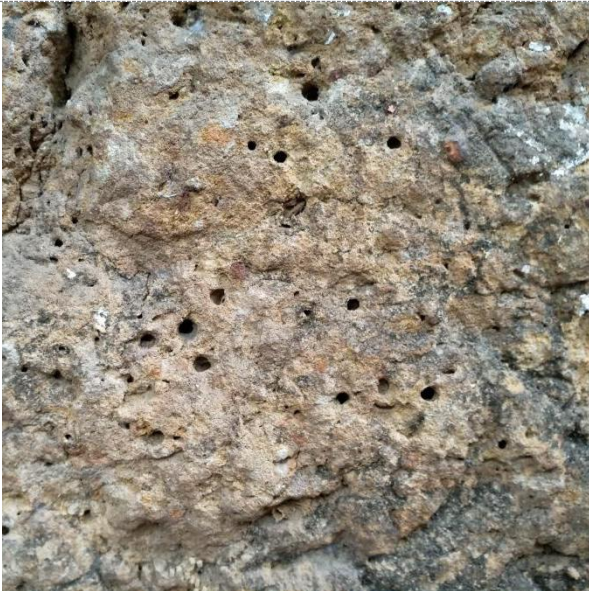
Damages incurred / problems faced: Mason-bee holes.

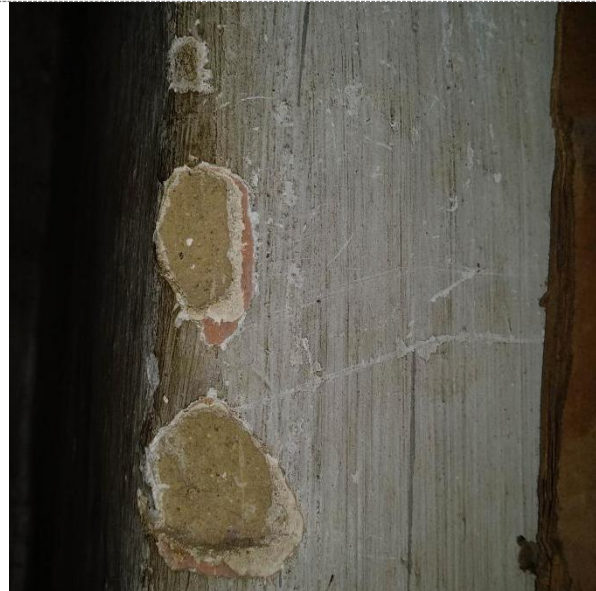
Damages incurred / problems faced: Plasters flaking and falling-off.

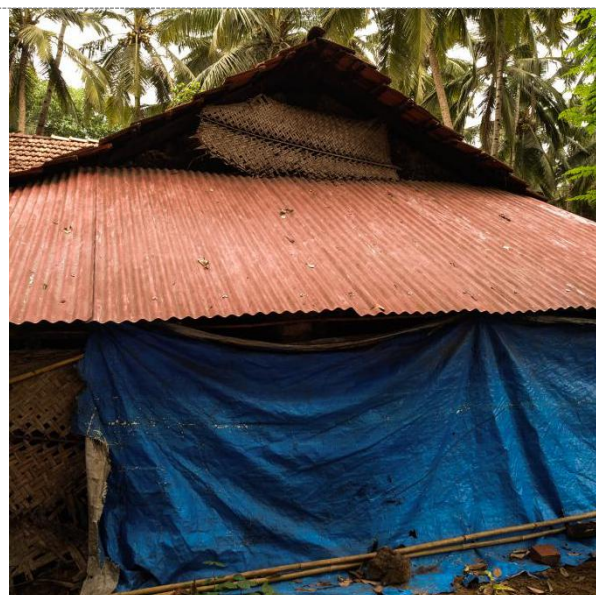
Maintenance and repairs: A woven coconut-frond ('molla') protects the gable from the sprays of rainwater.

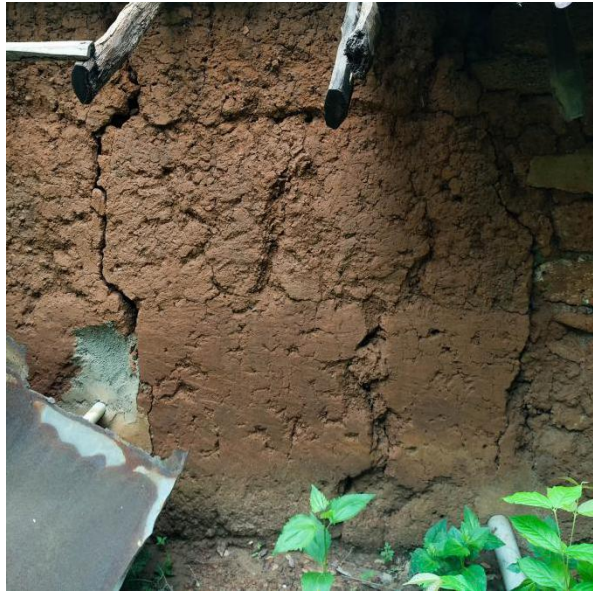
Observations: Some parts of the wall are less eroded than the others.

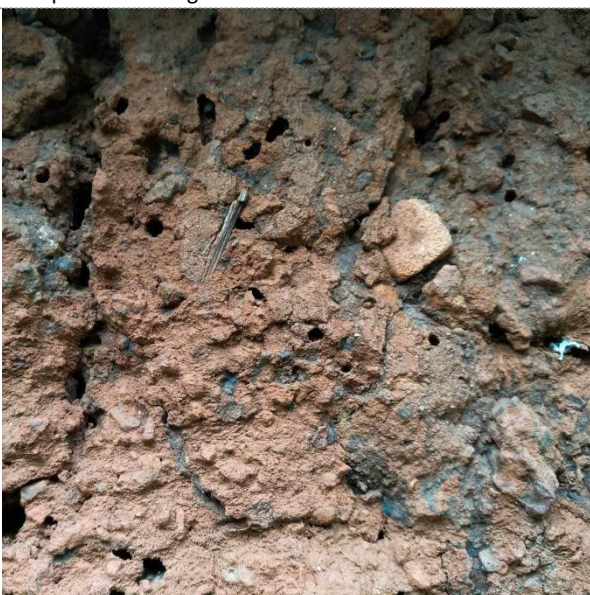
Damages incurred / problems faced: Mason-bee holes

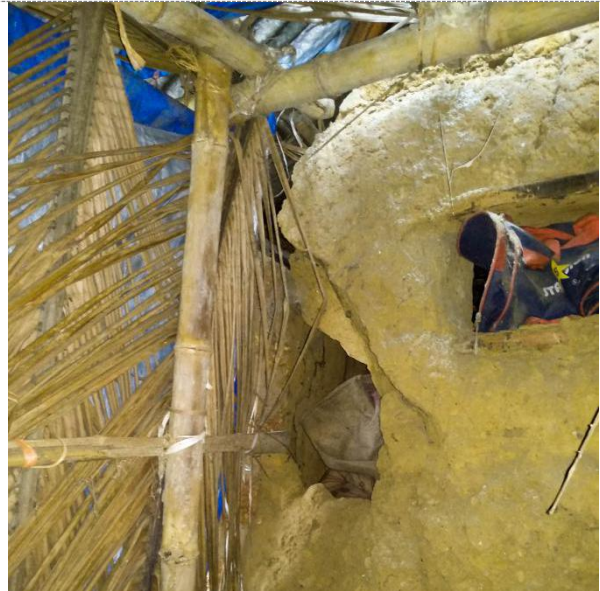
Damages incurred / problems faced: A crack in the roof caused rainwater to seep into the walls and created a hole in the corner.

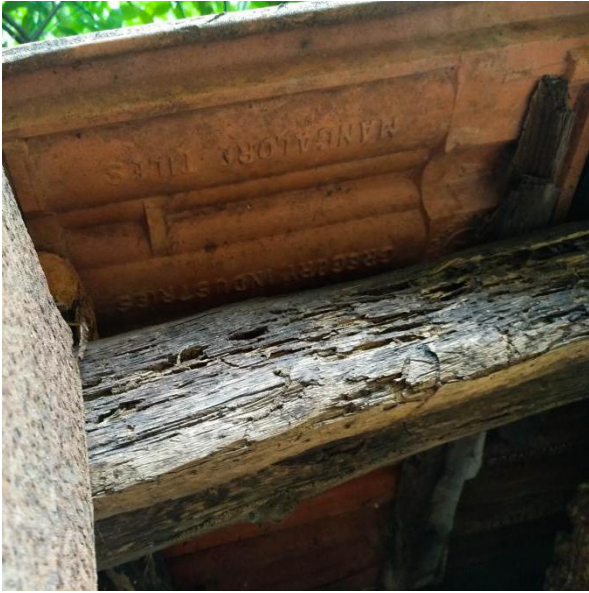
Damages incurred / problems faced: Roof-frame is rotting.

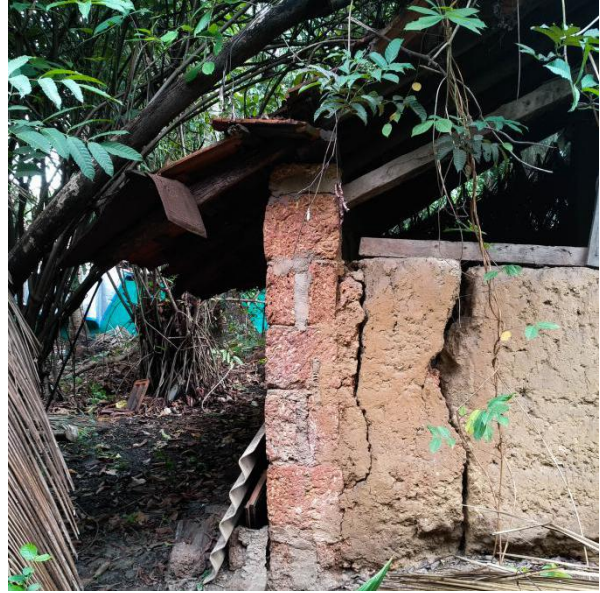
Damages incurred / problems faced: Structural cracks.

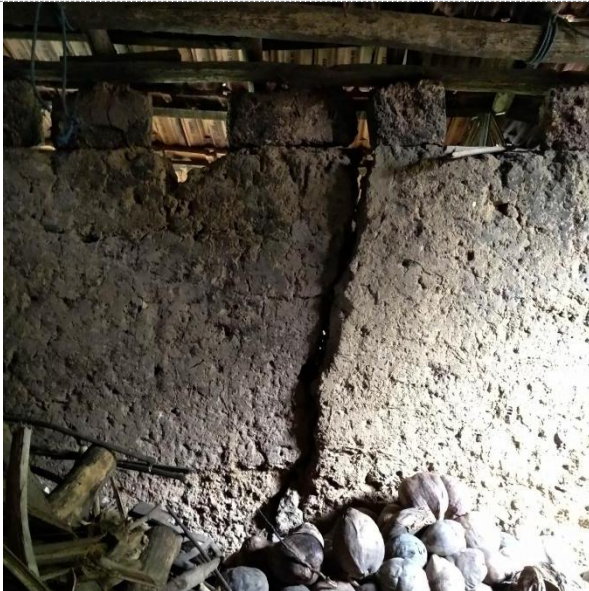
Damages incurred / problems faced: Structural cracks.

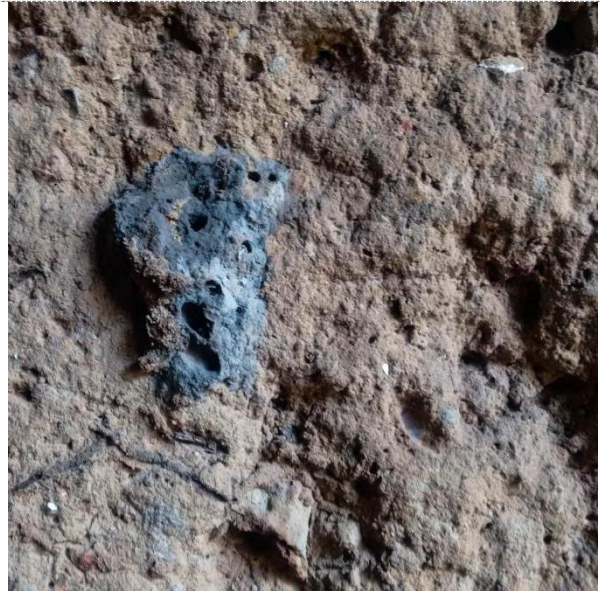
Damages incurred / problems faced: Insects have built earthen-nests on wall.

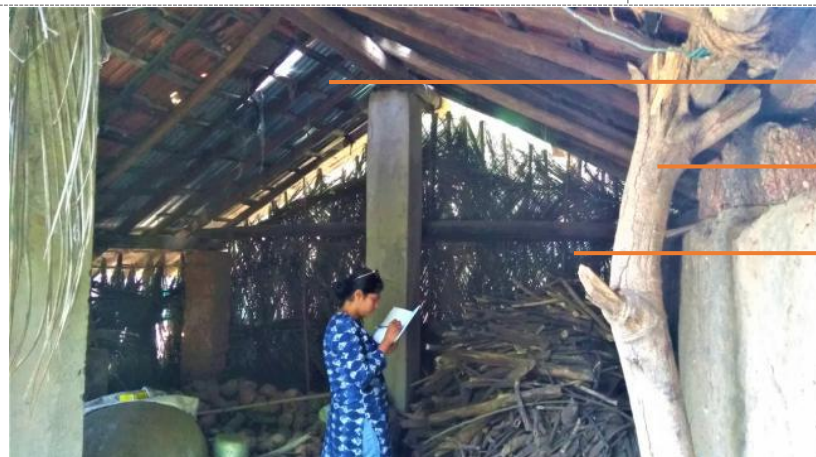
→ Metal-sheets cover damaged parts of roof.

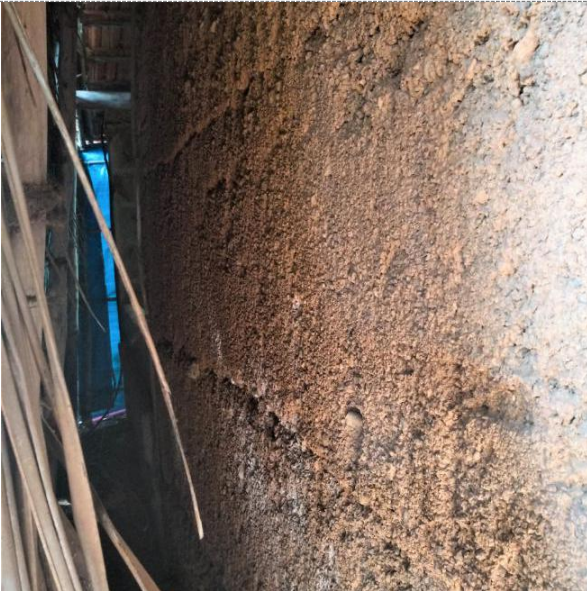
(South wall.)

Maintenance and repairs: The entire south facade is protected by a coconut-palm barrier to protect the wall from rainwater. The south wall is thus less eroded than the north.

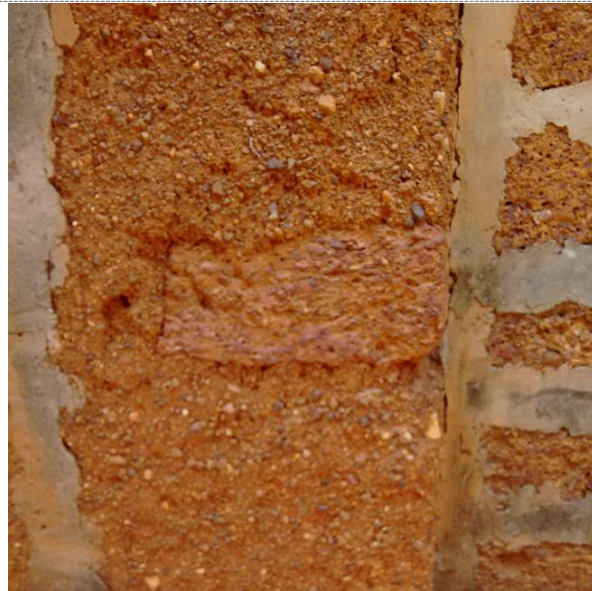
(North wall.)

Damages incurred / problems faced: Cracks.

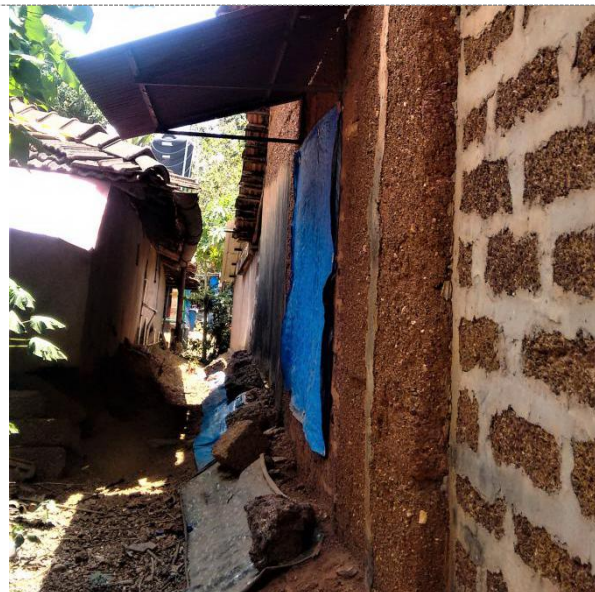
Maintenance and repairs: Overhangs over facade windows protect interiors from rainwater. The gradient and window along the north are covered with Tarpaulin.

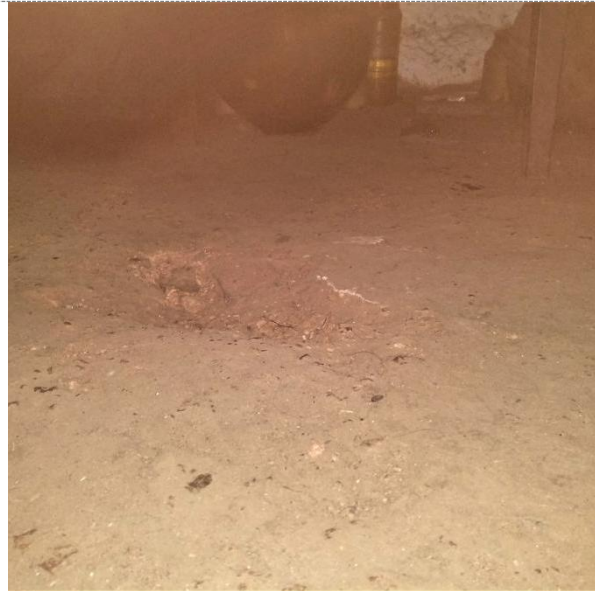
Damages incurred / problems faced: Holes and chipping on flooring.

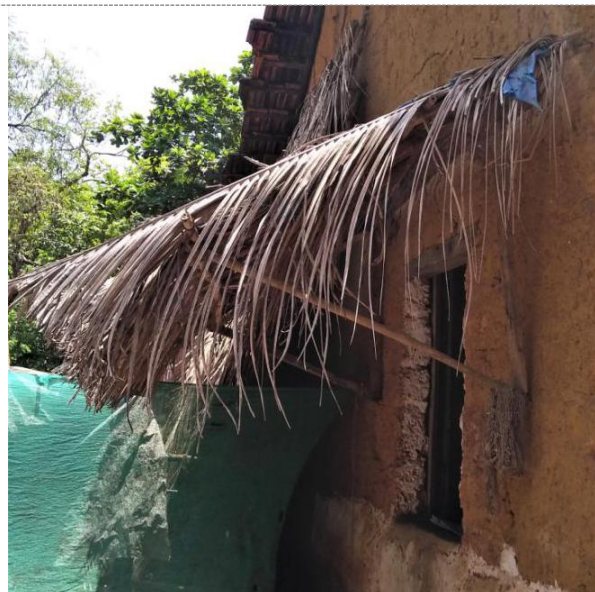
Maintenance and repairs: Every year before the monsoons, old palm-leaf overhangs are replaced with new ones.

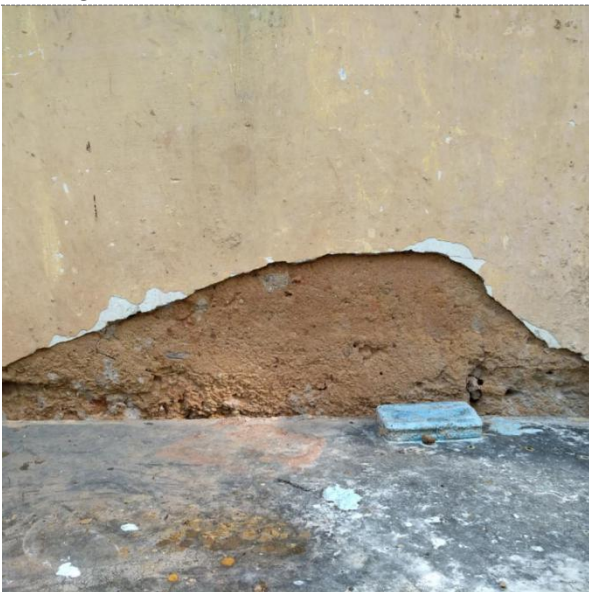
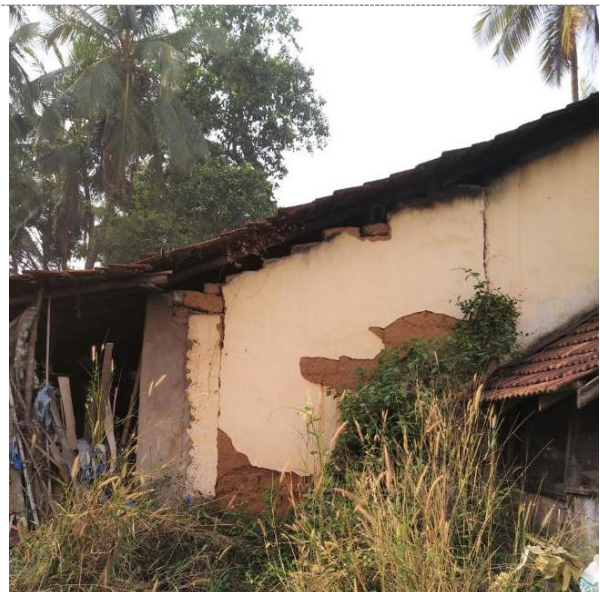
Damages incurred / problems faced: Flaking and falling plasters.

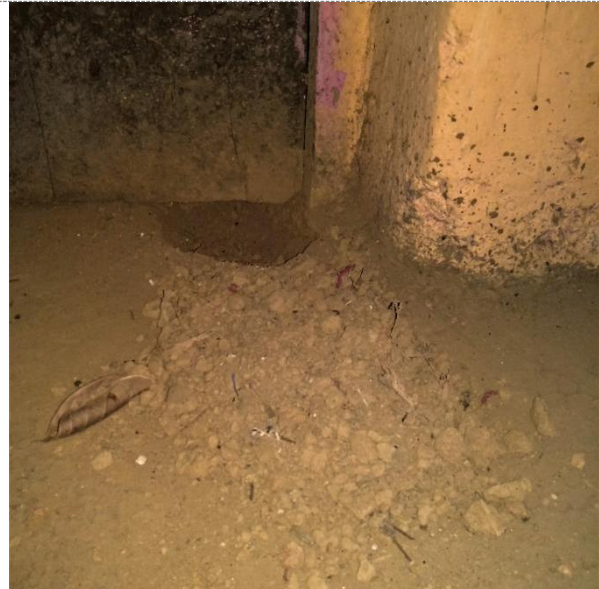
Damages incurred / problems faced: Rats holes. Rats come into the house to eat the rice grains stocked inside.

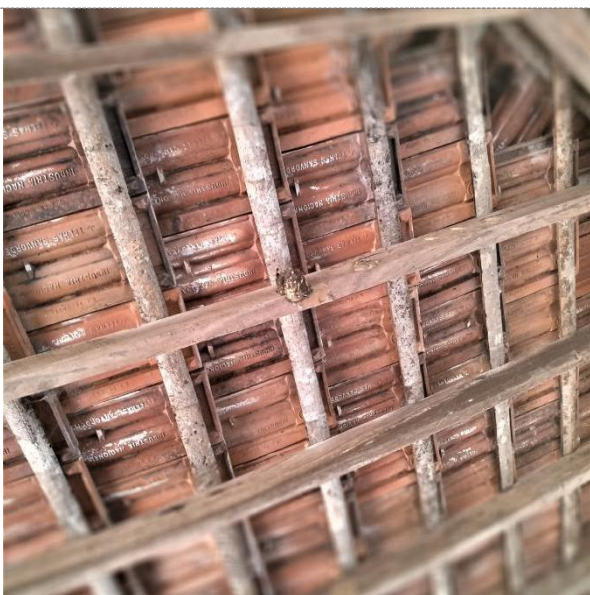
Damages incurred / problems faced: Insects called 'bateen' make nests out of mud on roofs.

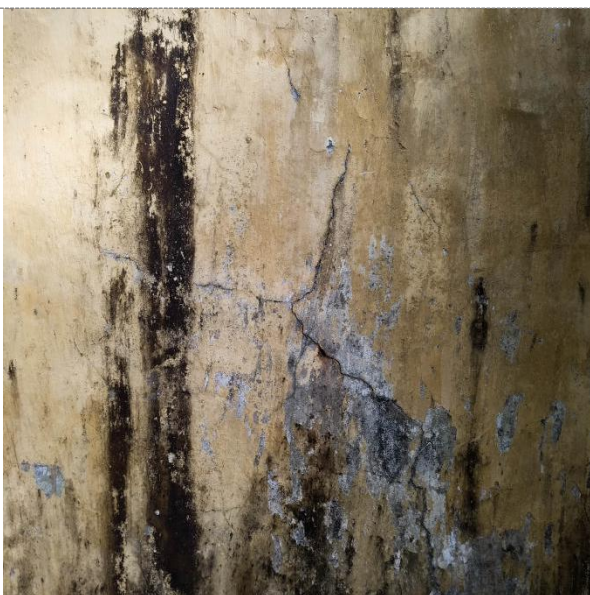
Damages incurred / problems faced: Cracks and dampness

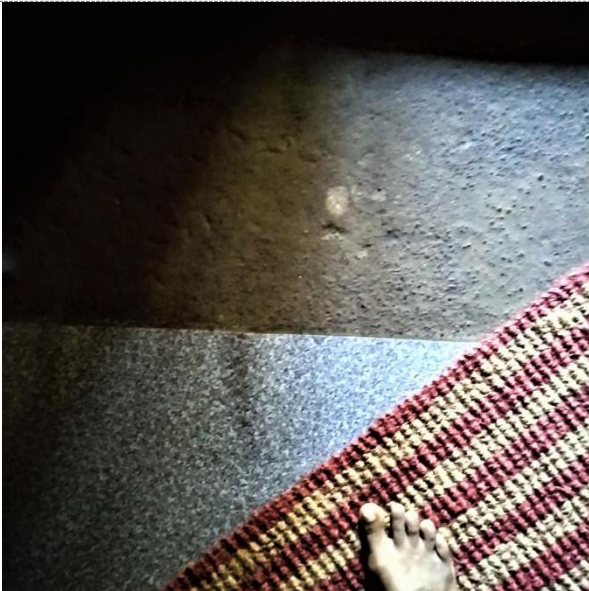
Maintenance and repairs: In the hall, the cow-dung floor is retouched less often as it has a temporary covering, which protects the cow-dung floor.

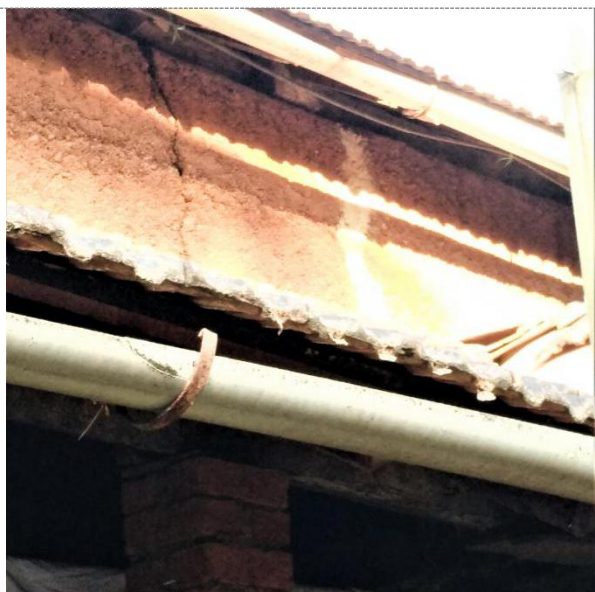
Damages incurred / problems faced: Cracks.

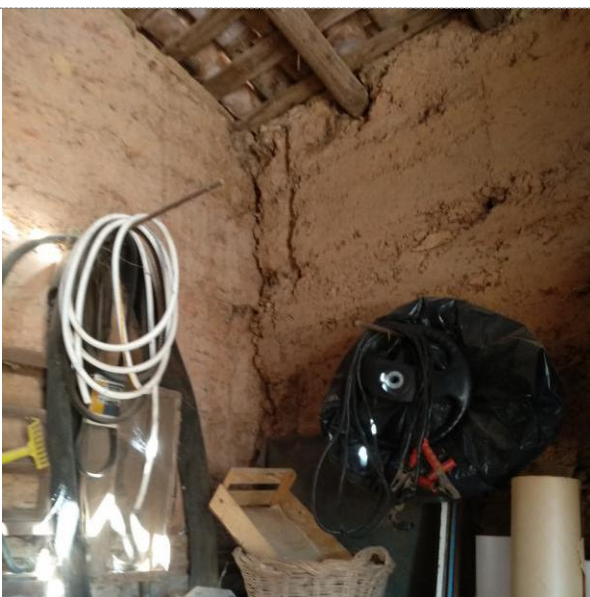
Damages incurred / problems faced: Cracks in corners.

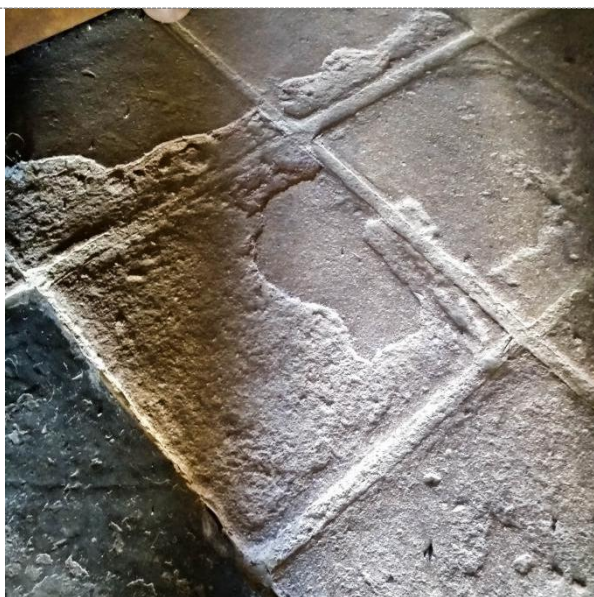
Damages incurred / problems faced: Clay 'baldosa' floor-tiles are chipped-off in some places.

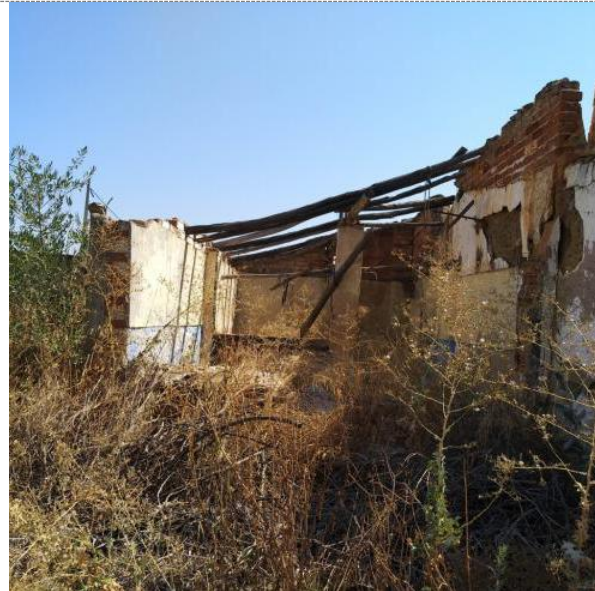
Damages incurred / problems faced: The house is in ruins, and there is vegetation inside and around it.

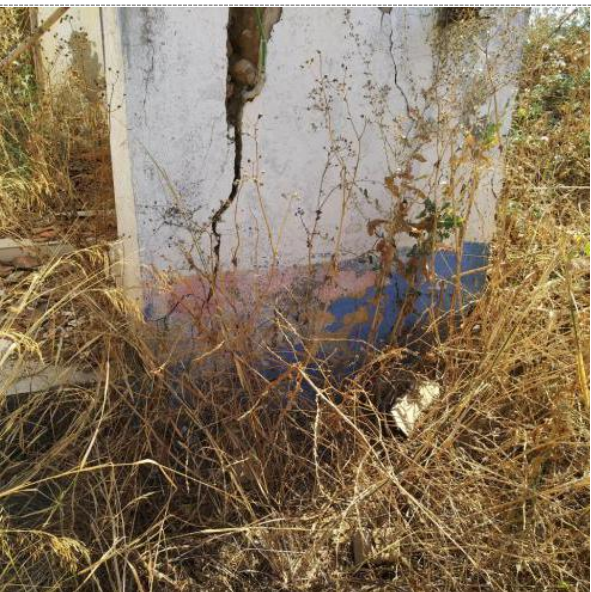
Damages incurred / problems faced: Cracks appeared and the walls began falling apart.
