# Comparison of the vernacular earthen architecture in Goa (past Portuguese colony in India) and Alentejo (Portugal): local building cultures and conservation approaches

Mémoire du  
Diplôme de Spécialisation et d'Approfondissement — Architecture de Terre et Patrimoine,  
DSA-Terre 2016 - 2018

**Comparison of the vernacular earthen architecture in  
Goa (past Portuguese colony in India) and Alentejo (Portugal):  
Local building cultures and conservation approaches**

**RODRIGUES Chenelle Fatima**

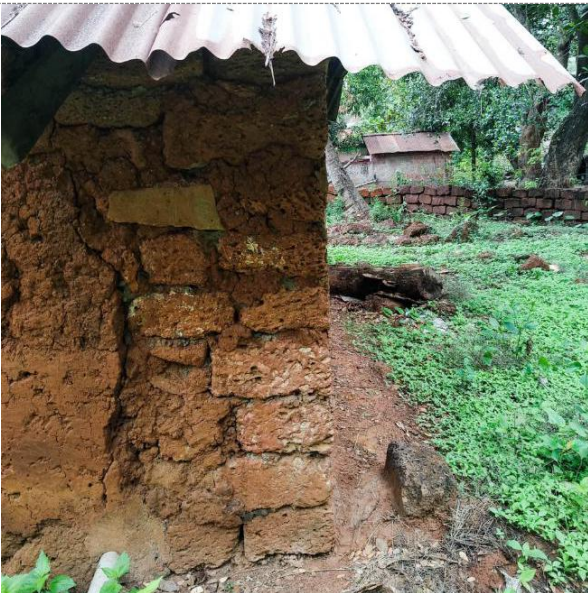
Observations: The laterite masonry in the corners has earthen or cement mortars. It is hard to say whether these corners are part of the original construction or a later addition.

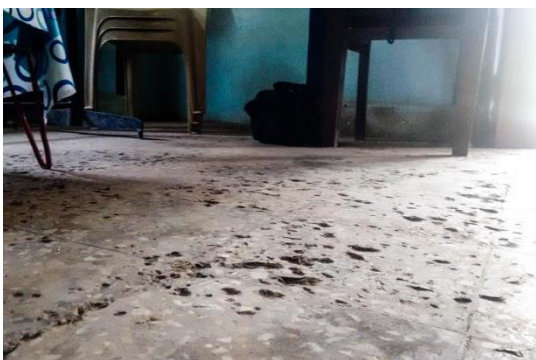
Damages incurred / problems faced:  
Chip-tiles are chipped-off.

**Observations:** Water run-off on east wall, oyster shell windows are not in a good condition, the floor in the hall has a hole and the chip-tiles are chipped-off.

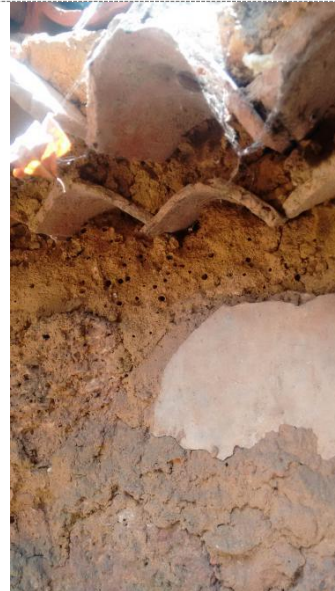
Damages incurred / problems faced: Mason-bee holes on the repaired part.

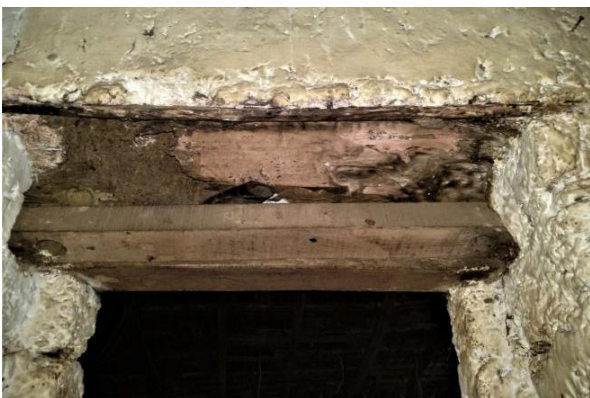
Damages incurred / problems faced: Rotting of lintels.

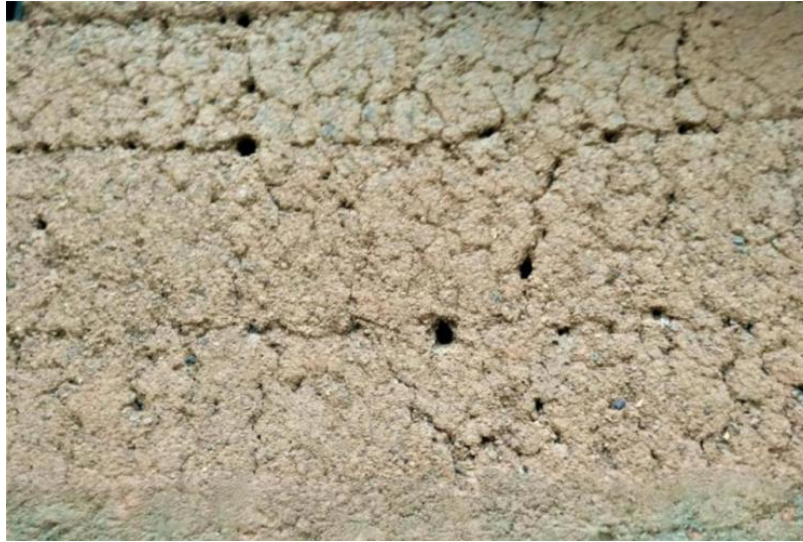
In Survey no. 11, there were holes along the horizontal 'lift' joints, which perhaps indicates the use of form-work in cob construction.

**Image 70: Holes along the horizontal 'lift' joints, which perhaps indicates the use of form-work in cob construction (Survey no. 11).**

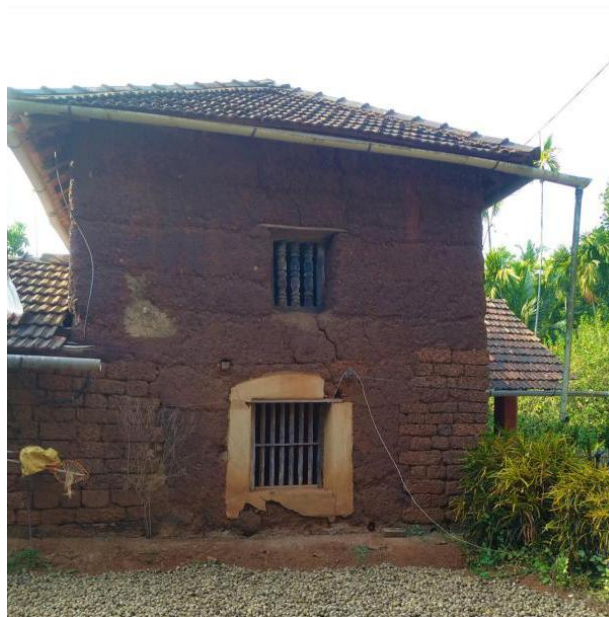
Similarly, the corners were in earth in Survey nos. 12 and 13. In Survey no. 15, the lower walls had laterite masonry corners, and the upper walls were in earth.

In Survey no. 15, some parts of the walls were also built in laterite masonry.

**Image 76:** Corners; lower walls in laterite masonry, upper walls in earth. Some parts of the walls were also built in laterite masonry. (Survey no. 15)

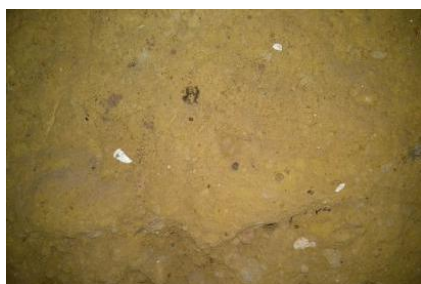
Image 80: Yellowish soil; includes clay, sand, and rubble (Survey no. 4).

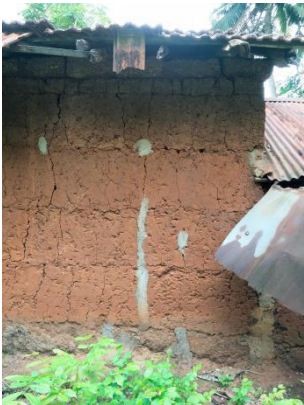
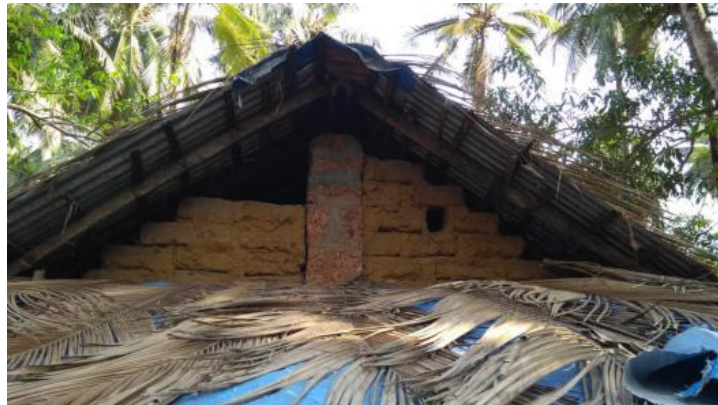
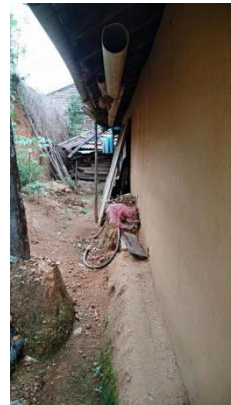
Image 83: Cob (Survey no. 2). Image 84: Adobe-bricks (Survey no. 4). Image 85: Rammed-earth (Survey no. 13).

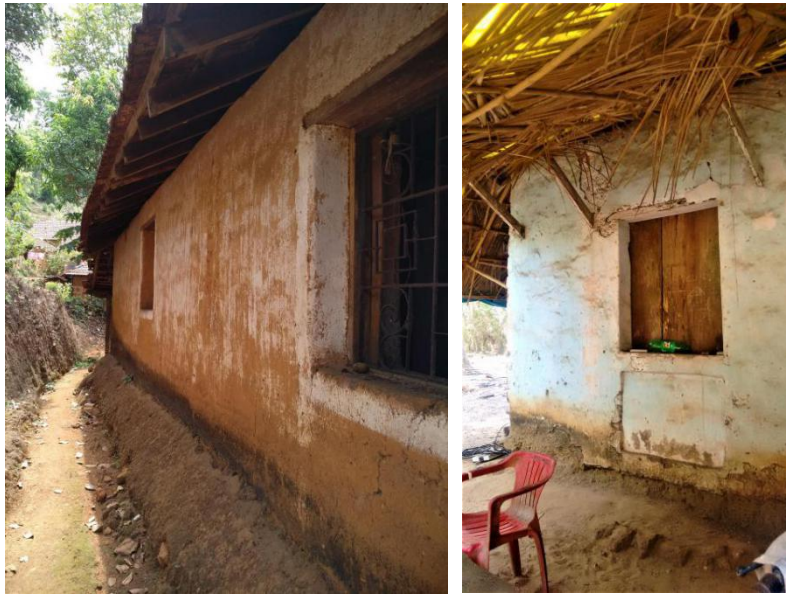
Image 87: A small, earthen gradient covered the foot of external walls (Survey no. 12).

Image 88: Sometimes, laterite-stones fringe the gradient (Survey no. 1).

The earthen gradient acts as a barrier, and aids keeping rainwater from seeping into the wall. As spelled-out by Romeo (Survey no. 2), if rainwater accumulated around the house and rose by a few centimeters, the slope would prevent the water from entering the wall. However, if there is a flood, the slope would not help.

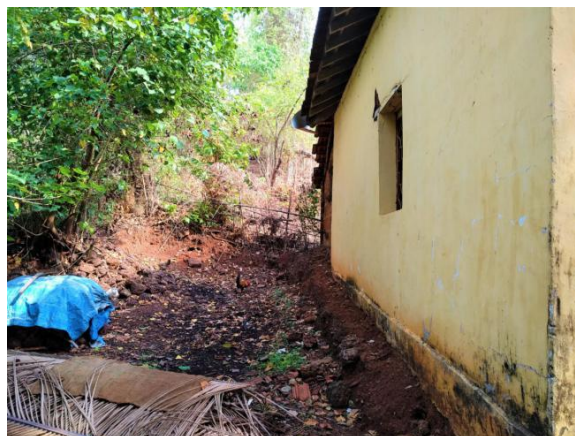
Image 89: Setback along the base-course (Survey no. 14).

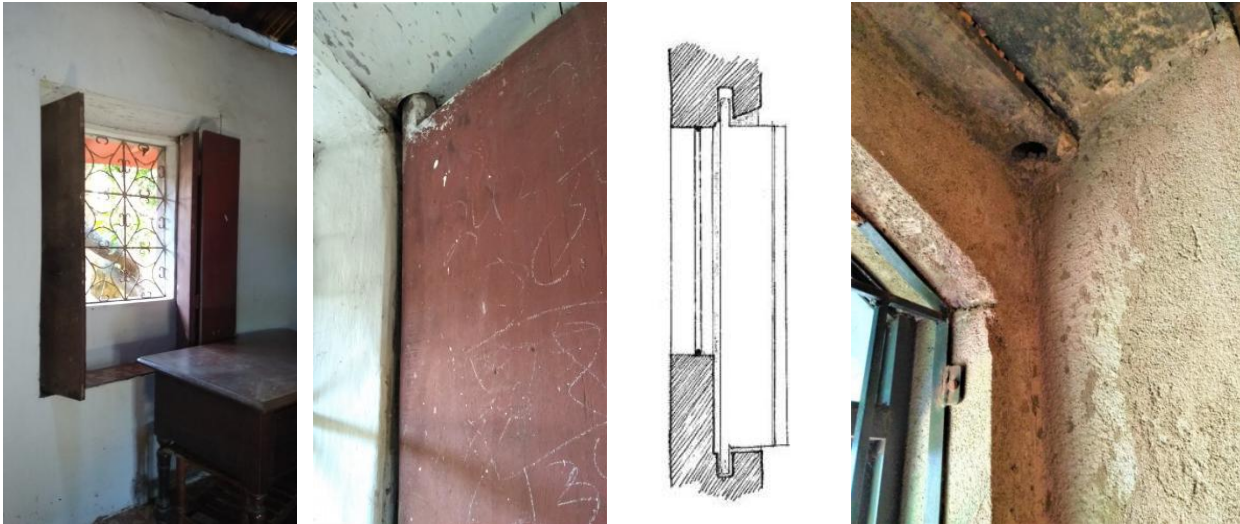
Image 94, Image 95 and Image 96: The wooden shutters constitute a protruded extension in the inner corners, which served as hinges. These elongated corners were loosely fitted into holes made in the lintel. This provision facilitated the opening and closing the shutters. (Survey no. 7). Image 97: Evidence of holes in the lintels suggests that that the old-styled hinged windows once existed (Survey no. 6).

In Survey no. 6, the window shutters were replaced with modern ones but evidence of holes in the lintels suggests that that the old-styled hinged windows once existed.

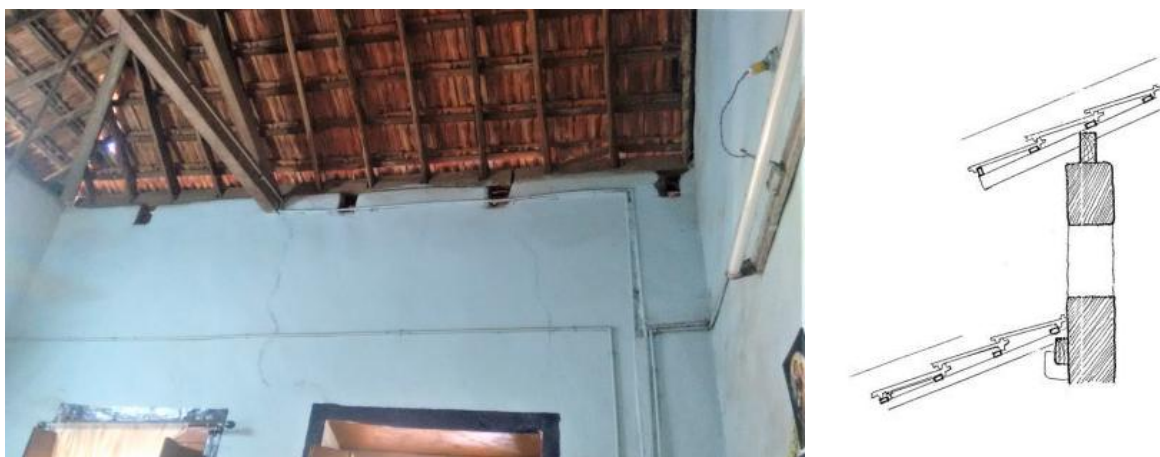
Image 98: Vents along wall tops (Survey no. 3a). Image 99: Section of a vent (Survey no. 11).

It is possible that these vents are actually openings left from previous rafters.

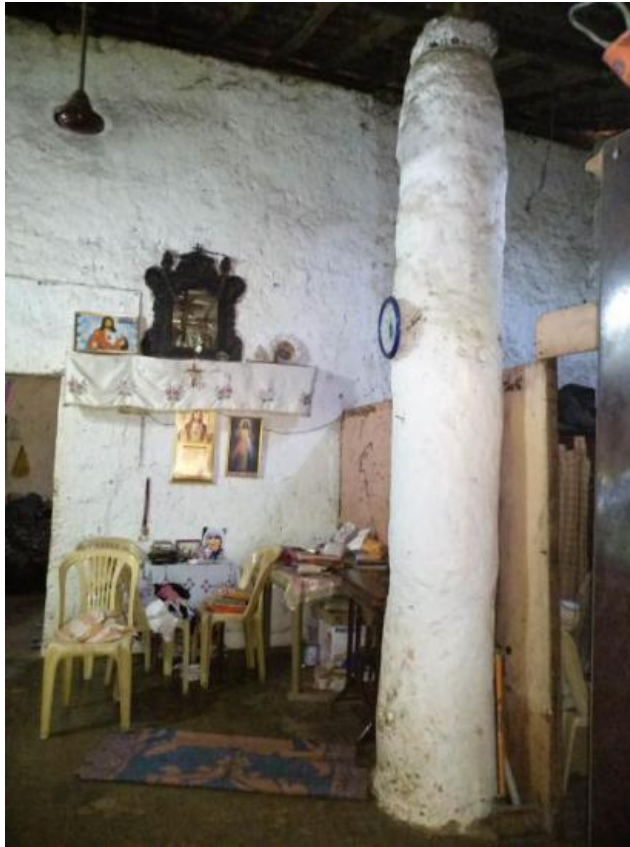
Image 100: Earthen pillar (Survey no. 8).

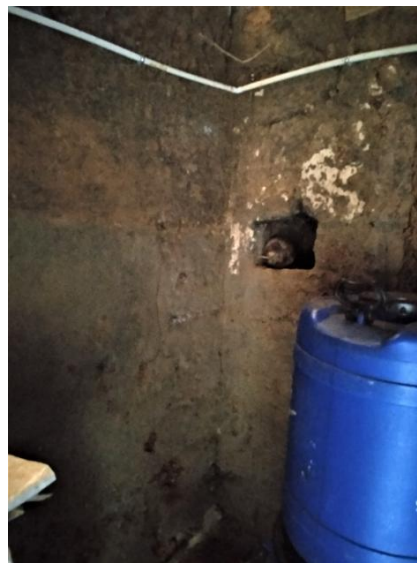
The niches seem to be constructed in laterite masonry, as visible in Survey no. 9, where the walls are not plastered.

Image 102 and Image 103: Laterite masonry niches in earthen walls (Survey no. 9).

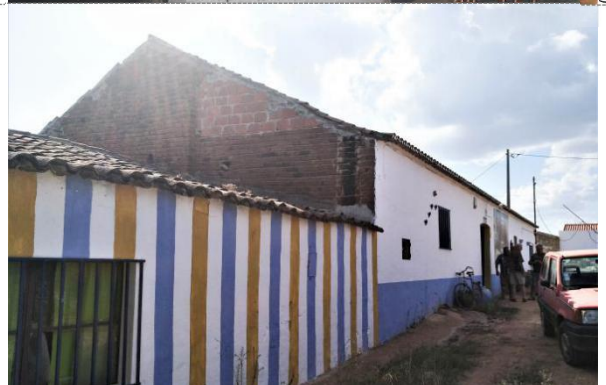
In 2018

Roof replaced, workers' quarters converted into an atelier, chimney torn-down and east gable wall partly reconstructed, facade walls repainted in white, blue and yellow.

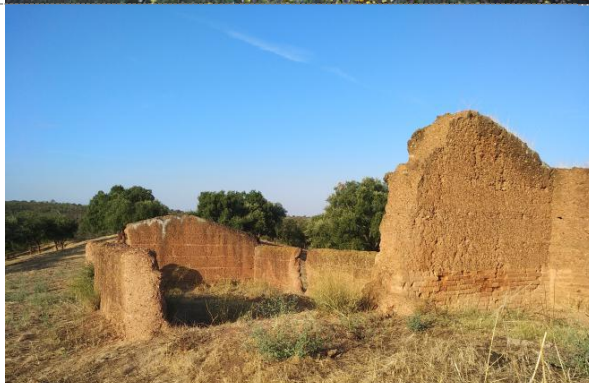
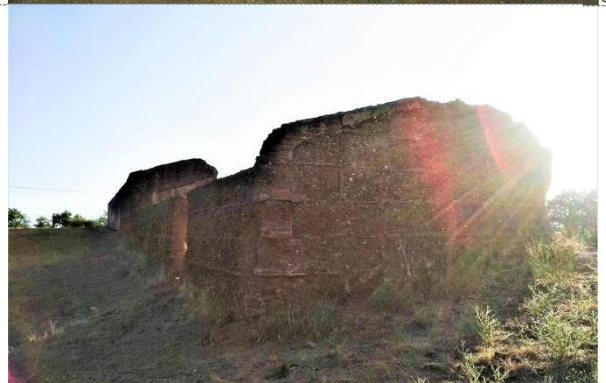
In 2018

Parts of rammed-earth walls have fallen.
