Comparison of the vernacular earthen architecture in Goa (past Portuguese colony in India) and Alentejo (Portugal): local building cultures and conservation approaches

Mémoire du
Diplôme de Spécialisation et d'Approfondissement — Architecture de Terre et Patrimoine,
DSA-Terre 2016 - 2018

RODRIGUES Chenelle Fatima

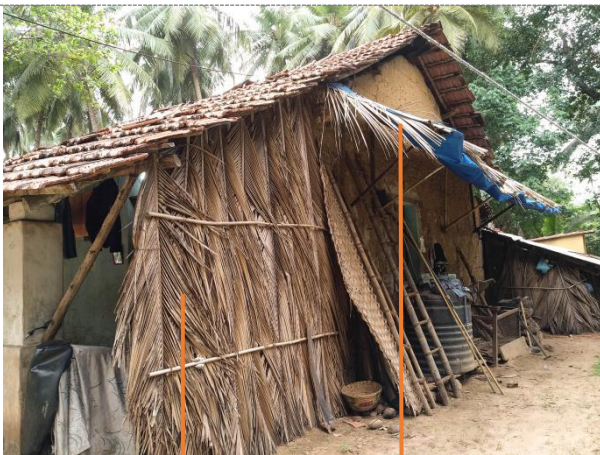
Palm-leaf barrier along walls ('dollo').

Palm-leaf overhang ('pakadi').

Maintenance and repairs: Woven coconut-palms ('molla'), palm-leaf barriers ('dollo'), and overhangs ('pakadi') are used to protect walls from rainwater.

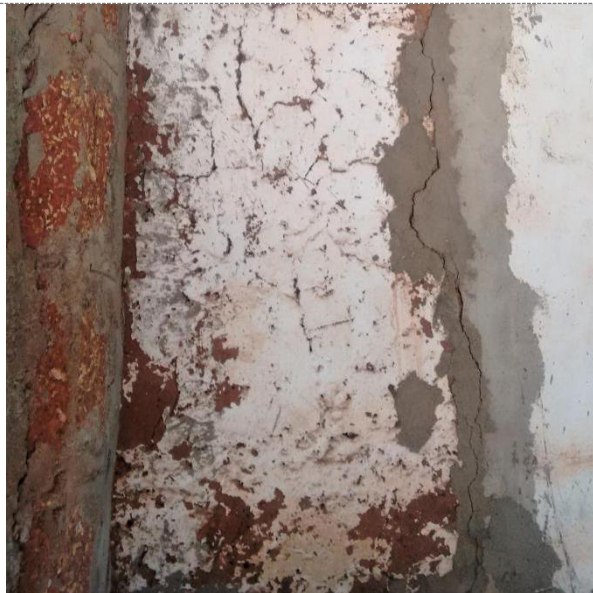
Plasters: A coat of lime or paint on south facade.

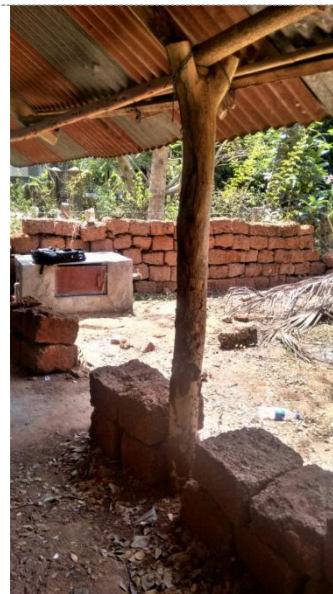
Observations: A make-shift lean-to aids in protecting facade walls from rain water. Simple branches are used to support the roof of the lean-to.

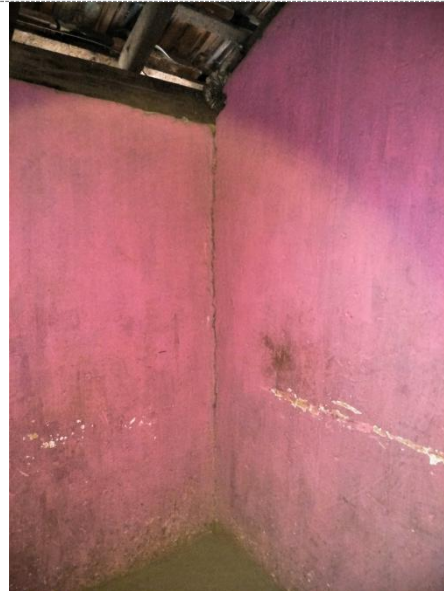
Damages incurred / problems faced: A crack appeared just after the construction was complete.

A crack appeared just after the construction was complete.

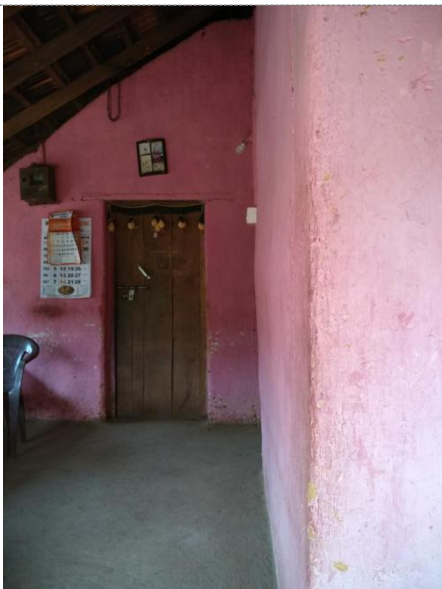
Damages incurred / problems faced: Bulging of wall.

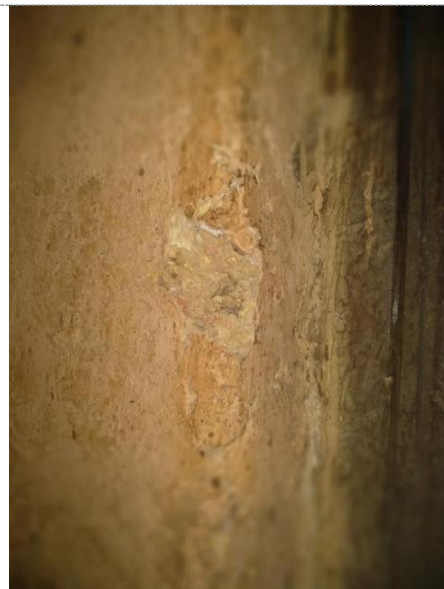
Damages incurred / problems faced: Chipping of wall edges.

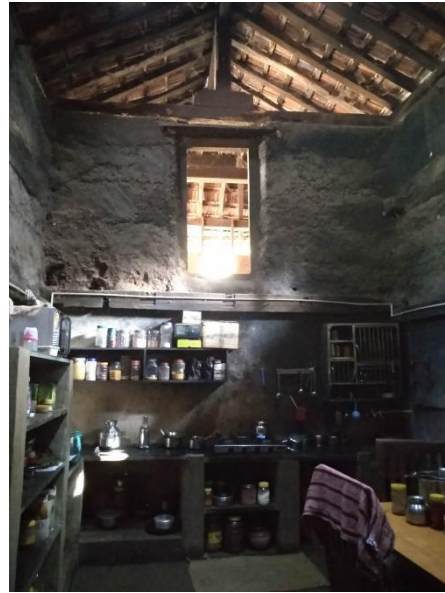
Restorations and/or interventions: Earlier, there used to be a loft in the kitchen, which is now taken-off. The door to the loft can still be seen.

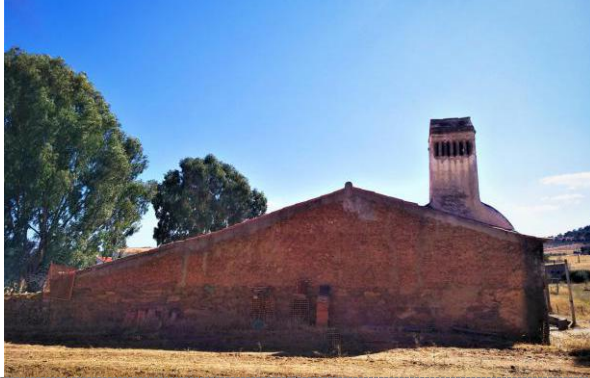
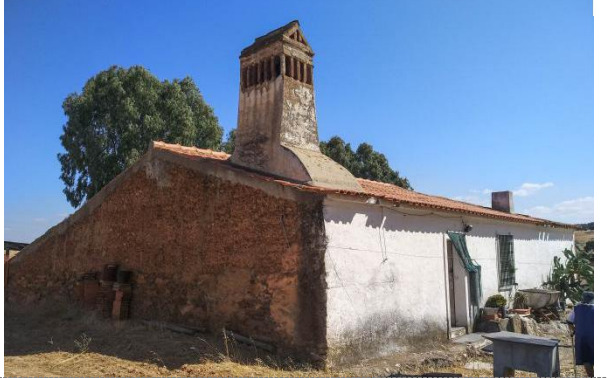
In 2018

The roof of the lean-to has fallen. The wooden part of the east wall is now covered with panels and shutters.

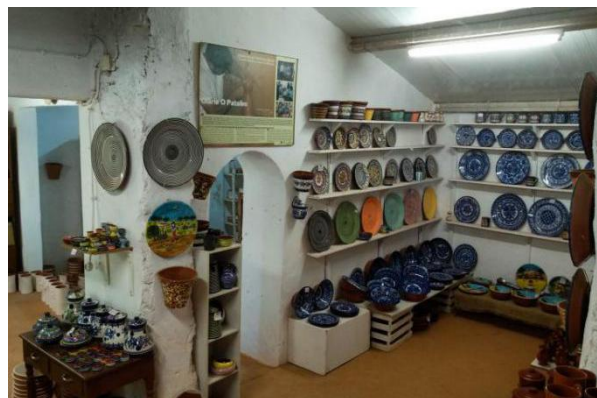
Damages incurred / problems faced: Part of the roof caught fire.

Observations: Cracks on walls, some floor-tiles chipped-off.

Repairs: Roof that caught fire was redone.

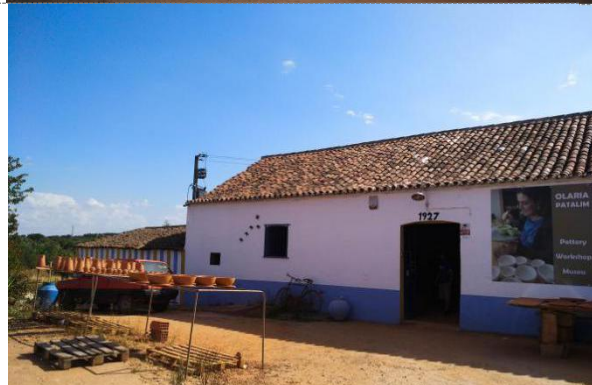
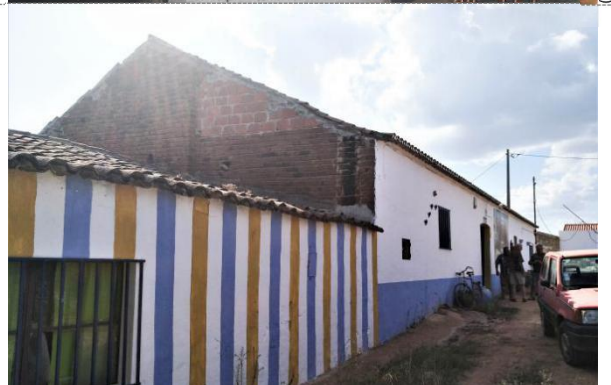
In 2018

Roof replaced, workers' quarters converted into an atelier, chimney torn-down and east gable wall partly reconstructed, facade walls repainted in white, blue and yellow.

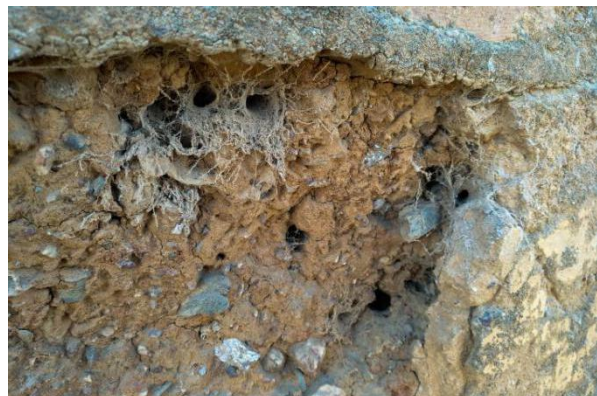
Damages incurred / problems faced: Mason-bee holes.

Observations: Walls and roof in ruins, cracks on walls, falling plasters, mason-bee holes, damaged fire-bricks (probably not part of the original construction), vegetation in and around the building.

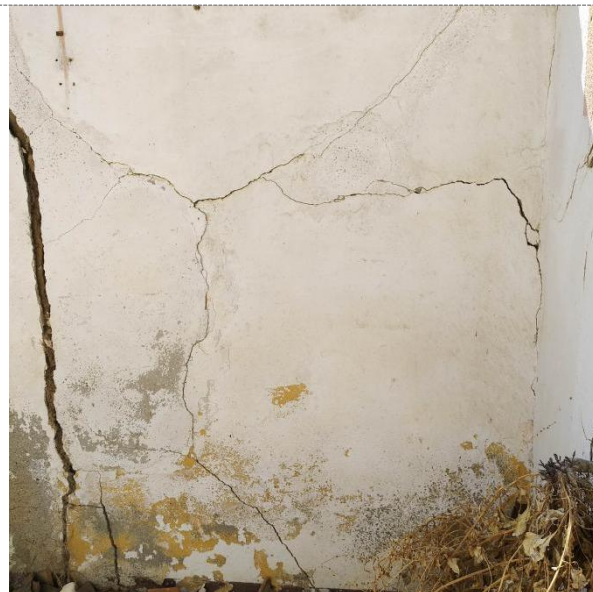
Damages incurred / problems faced: Cracks appeared and the walls began falling apart.

The house was poorly maintained and hence was not in the best condition when Joaquim bought it. There were problems mainly with the walls because they were exposed. There were cracks and the walls began falling apart.

Repairs: The walls were coated with lime. Yellow water-based paint (referred to as 'tinta da agua' in Portuguese) was used on walls. The worker's family did it themselves.

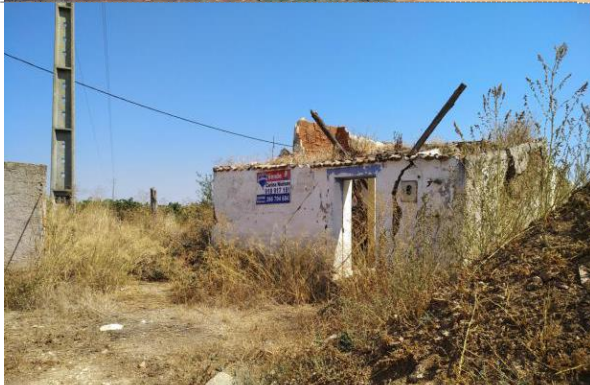
In 2018

The house is in ruins. The chimney and roof have fallen, walls are cracked and broken, there are debris and abandoned cars around the house. Wall extended in brick along east facade. Wall-bases repainted in blue (records from 2000 show yellow), door border also painted.

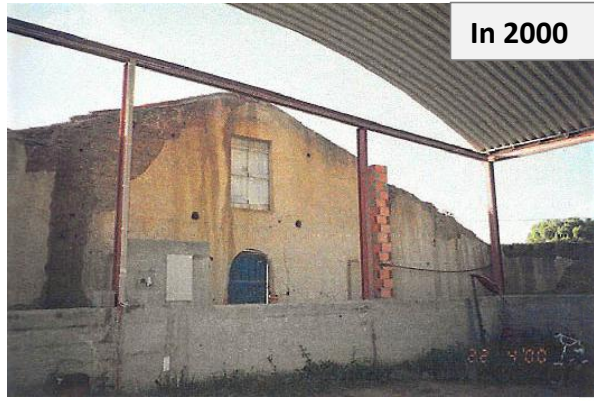
Interior view before the fire.

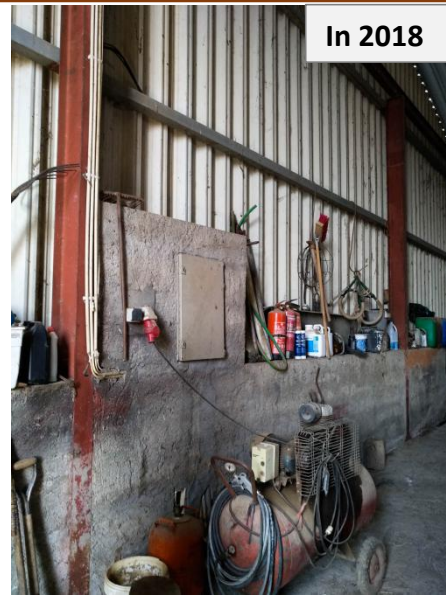
Interior view after the structure was rebuilt.

The building caught fire. No rammed-earth walls remain. It was **rebuilt**, and is covered on all four sides by cement blocks and metal sheets.

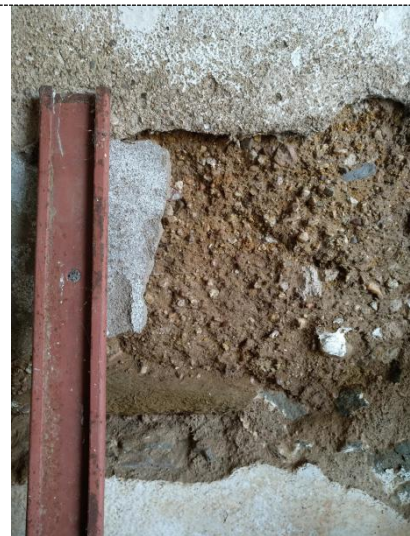
Damages incurred / problems faced: Warping, cracking and fallen plaster.

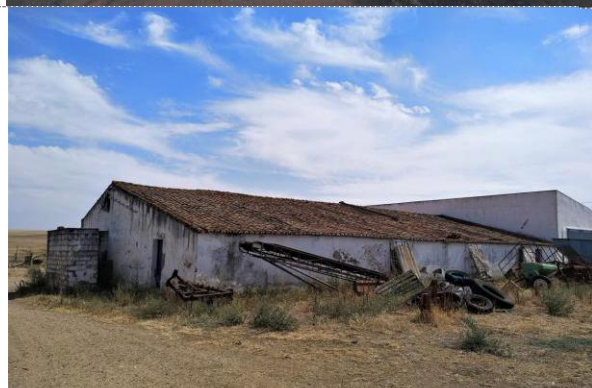
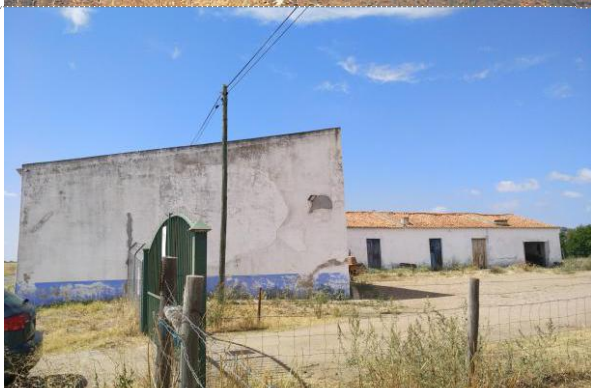
In 2018

Chimney no longer there, roof repaired, blue paint along wall-bases on front facades.

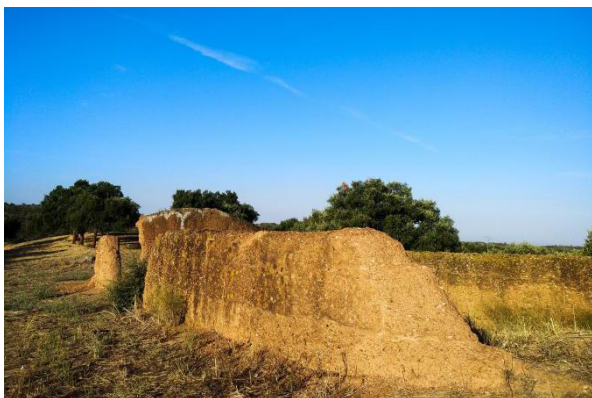
Damages incurred / problems faced: Wall damages got worse with time as the building has not had a roof for many years, some parts of the walls have fallen, vegetation in and around the structure.
