Comparison of the vernacular earthen architecture in Goa (past Portuguese colony in India) and Alentejo (Portugal): local building cultures and conservation approaches

Mémoire du
Diplôme de Spécialisation et d'Approfondissement — Architecture de Terre et Patrimoine,
DSA-Terre 2016 - 2018

**Comparison of the vernacular earthen architecture in
Goa (past Portuguese colony in India) and Alentejo (Portugal):
Local building cultures and conservation approaches**

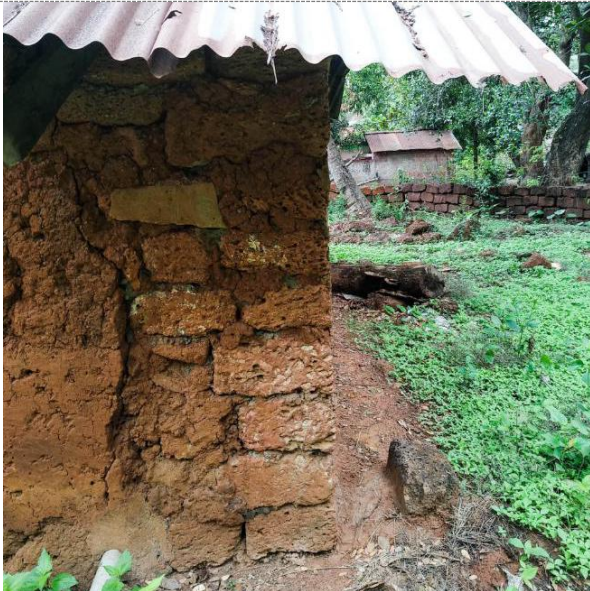
Observations: The laterite masonry in the corners has earthen or cement mortars. It is hard to say whether these corners are part of the original construction or a later addition.

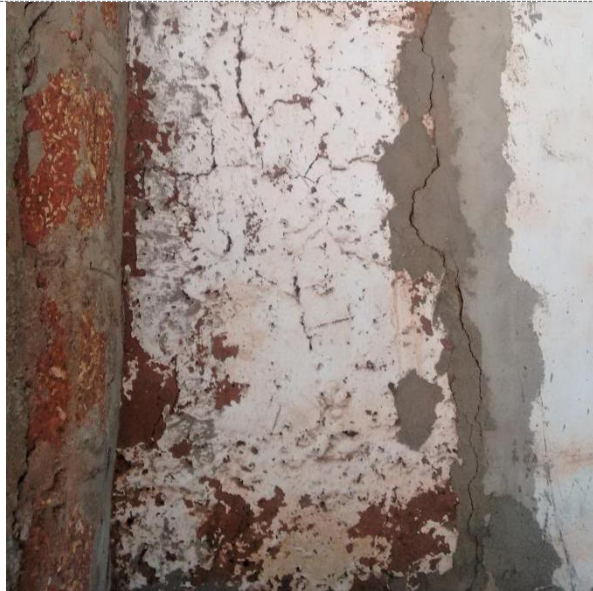
Plasters: A coat of lime or paint on south facade.

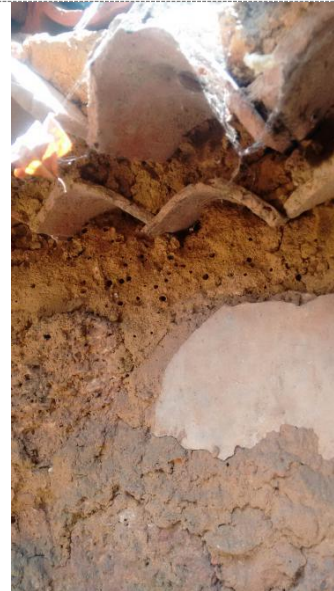
Damages incurred / problems faced: Mason-bee holes on the repaired part.

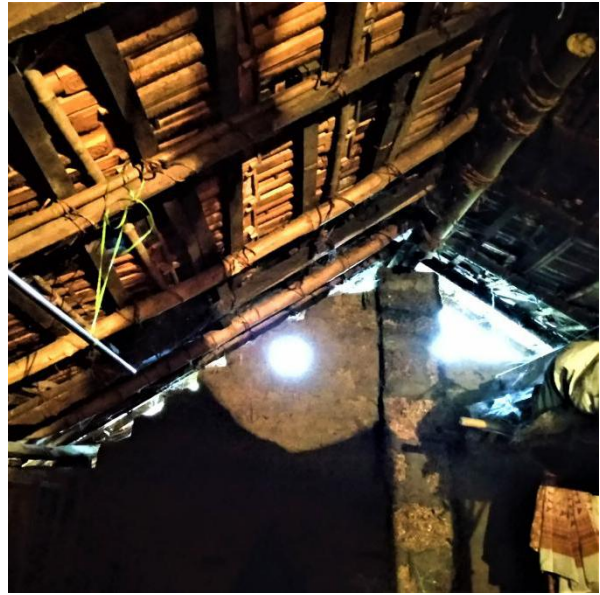
Openings: Vent in the adobe-brick gable.
The opening in the North gable is because the adobe-bricks fell short while building.

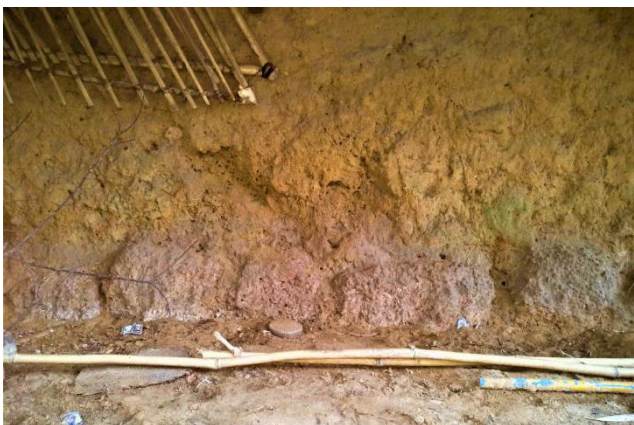
Damages incurred / problems faced: Erosion of the walls has created depressions above base-courses of external walls.

A crack in the roof caused rainwater to seep into the walls and created a hole on the north-east corner; roof problems have also damaged kitchen walls. Erosion of the walls has created depressions above base-courses on east and rear facades. Cracks, and holes created by rats, especially on kitchen walls. Insects have built earthen-nests on interior walls. Blackened kitchen walls due to smoke from wood-burning-stoves.

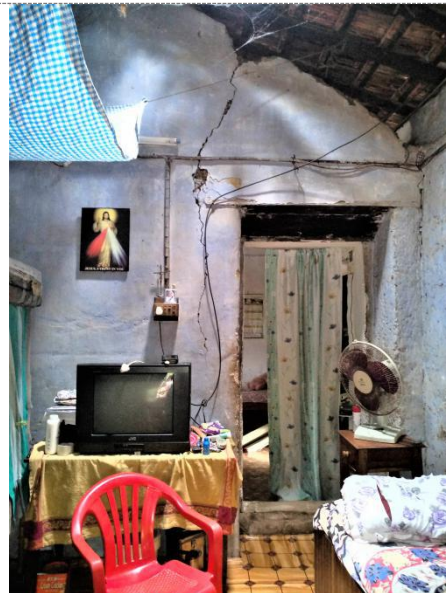
(Bedroom.)

Damages incurred / problems faced: Cement was used on one side of the wall, and the crack on the other side started getting longer (common wall that separates hall and bedroom).

4. About 3-4 years back, cement was used on a wall, and the crack on the other side of the same wall started getting longer (wall that separates hall and bedroom).

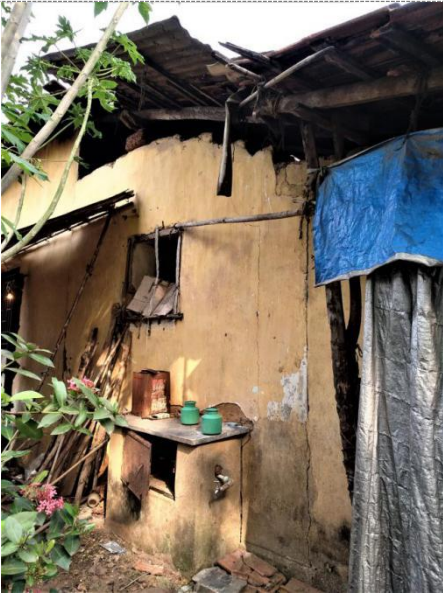
North facade, adobe-brick extension. Observations: Stepped decline on the wall top. Damages: Cracks demarcating the original, earthen-walls and the new, laterite-walls.

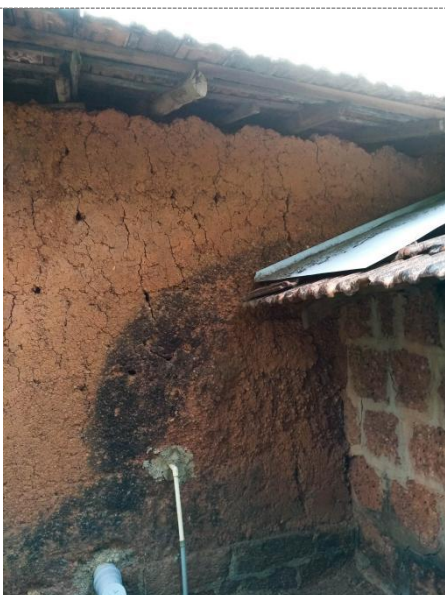
Damages incurred / problems faced: Black dampness blotch on rear wall.

Observations: Some roof-tiles missing along overhangs, evidence of termite attack on rafters, small holes in walls, black dampness blotch on rear wall.

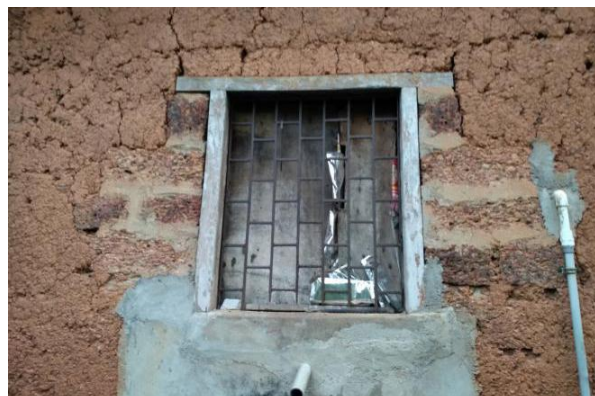
Maintenance and repairs: Cement repairs.

Repairs: Cement used to fill cracks, for re-pointing, and other repairs.

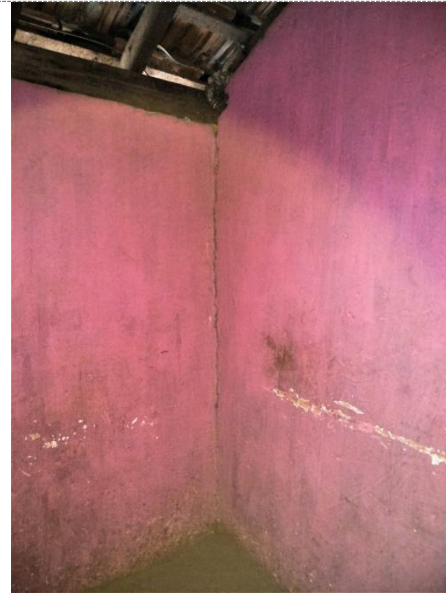
Damages incurred / problems faced: A crack appeared just after the construction was complete.

Damages incurred / problems faced:
A crack appeared just after the construction was complete.

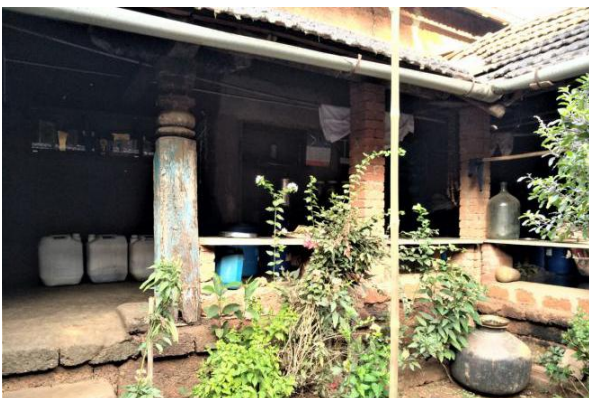
Distinct architectural details: Intricate wooden pillars once supported the veranda around the inner courtyard. Most of them are now replaced with fired-brick pillars.

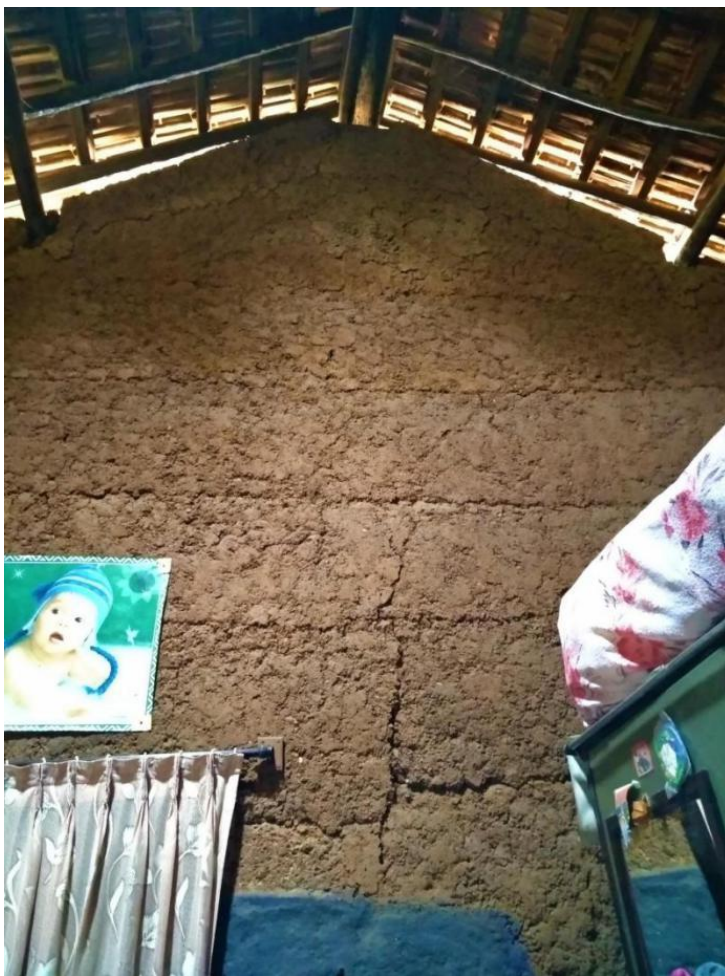
Image 67: 'Lift' joints visible (Survey no. 6).

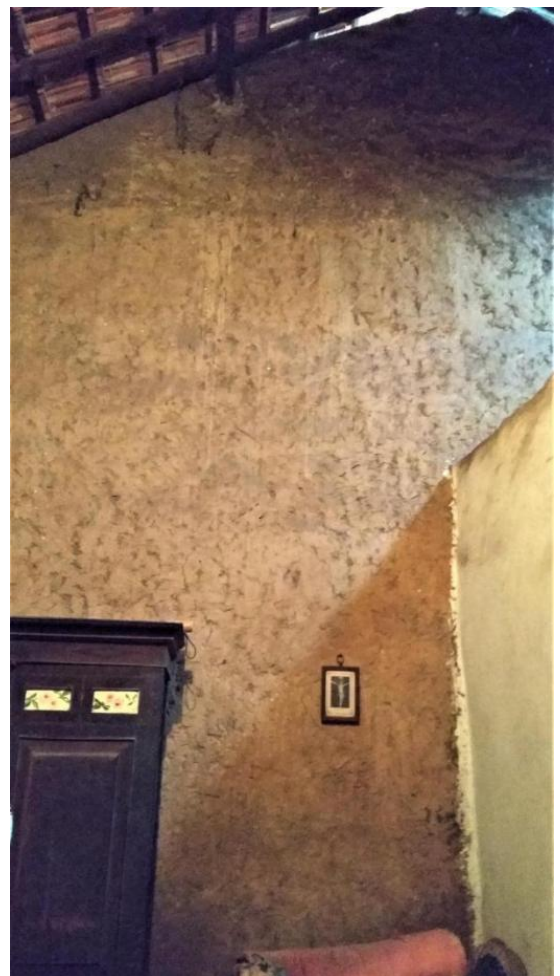
Image 68: 'Lift' joints not visible; the wall displays a uniform finish (Survey no. 9).

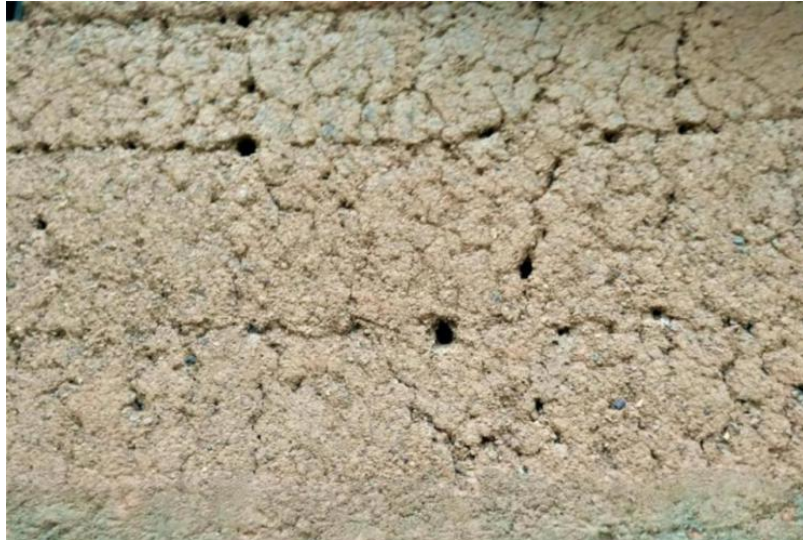
In Survey no. 11, there were holes along the horizontal 'lift' joints, which perhaps indicates the use of form-work in cob construction.

Image 70: Holes along the horizontal 'lift' joints, which perhaps indicates the use of form-work in cob construction (Survey no. 11).

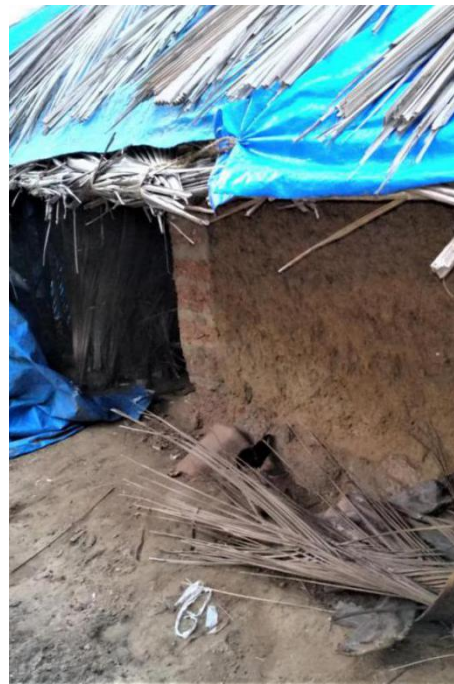
Image 74: Corners; laterite-and-cement pillars; not original to the structure (Survey no. 4).

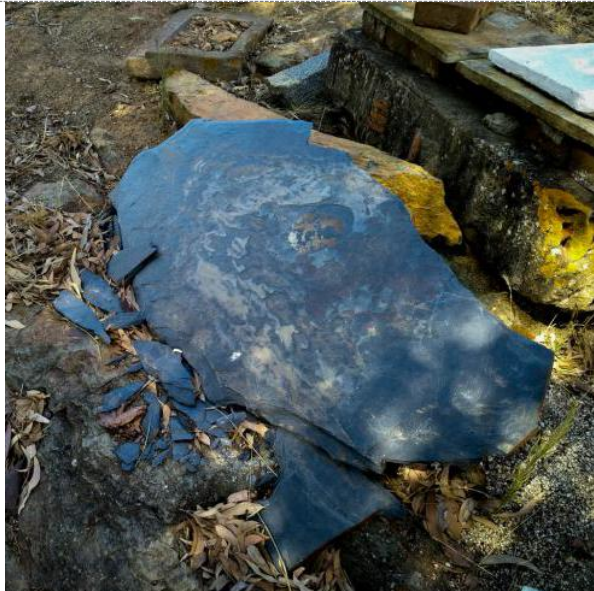
Damages incurred / problems faced: Cracks in corners.

Damages incurred / problems faced: Clay 'baldosa' floor-tiles are chipped-off in some places.

Observations: Cracks in corners, clay 'baldosa' floor-tiles chipped-off in some places.

Repairs: In the 1980s, the roof was redone because the wood had rotted. At the same time, part of the roof was fitted with new tiles. For cracks, sand (3 portions) + lime (1 portion) were mixed in a bucket and used to fill-up cracks. The last crack was repaired about 30 years ago. There has been no need of repairs since then.

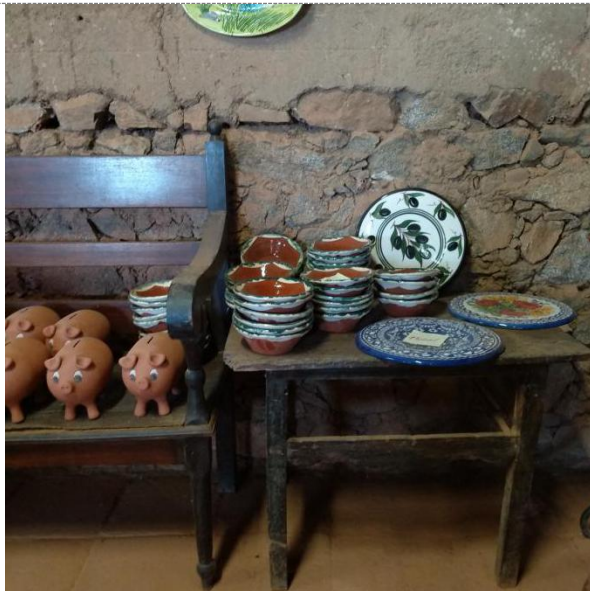
Base-course: Stone masonry.

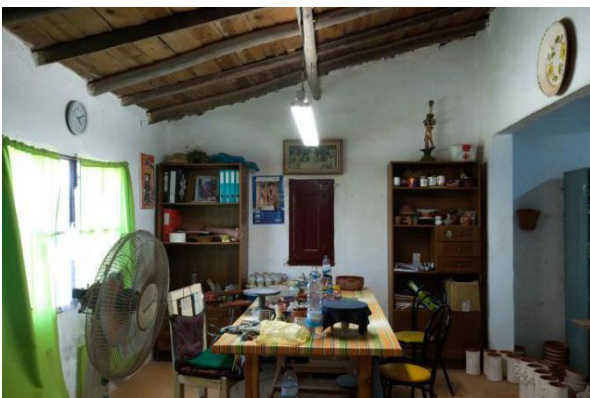
Restorations and/or interventions: The old workers' quarters is converted into an atelier.

Damages incurred / problems faced: Part of the roof caught fire.

Observations: Cracks on walls, some floor-tiles chipped-off.

Repairs: Roof that caught fire was redone.

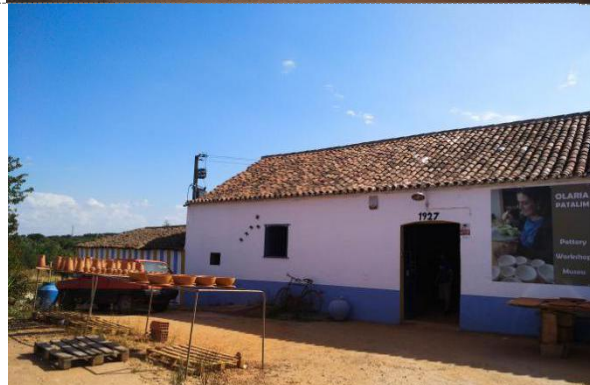
In 2018

Roof replaced, workers' quarters converted into an atelier, chimney torn-down and east gable wall partly reconstructed, facade walls repainted in white, blue and yellow.

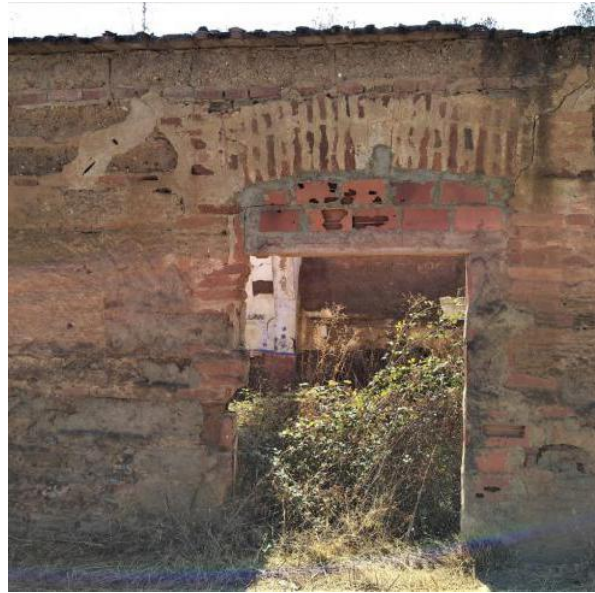
Base-course: In schist and granite masonry.
Use of fired-bricks along door frame.

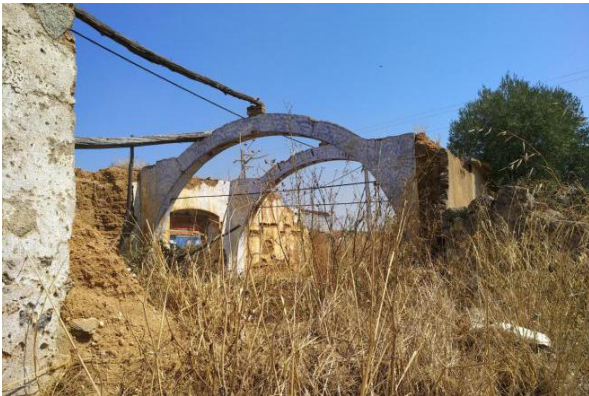
Distinct architectural details: Arches on the interior.
Maintenance and repairs: Ties between arches.

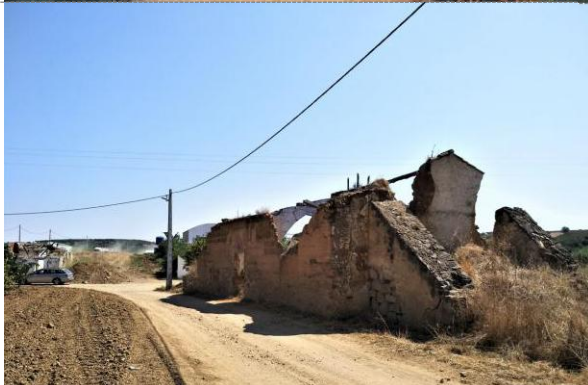
In 2018

Roof has collapsed; walls in ruins; blue daubs or design on interior plaster, especially on arches.

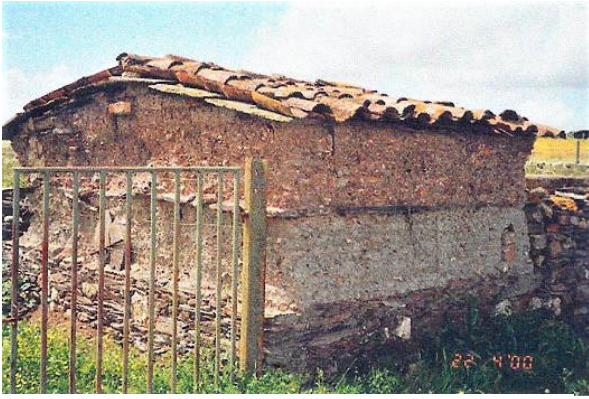
Description of earth used: The second 'lift' is more red and has more schist.

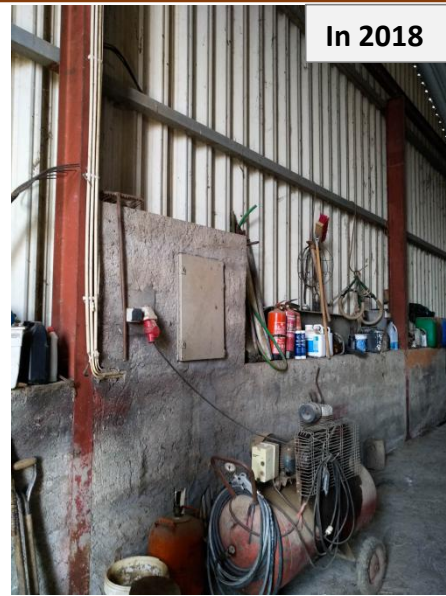
Interior view after the structure was rebuilt.

The building caught fire. No rammed-earth walls remain. It was **rebuilt**, and is covered on all four sides by cement blocks and metal sheets.

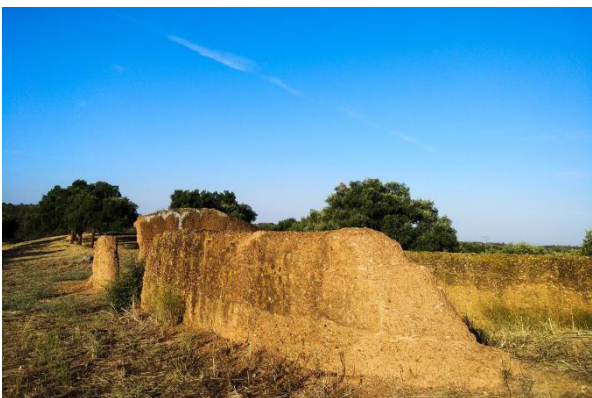
Damages incurred / problems faced: Wall damages got worse with time as the building has not had a roof for many years, some parts of the walls have fallen, vegetation in and around the structure.

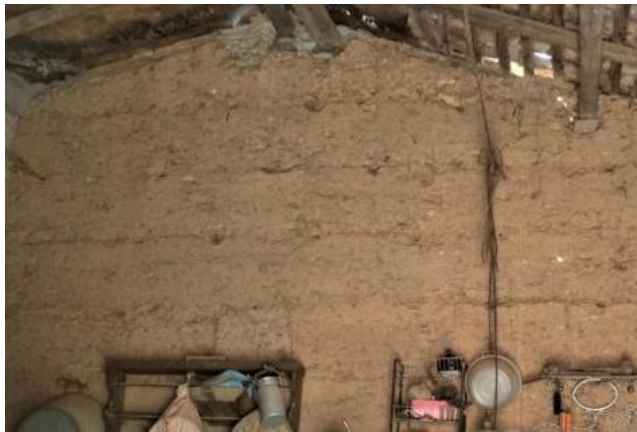
Image 170: Simple typology i.e. walls without mortar or other materials (Survey no. 1[1]).

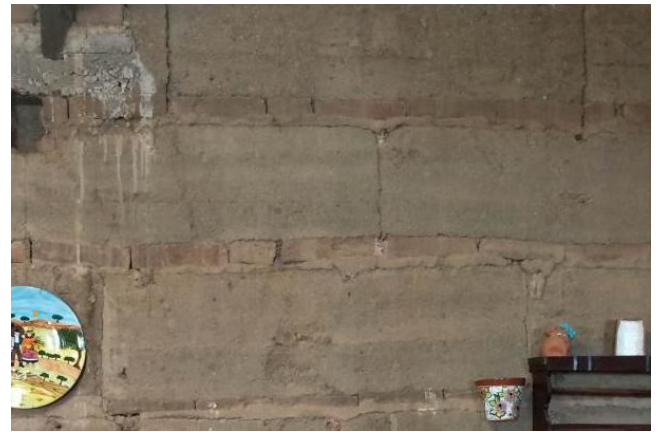
Image 171: 'Lifts' separated by a layer of mortar + fired-bricks (Survey no. 2[38]).
