Comparison of the vernacular earthen architecture in Goa (past Portuguese colony in India) and Alentejo (Portugal): local building cultures and conservation approaches

Mémoire du
Diplôme de Spécialisation et d'Approfondissement — Architecture de Terre et Patrimoine,
DSA-Terre 2016 - 2018

RODRIGUES Chenelle Fatima

Janvier 2020

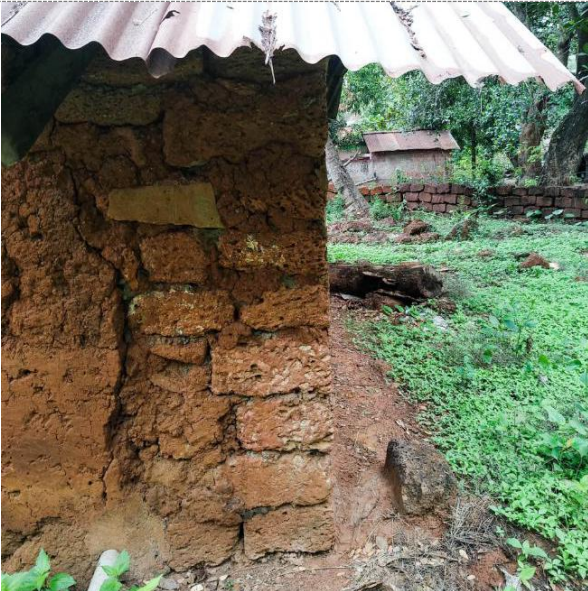
Observations: The laterite masonry in the corners has earthen or cement mortars. It is hard to say whether these corners are part of the original construction or a later addition.

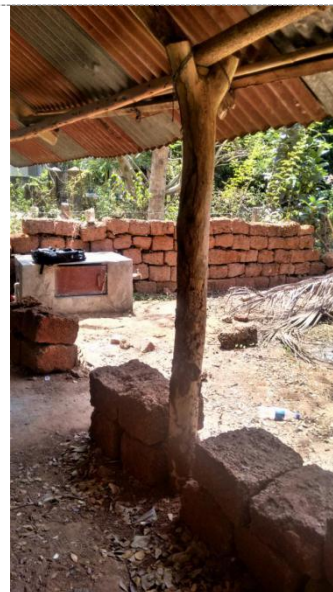
Damages incurred / problems faced: Mason-bee holes

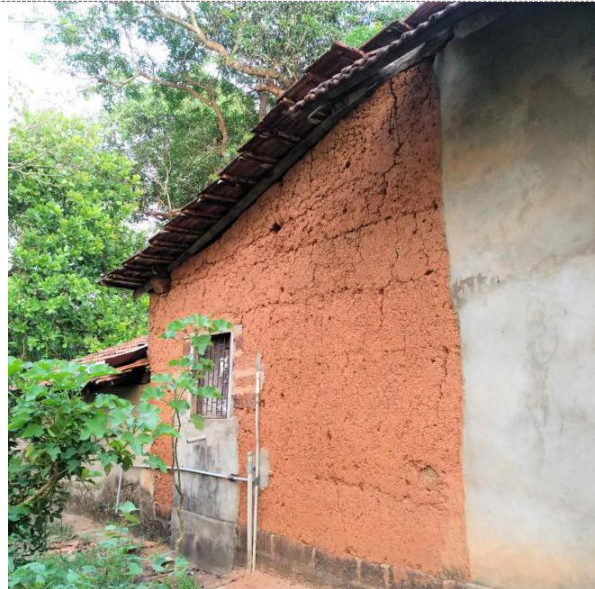
Distinct characteristics: Two, finer 'lifts' constitute the gable (other surveyed structures displayed a single 'lift' in the gable or 'lifts' with more height. Refer images in Survey nos. 1, 2, 6, 7).

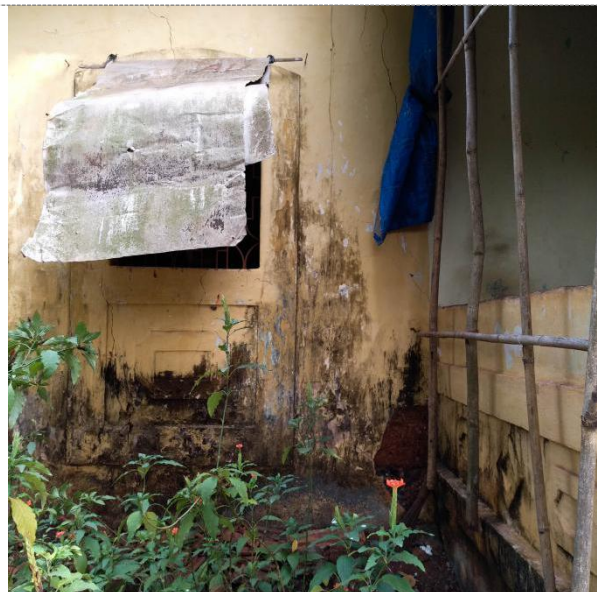
Maintenance and repairs: A make-shift overhang covers the window on the front facade.

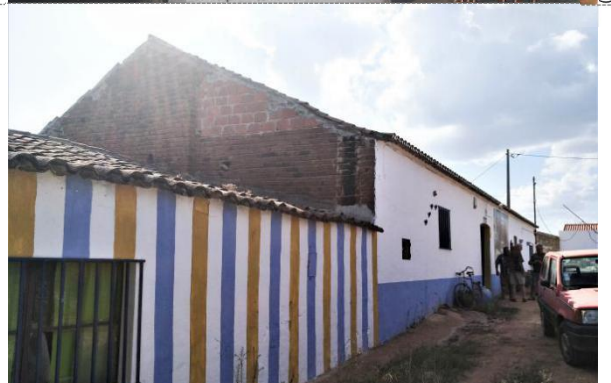
In 2018

Roof replaced, workers' quarters converted into an atelier, chimney torn-down and east gable wall partly reconstructed, facade walls repainted in white, blue and yellow.

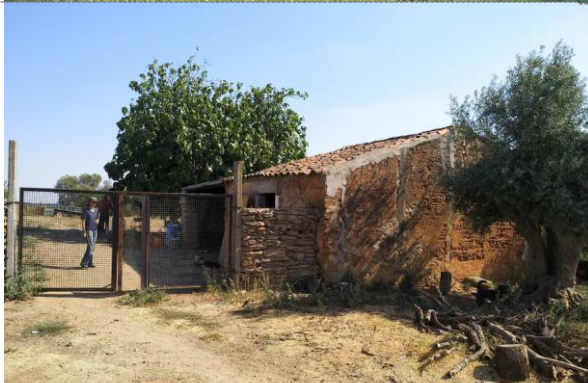
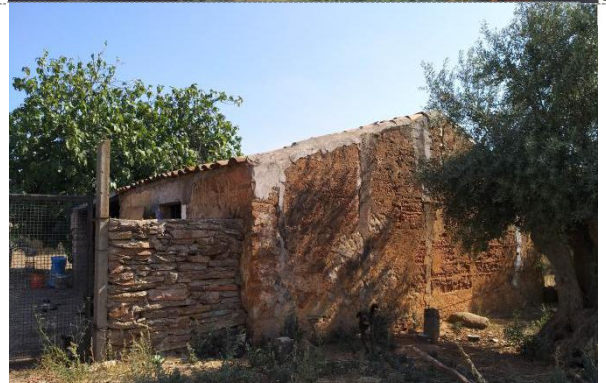
In 2018

No major damage incurred.

Repairs: Cement is added on walls when needed.

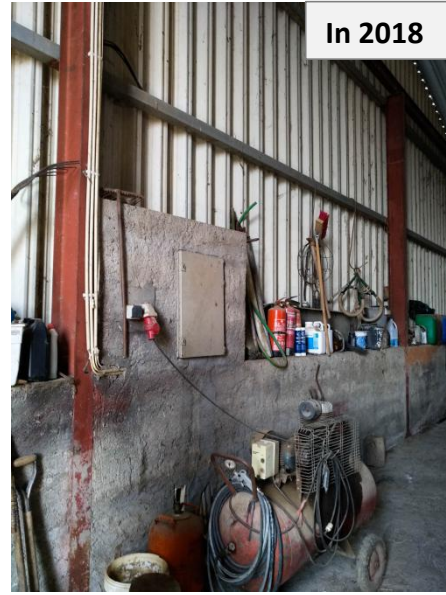
In 2018

Interior view after the structure was rebuilt.

The building caught fire. No rammed-earth walls remain. It was **rebuilt**, and is covered on all four sides by cement blocks and metal sheets.

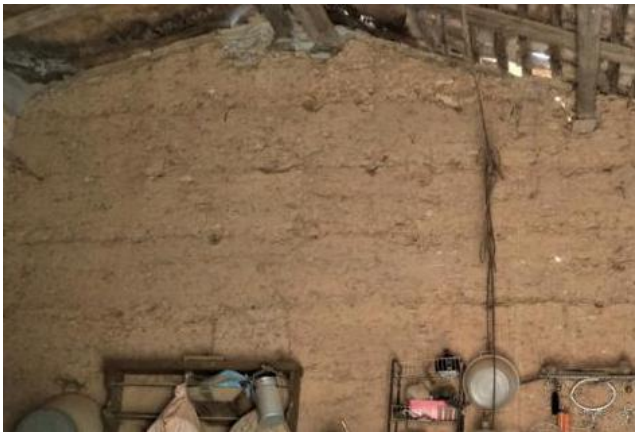
Image 170: Simple typology i.e. walls without mortar or other materials (Survey no. 1[1]).

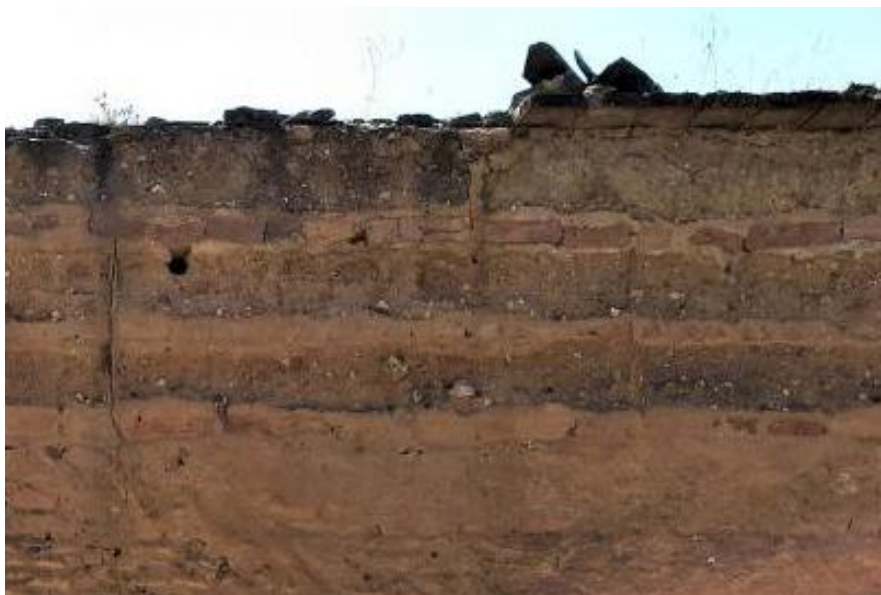
Image 172: Two rammed-earth layers within each block, separated by a layer of mortar + fired-brick + mortar (Survey no. 3[9]).
