# Comparison of the vernacular earthen architecture in Goa (past Portuguese colony in India) and Alentejo (Portugal): local building cultures and conservation approaches

Mémoire du  
Diplôme de Spécialisation et d'Approfondissement — Architecture de Terre et Patrimoine,  
DSA-Terre 2016 - 2018

**RODRIGUES Chenelle Fatima**

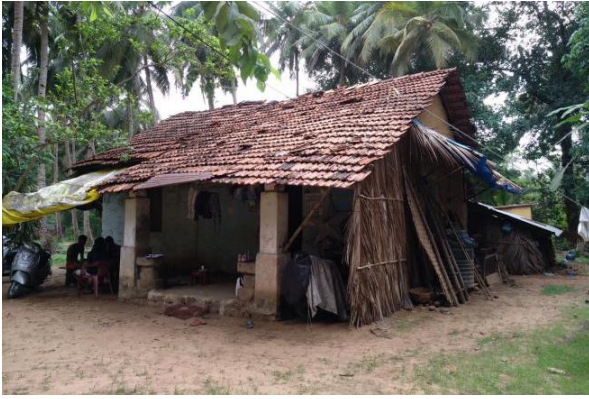
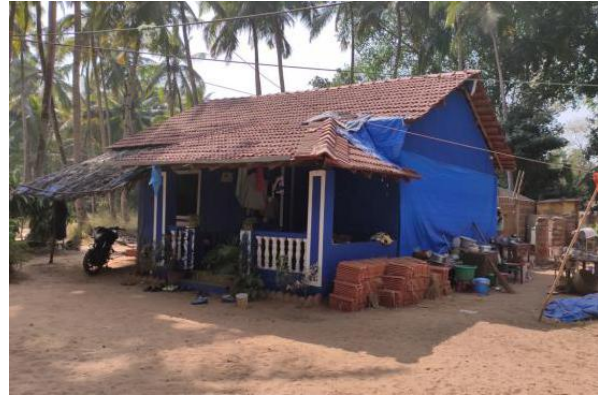
This house was renovated in 2019 before the wedding of the eldest son, Agnele.

**Observations:** Roof overhang on main facade slightly damaged, mason-bee holes on north and south facades, plasters flaking and falling-off, interior kitchen walls have darkened because of smoke, floor chipped in some places.

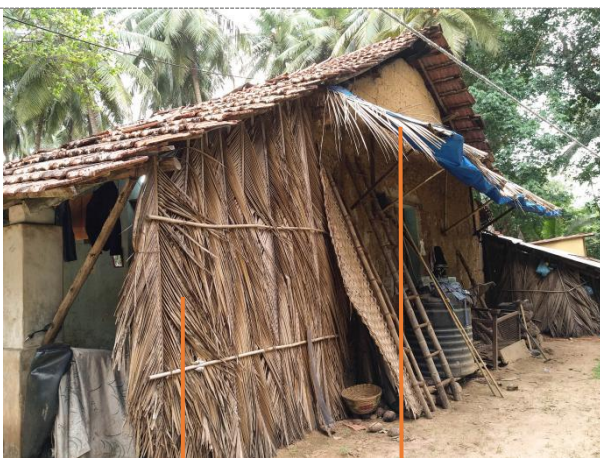
Palm-leaf barrier along walls ('dollo').

Palm-leaf overhang ('pakadi').

Maintenance and repairs: Woven coconut-palms ('molla'), palm-leaf barriers ('dollo'), and overhangs ('pakadi') are used to protect walls from rainwater.

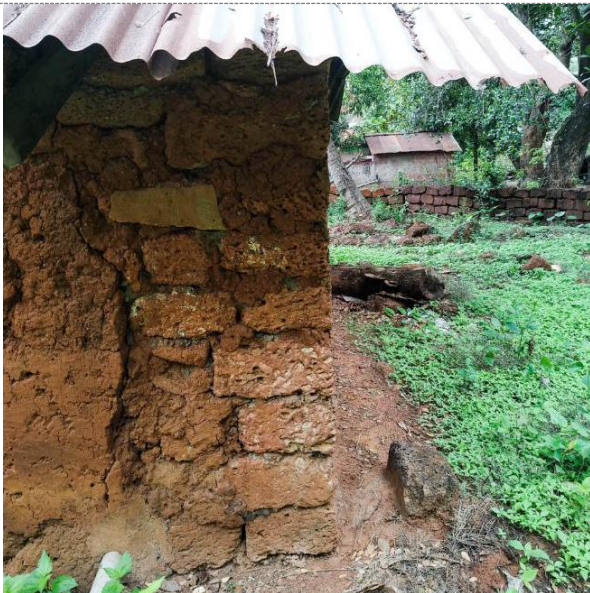
Observations: The laterite masonry in the corners has earthen or cement mortars. It is hard to say whether these corners are part of the original construction or a later addition.

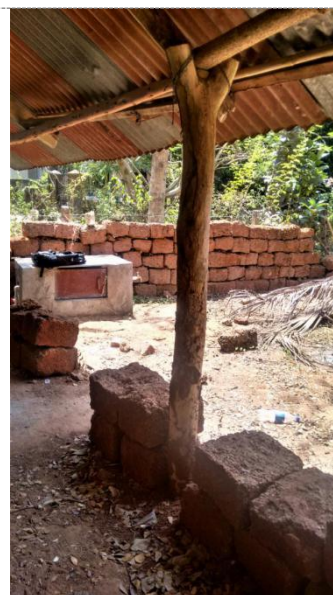
Observations: A make-shift lean-to aids in protecting facade walls from rain water. Simple branches are used to support the roof of the lean-to.

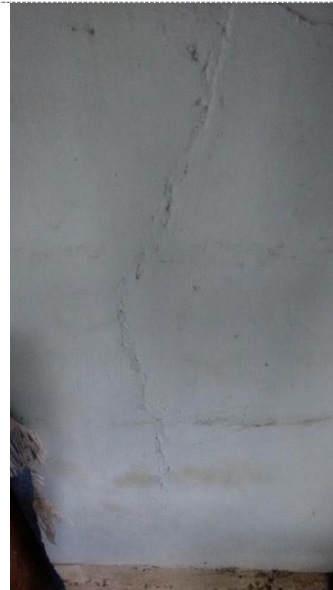
Damages incurred / problems faced: Cracks on internal walls.

There are cracks on internal and external walls, which got wider especially in case of earthquakes.

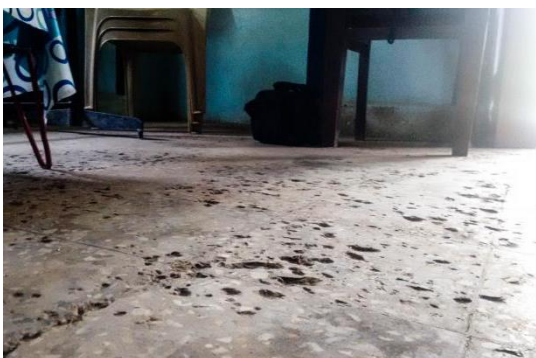
Damages incurred / problems faced:  
Chip-tiles are chipped-off.

**Observations:** Water run-off on east wall, oyster shell windows are not in a good condition, the floor in the hall has a hole and the chip-tiles are chipped-off.

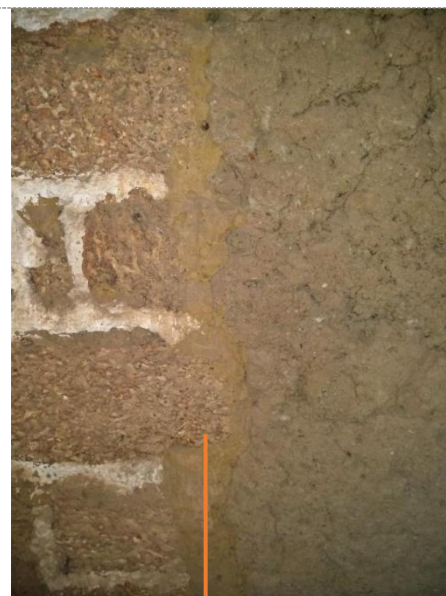
'menki matti' (a type of earth).

Maintenance and repairs: Crack filled-up with 'menki matti'.

**Repairs:** Some years ago, cracks on the west wall were filled-up with 'menki matti' (a type of earth). Just before 2004, some other cracks were covered with cement.

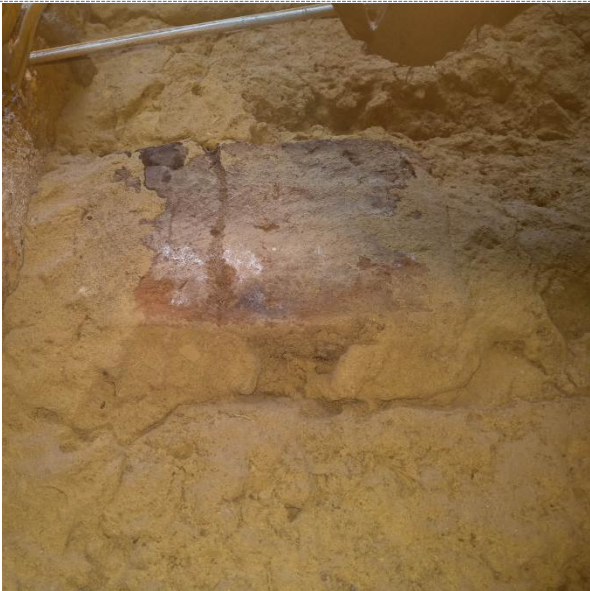
Observations: There is a (piece of) fired brick in the adobe-brick gable.

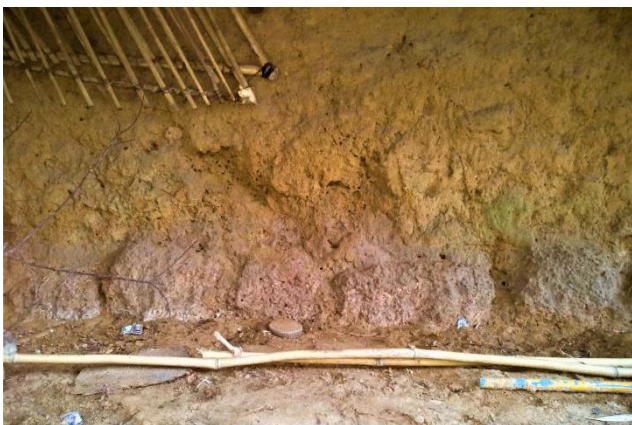
Damages incurred / problems faced: Erosion of the walls has created depressions above base-courses of external walls.

A crack in the roof caused rainwater to seep into the walls and created a hole on the north-east corner; roof problems have also damaged kitchen walls. Erosion of the walls has created depressions above base-courses on east and rear facades. Cracks, and holes created by rats, especially on kitchen walls. Insects have built earthen-nests on interior walls. Blackened kitchen walls due to smoke from wood-burning-stoves.

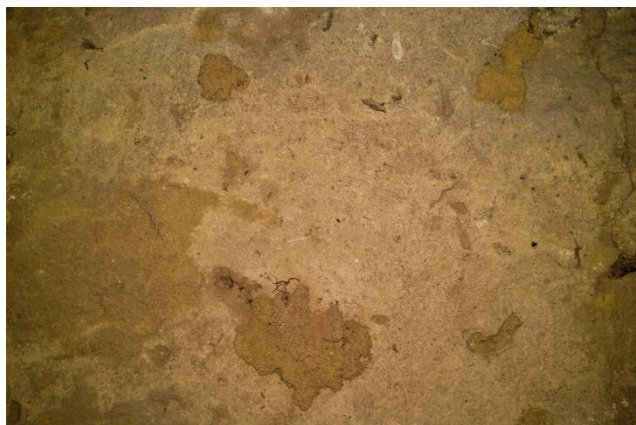
Damages incurred / problems faced: Insects have built earthen-nests on interior walls.

**Periodic interventions:** The roof is repaired every two years, earthen-nests built by insects are broken manually, fresh layer of cow-dung is applied every 2-3 months.

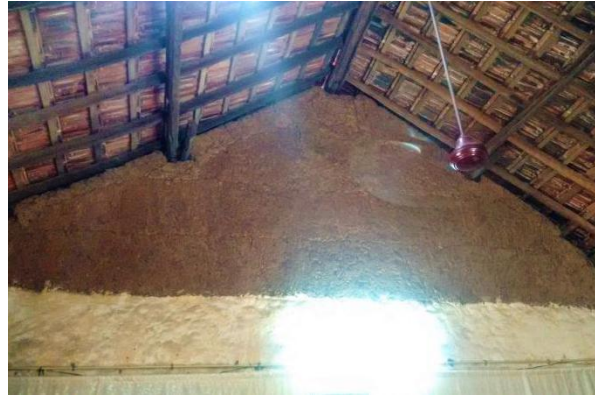
Observations: An additional layer of earth caps the roof-line. Looks like this was done after the roof was installed in order to secure the rafters to the wall.  
(Also refer image in 'Typology' section.)

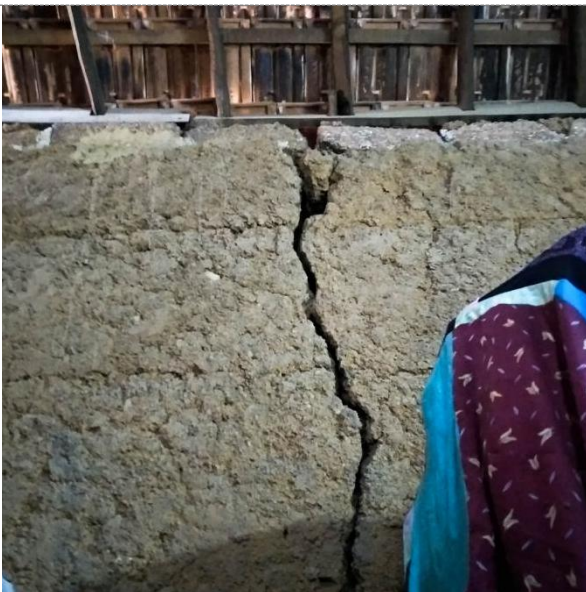
(North wall.)

Damages incurred / problems faced: Cracks.

**Repairs:** Cement used to repair cracks.

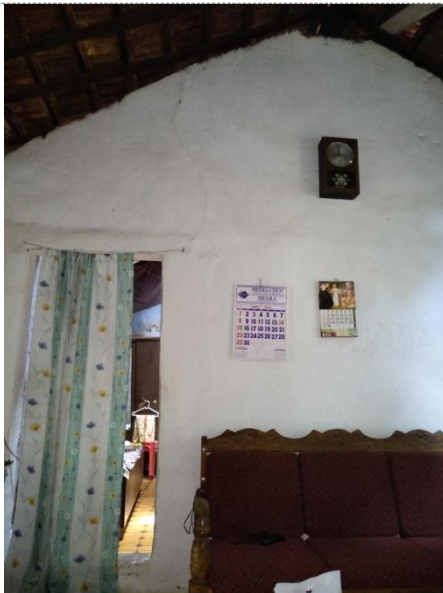
(Hall.)

Damages incurred / problems faced: Cracks, especially near lintels.

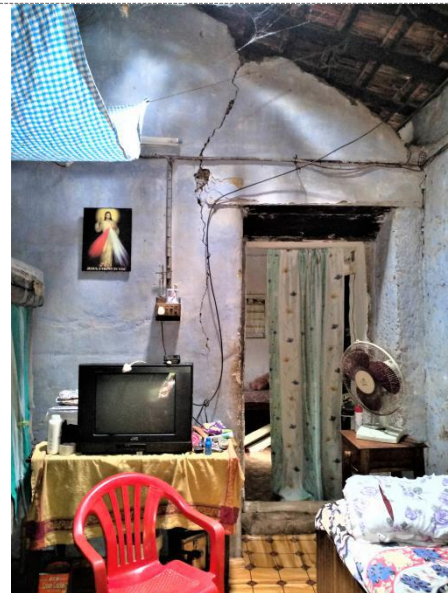
(Bedroom.)

Damages incurred / problems faced: Cement was used on one side of the wall, and the crack on the other side started getting longer (common wall that separates hall and bedroom).

4. About 3-4 years back, cement was used on a wall, and the crack on the other side of the same wall started getting longer (wall that separates hall and bedroom).

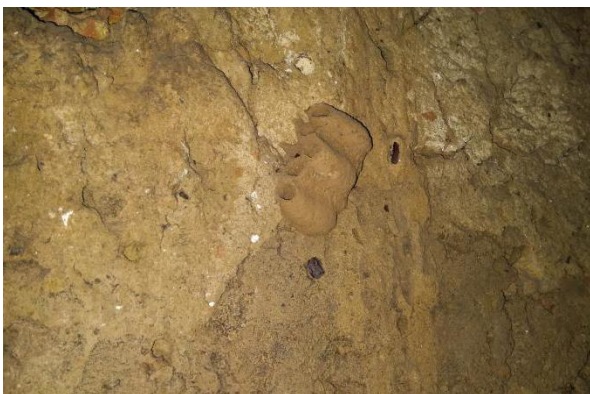
Damages incurred / problems faced: Honey-bees build earthen-nests on the wall surfaces, and store worms in them, especially during the monsoons.

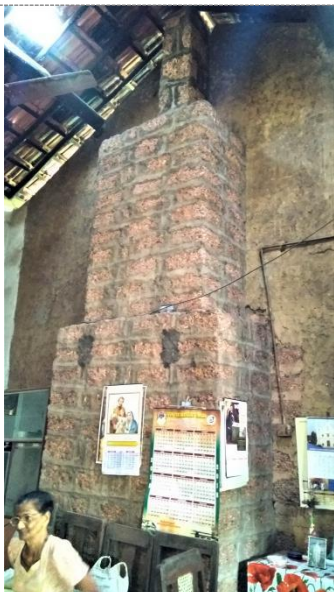
About 20 years ago, a storm led to many cracks on walls. One major crack around the window of the west wall destabilised the wall. Parrots make holes in the walls.

Maintenance and repairs: A laterite block was built to cover the major crack and window opening, and thereby stabilise the wall. The block turned out to be more voluminous than needed.

**Repairs:** The smaller cracks that appeared with the storm were repaired with 'menki mati' (type of mud), and the big ones were covered with cement. A laterite block was built to cover the major crack as well as the window opening on the west wall, and thereby stabilise it. The block turned out to be more voluminous than needed; it was a mason who went ahead with it and charged INR 15,000/-.

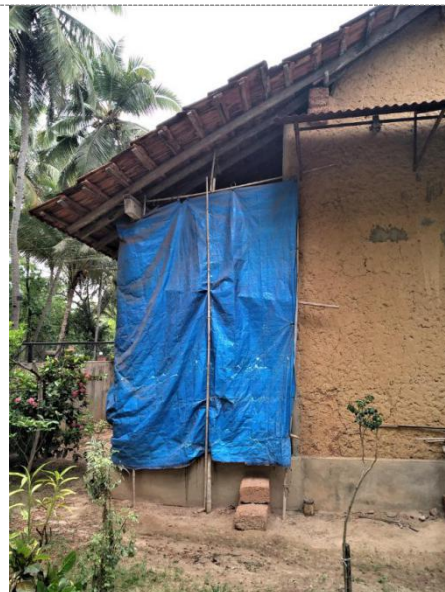
Observations: Metal overhangs and tarpaulins protect walls from rainwater.

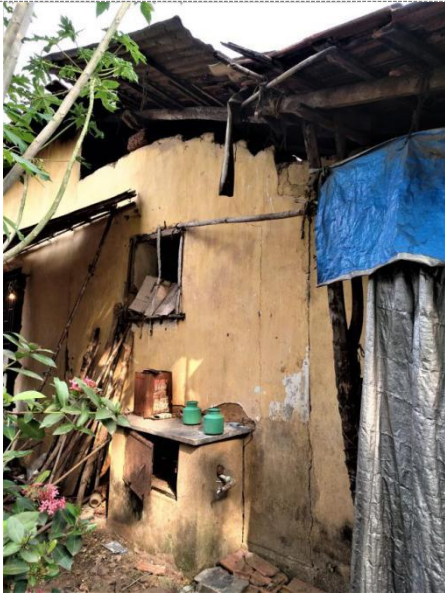
North facade, adobe-brick extension. Observations: Stepped decline on the wall top. Damages: Cracks demarcating the original, earthen-walls and the new, laterite-walls.

**Observations:** Cracks demarcating the original, earthen-walls and the new, laterite-stone walls. Flaking and falling plasters. Walls have blackened due to the smoke from the oven.

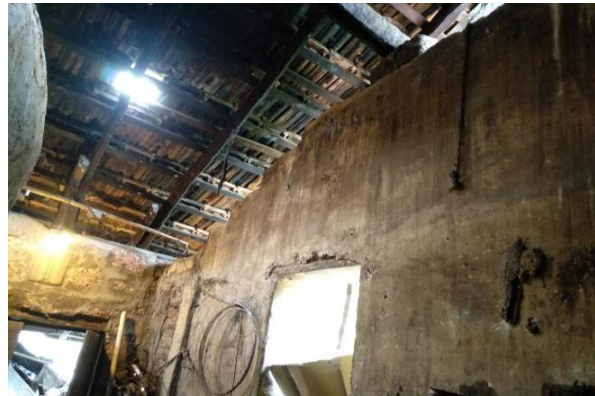
Restorations and/or interventions: The rear adobe-brick wall was torn-down and a laterite-and-cement was built in its place. Damages incurred: Walls have blackened due to the smoke from the oven.

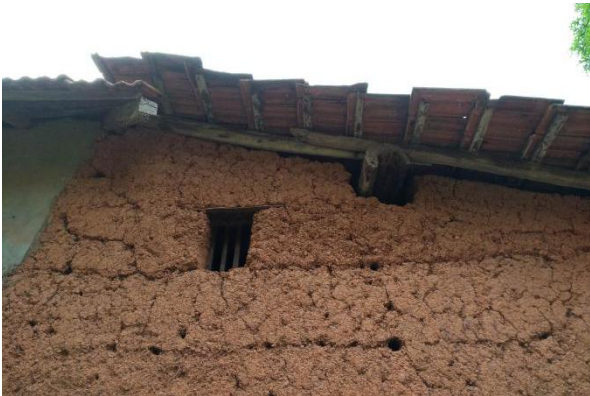
Distinct characteristics: Some holes on walls are well defined (suggesting cob construction with shutters?).

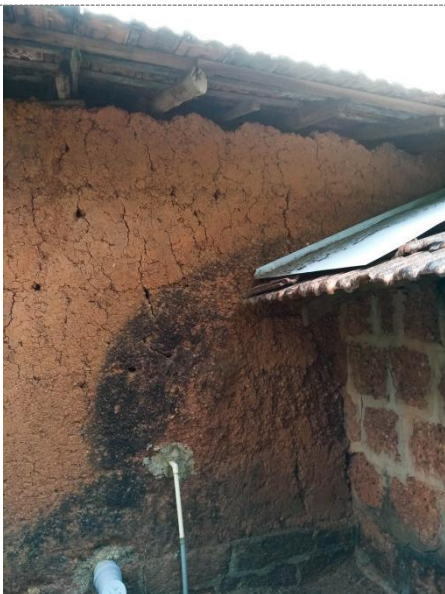
Damages incurred / problems faced: Black dampness blotch on rear wall.

**Observations:** Some roof-tiles missing along overhangs, evidence of termite attack on rafters, small holes in walls, black dampness blotch on rear wall.

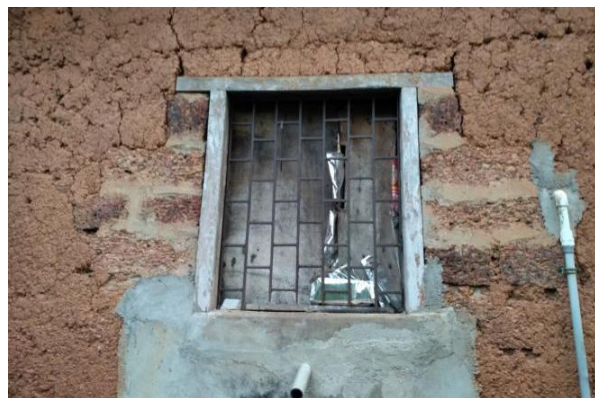
**Damages incurred / problems faced:** Cracks appeared a few years back because the house is old and also because of the weight of the roof.

Maintenance and repairs: Cement repairs.

**Repairs:** Cement used to fill cracks, for re-pointing, and other repairs.

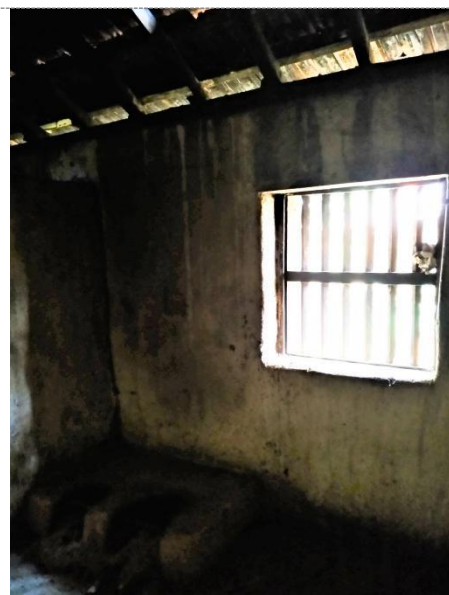
**Damages incurred / problems faced:** Insects called 'bateen' make nests out of mud on roofs. Rats holes; rats come into the house to eat the rice grains stocked inside.

Maintenance and repairs: Cooking indoors on traditional wood-burning stoves gives out smoke; the heat and dryness makes the wood in the roof stronger, and keeps termites at bay.

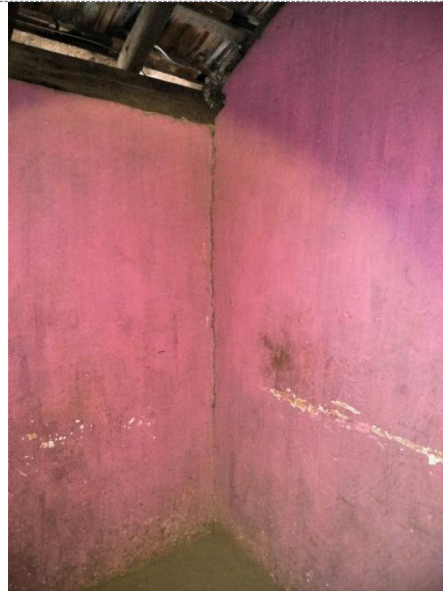
Damages incurred / problems faced: A crack appeared just after the construction was complete.

**Damages incurred / problems faced:**  
A crack appeared just after the construction was complete.

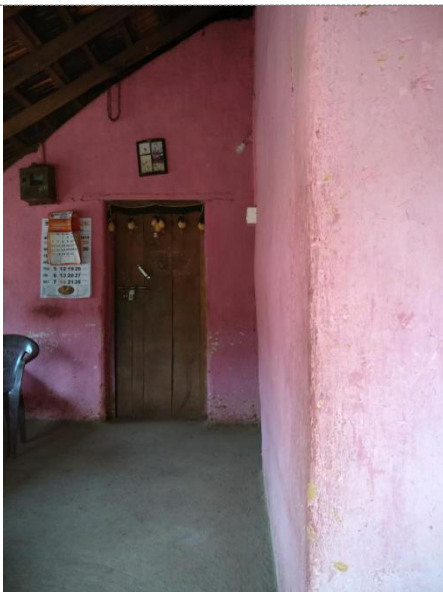
Damages incurred / problems faced: Bulging of wall.

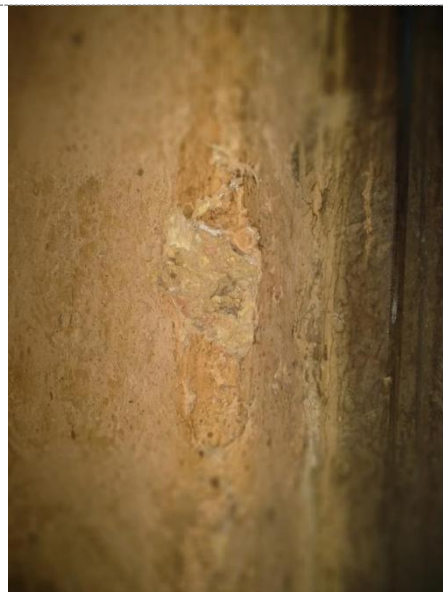
Damages incurred / problems faced: Chipping of wall edges.

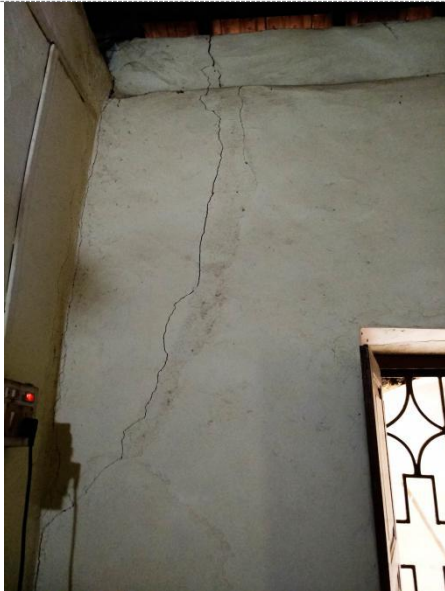
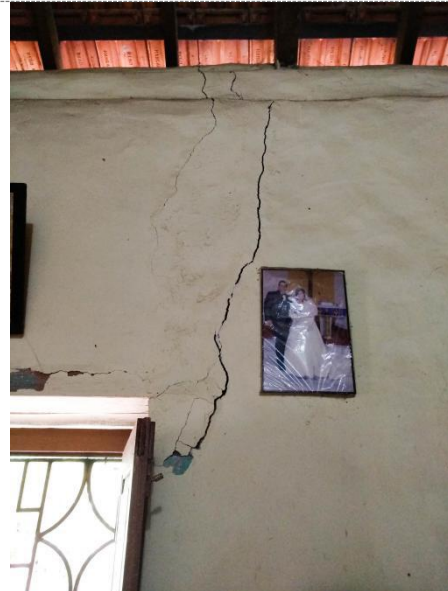
Damages incurred / problems faced: Cracks on the bedroom wall because of the weight of the roof.

A crack appeared on the front facade about two years back, and more recently, on the bedroom wall because of the weight of the roof. The cracks got wider over time.

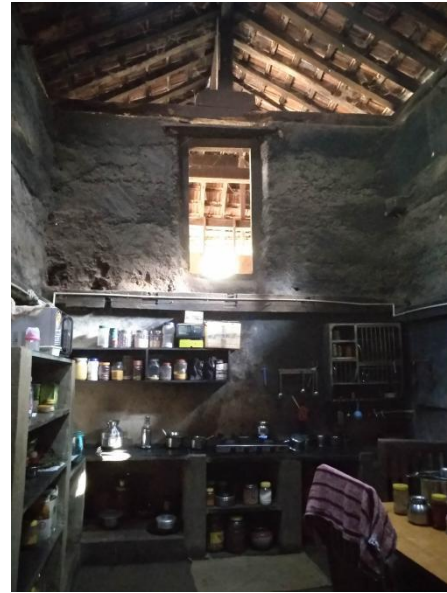
Restorations and/or interventions: Earlier, there used to be a loft in the kitchen, which is now taken-off. The door to the loft can still be seen.

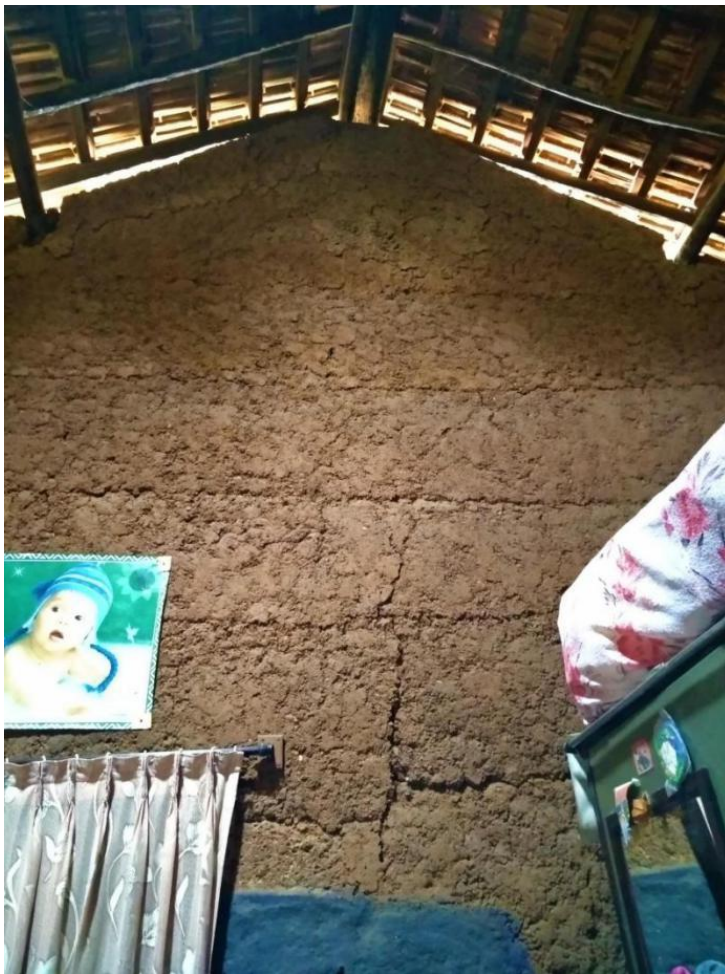
Image 67: 'Lift' joints visible (Survey no. 6).

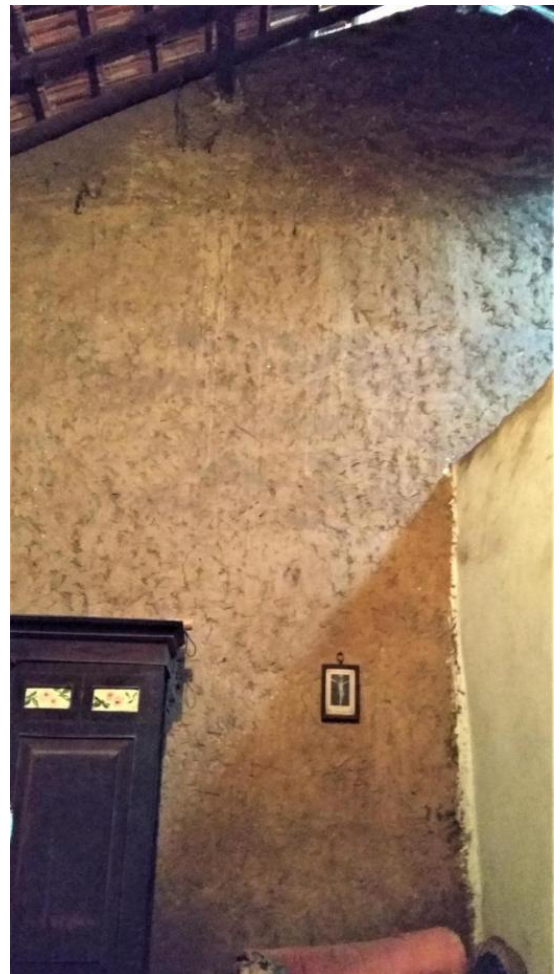
Image 68: 'Lift' joints not visible; the wall displays a uniform finish (Survey no. 9).

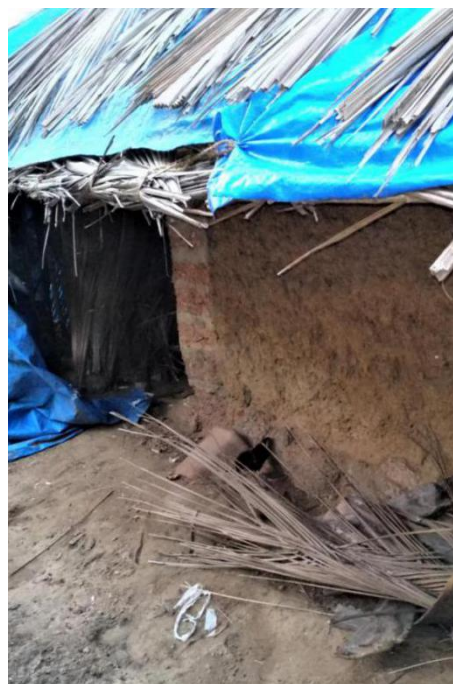
Image 74: Corners; laterite-and-cement pillars; not original to the structure (Survey no. 4).

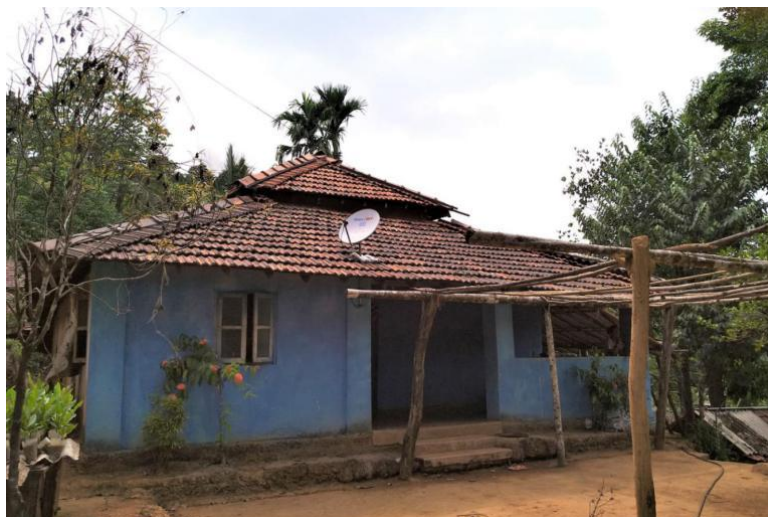
Image 109: The upper part of the roof thrusts upwards, and is separate from the lower part (Survey no. 12).

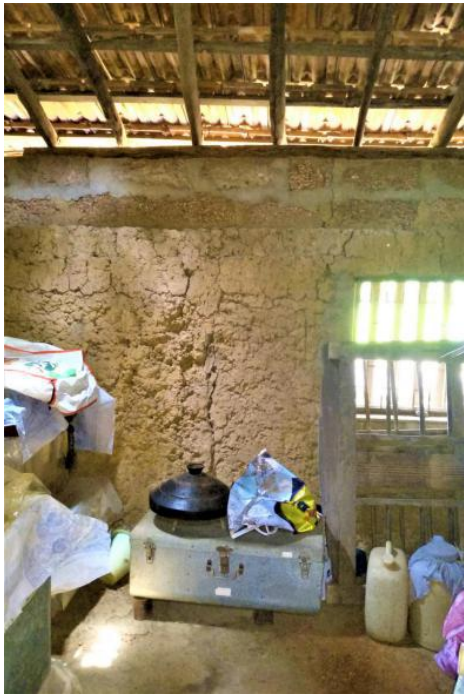
**Image 110: Wall heights were extended using laterite-stones (Survey no. 7).**

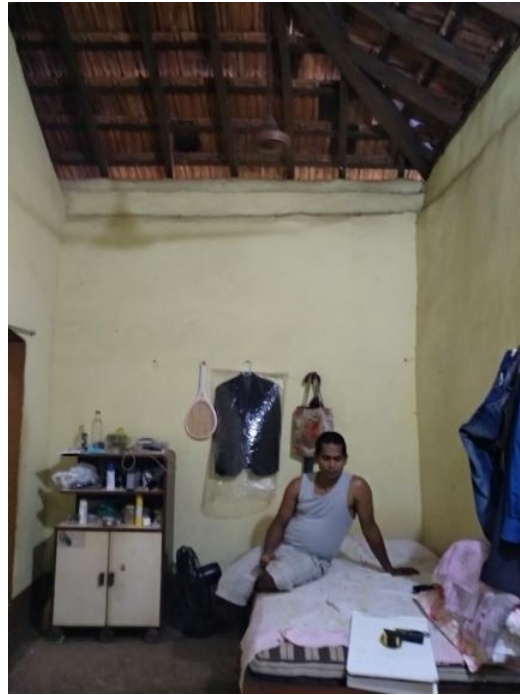
**Image 111: Sometimes, the raised part was plastered and painted like the rest of the wall, which made it difficult to verify the construction material used (Survey no. 14).**

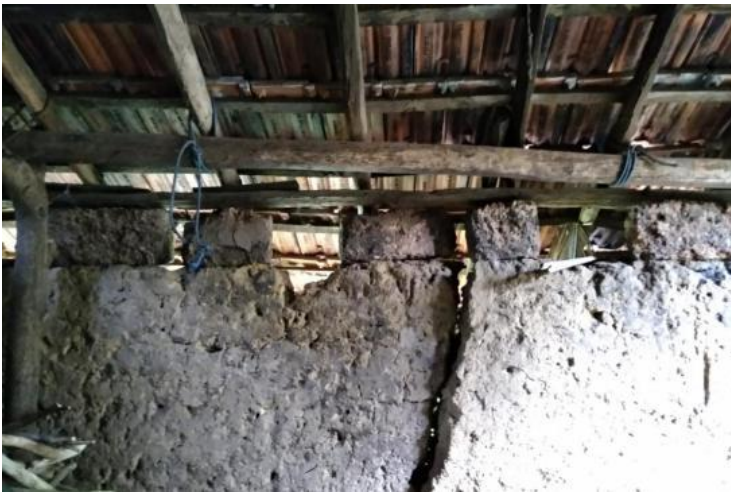
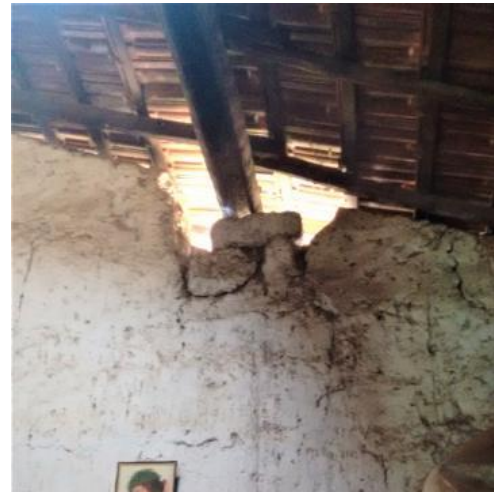
**Image 112 and Image 113: On some wall tops, laterite-stones were placed at random intervals, on which a wooden plate or rafter was placed (Survey nos. 5, 8).**

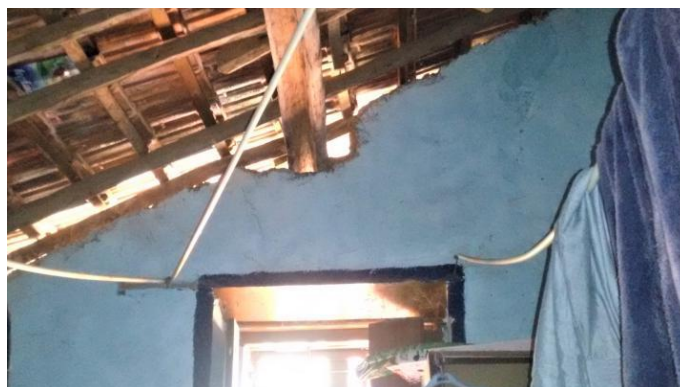
**Image 114: Sometimes, the wooden plate directly rested on the top of the wall, and held the framework. On gable tops, crude holes were usually made to accommodate the rafters (Survey no. 3a).**

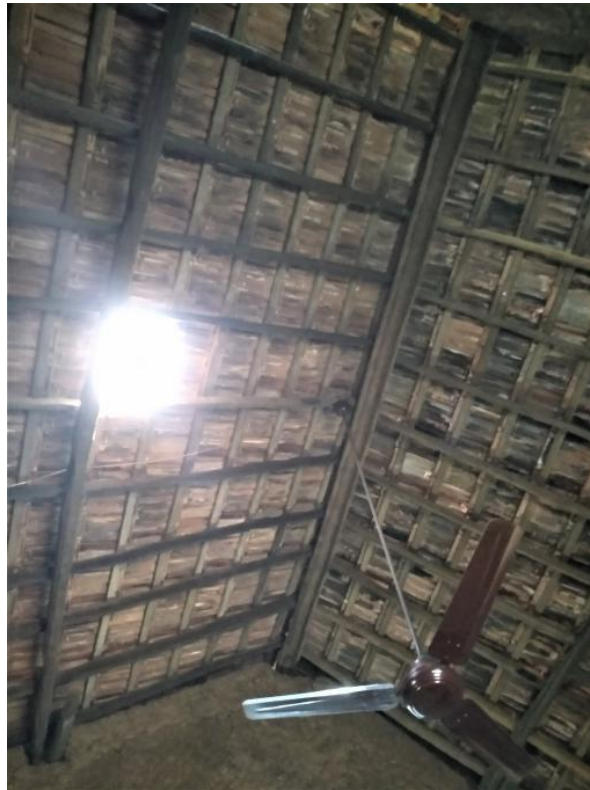
**Image 115:** The ridge of the roof framework was made from the trunk of the coconut tree. The trunk was split into two and the fibre from its core was taken out, forming a hollow in the middle. (Survey no. 6).

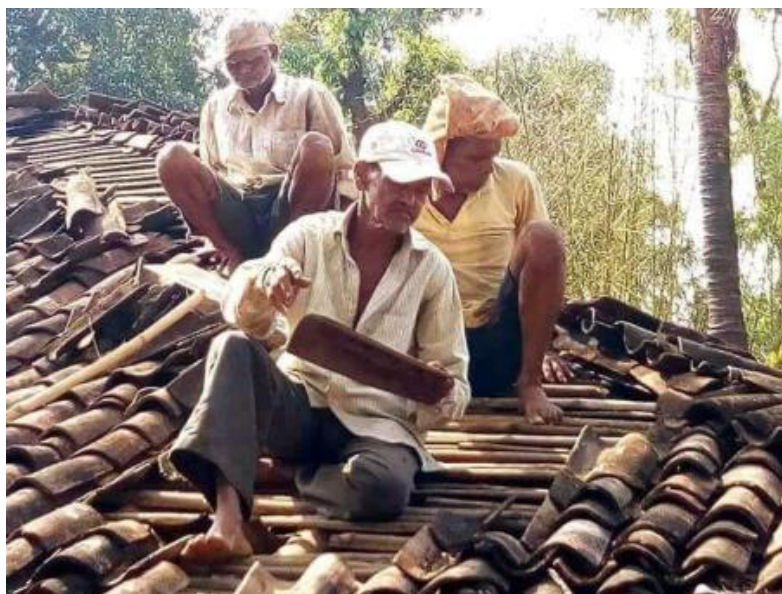
**Image 116:** Bamboo batons were used in case of 'Country-tile' roofs.

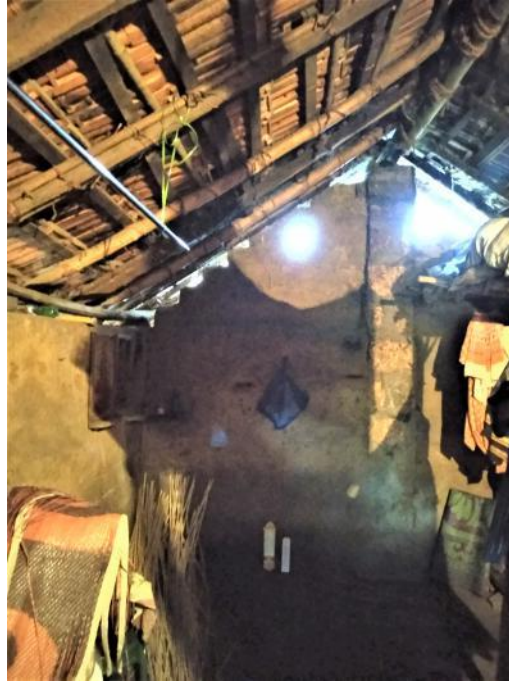
Image 117: Sometimes, bamboo and other similar materials were used even in the case of 'Mangalore-tiles' roof framework as well (Survey no. 4).

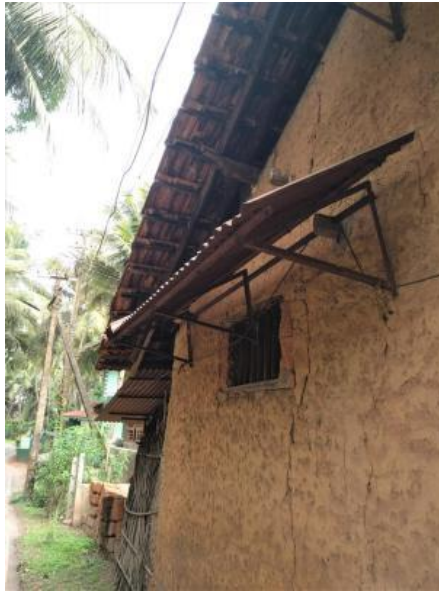
Image 120: Metal-sheet overhangs (Survey no. 9).

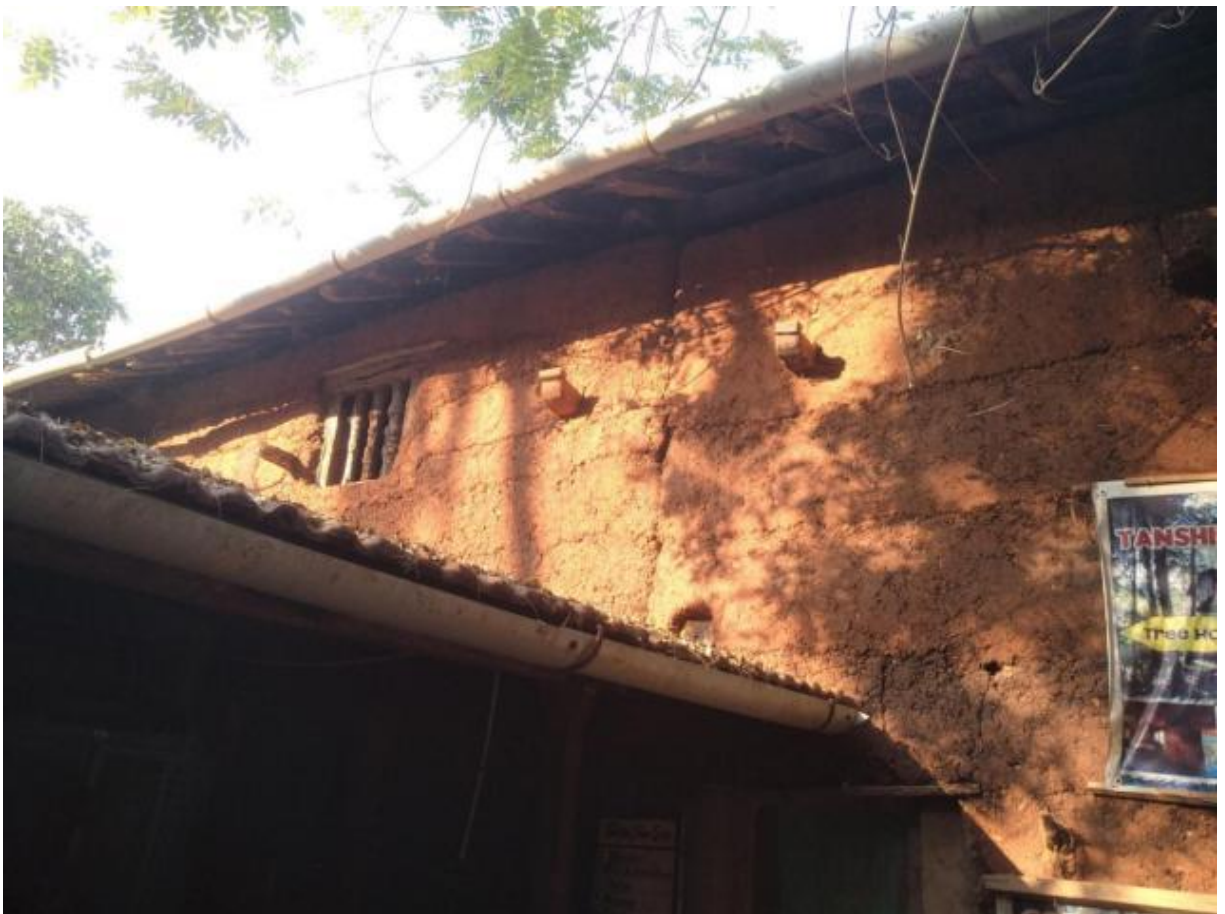
Image 121: Wooden pegs along the lengths of some façade walls (Survey no. 15).

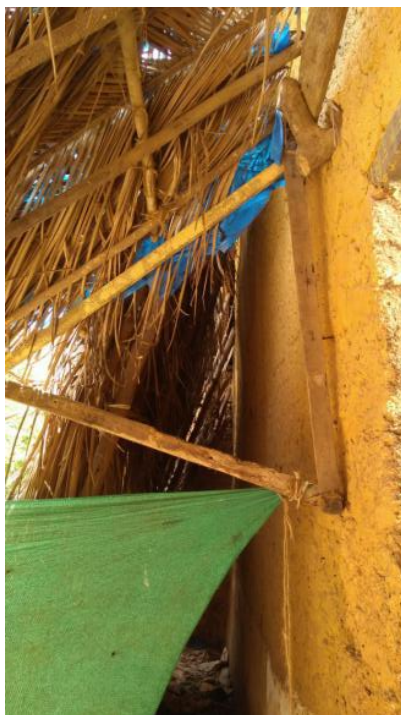
**Image 122:** In Survey no. 8, make shift hooks were observed.

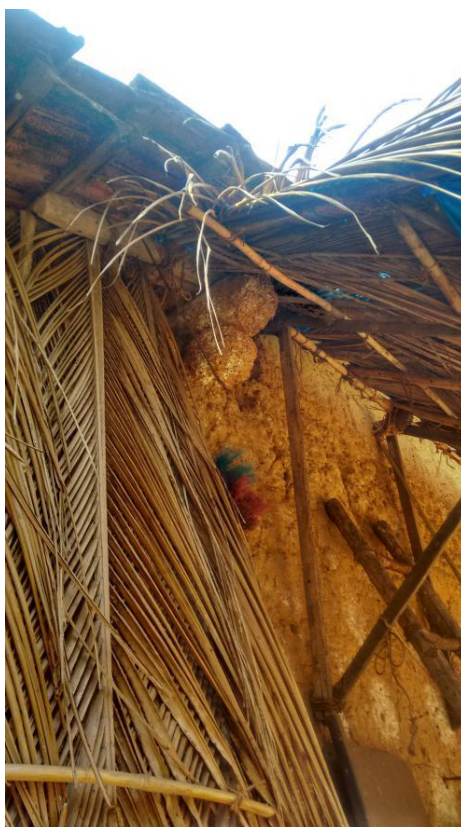
**Image 123:** Two decoratively cut laterite-stones that jutted-out from the wall top were probably meant to support the roof framework, but sometimes aided in holding the overhangs as well. (Survey no. 1).

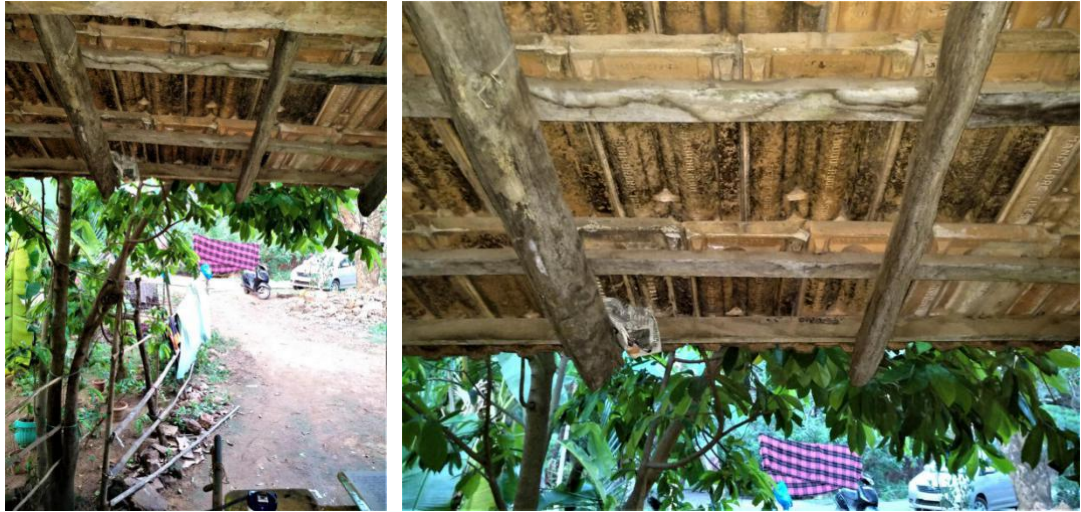
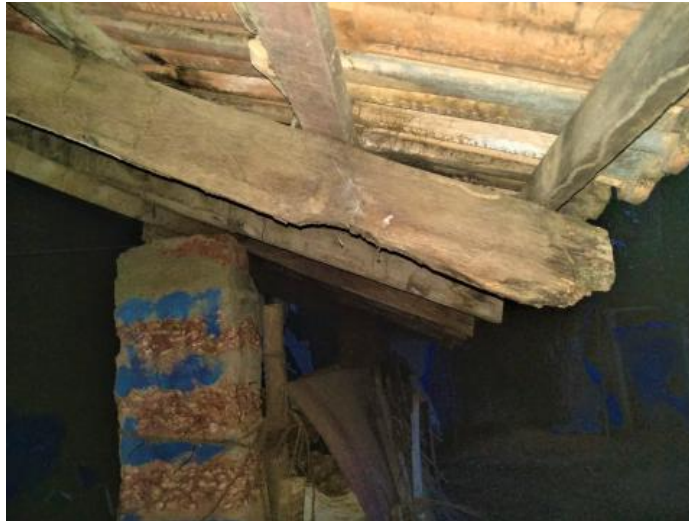
The last baton along the edge of the roof is placed with the smaller side resting on the rafters.  
Image 124 and Image 125: (Survey no. 8). Image 126: (Survey no. 3a).

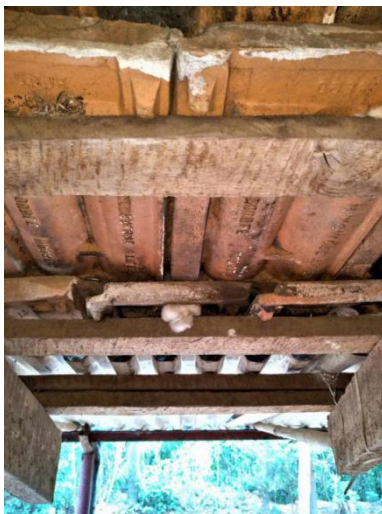
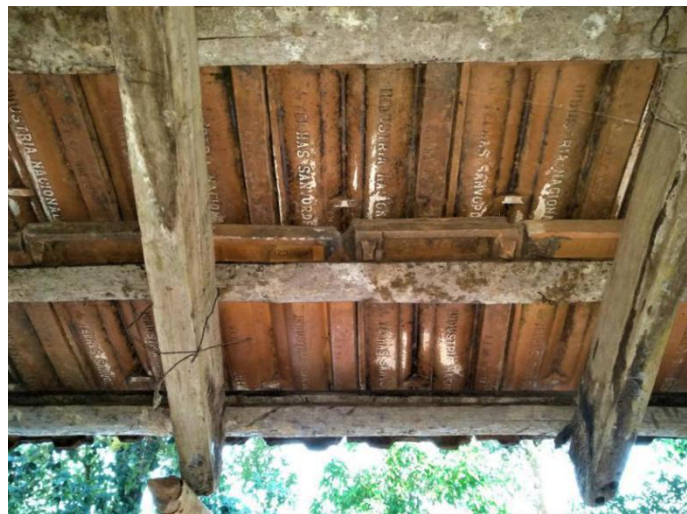
Image 127: Two, instead of one baton was fixed along the ends of the roof's framework (Survey no. 13).  
Image 128: Splits of the beetle-nut tree were used as batons. Two batons were used along the roof-line. (Survey no. 12).

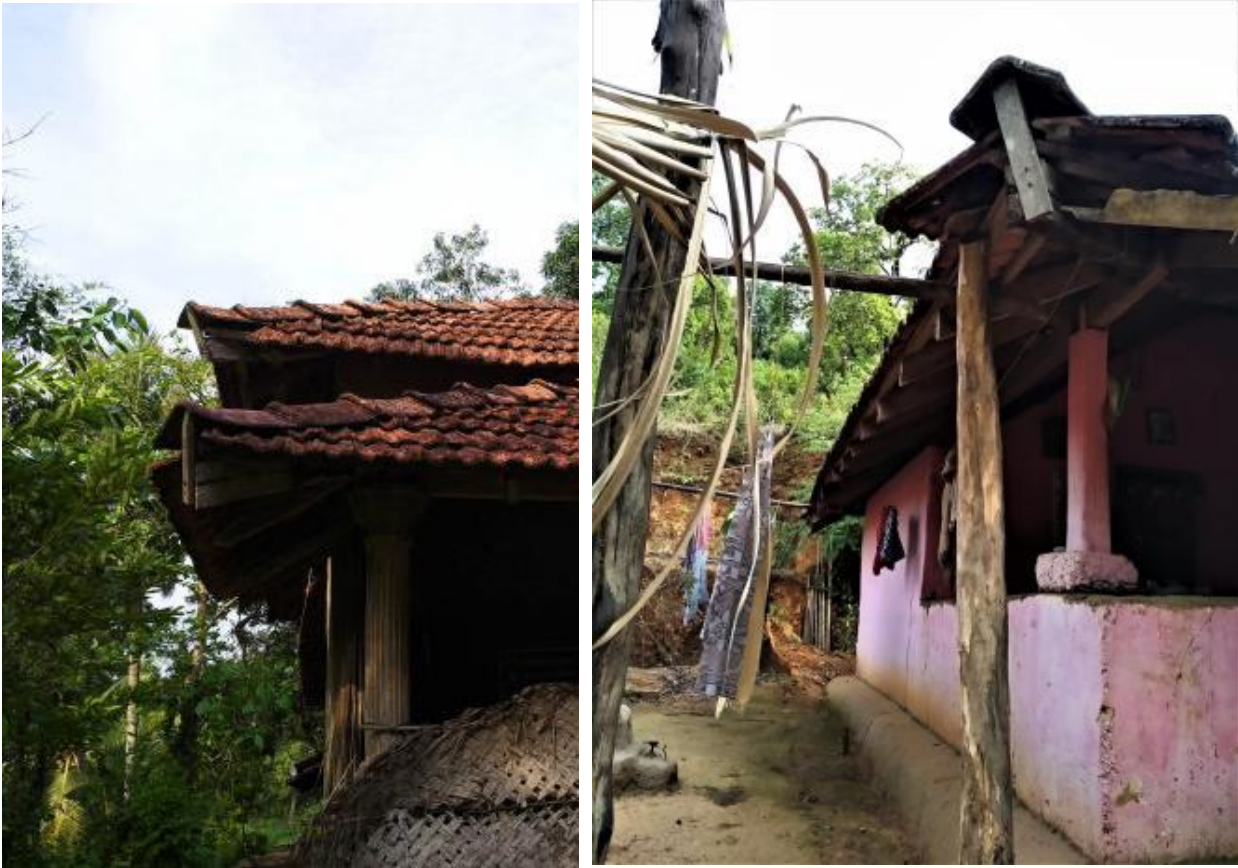
Image 129 and Image 130: Small, wooden batons were fixed on roof corners (Survey nos. 11, 13).

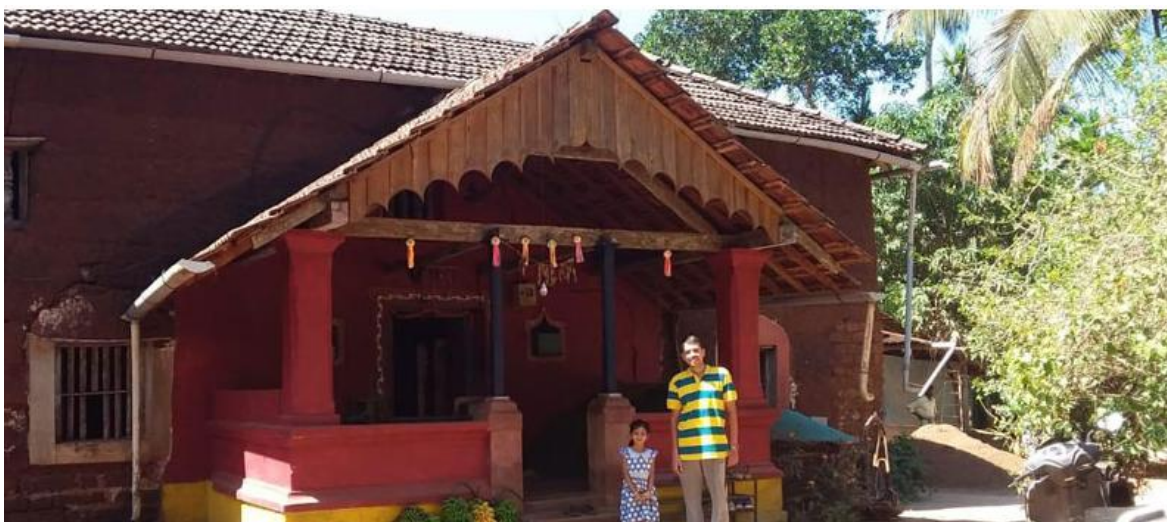
Image 131: Eaves (Survey no. 15).  
[Source: <https://www.tanshikarspicefarm.com/#>]

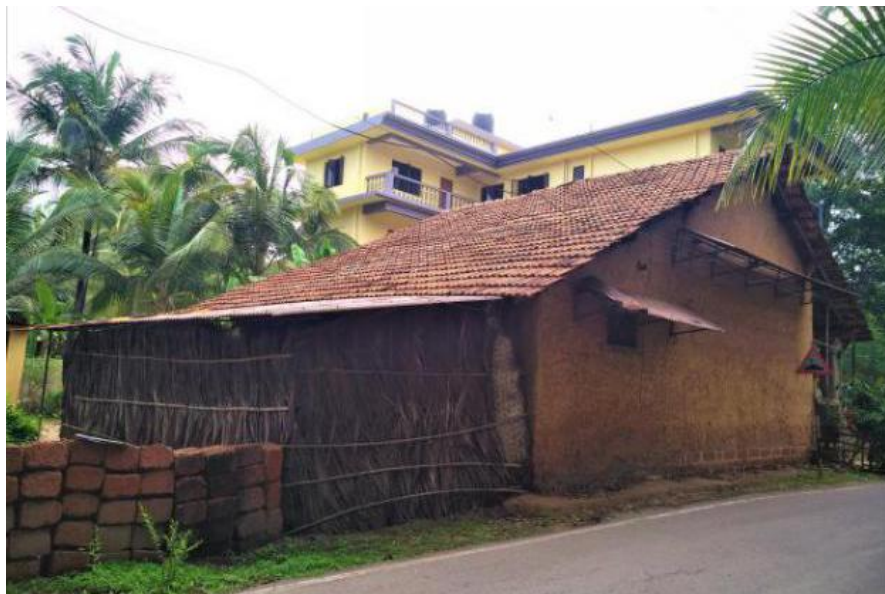
Image 132: Palm-leaf extension at the rear of the house (Survey no. 9).

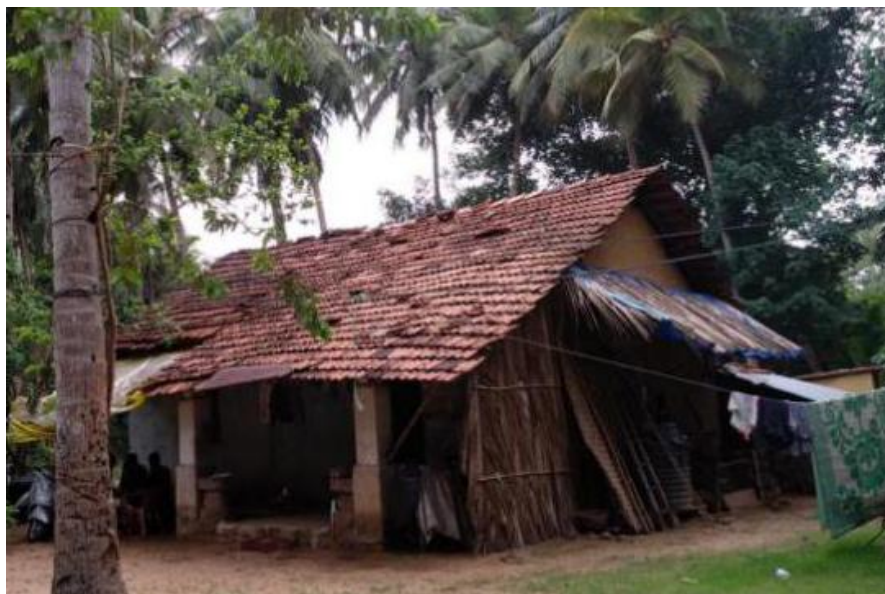
Image 133: Palm-leaf barriers poised parallel to earthen walls protected the walls from rainwater (Survey no. 1).

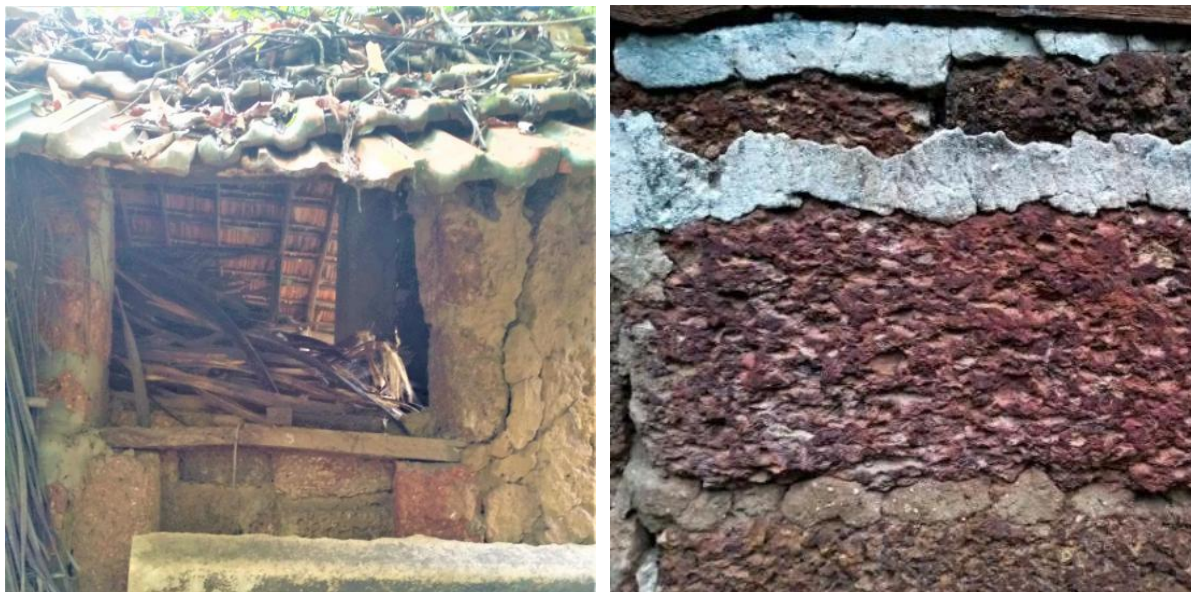
**Image 134:** Mortars were present in those parts of the walls that had laterite-stone masonry i.e. in the base-courses, window frames, corners, etc. (Survey no. 5).

**Image 135:** Earthen mortars with lime re-pointing (Survey no. 3a).

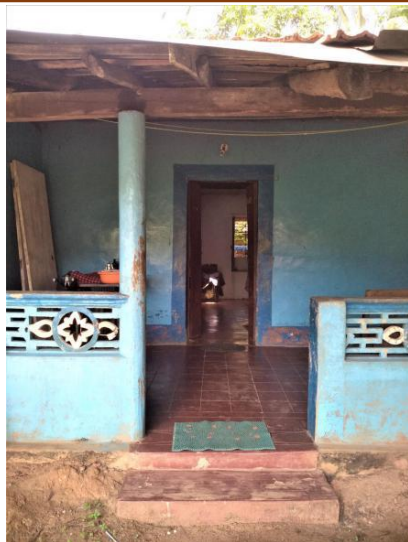
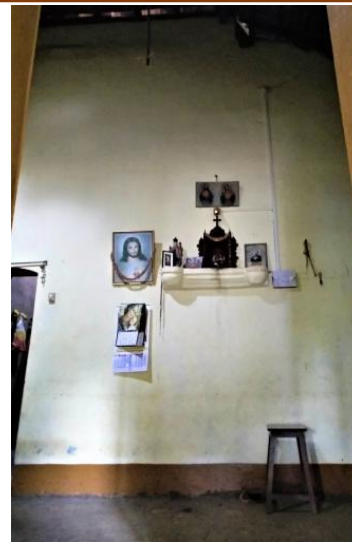
A brighter shade highlighted columns, motifs, wall-bases, and borders of doors and/or windows.

Image 136: This was observed on exterior walls, especially on front facades (Survey no. 7).

Image 137: In some cases, it was observed on interior walls as well (Survey nos. 3a, 14).

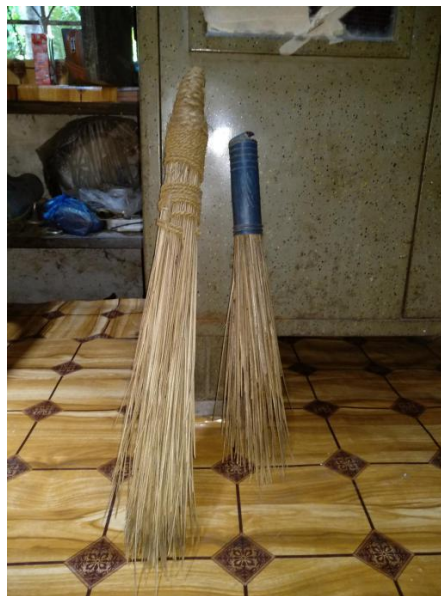
**Image 139: Old abraded stick-brooms used when the roof in Survey no. 7 was repaired in 2018.**
