# Comparison of the vernacular earthen architecture in Goa (past Portuguese colony in India) and Alentejo (Portugal): local building cultures and conservation approaches

Mémoire du  
Diplôme de Spécialisation et d'Approfondissement — Architecture de Terre et Patrimoine,  
DSA-Terre 2016 - 2018

**RODRIGUES Chenelle Fatima**

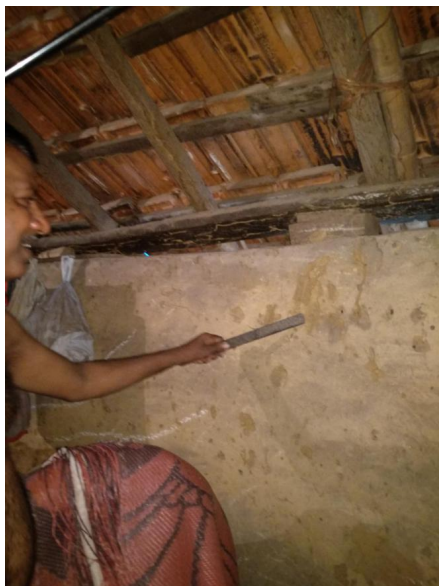
Image 140: An owner demonstrating how to manually break earthen-nests built by insects on interior walls (Survey no. 4).

22) On the interiors, the **earthen-nests built by insects are broken manually** ('Region A' — Survey no. 4).

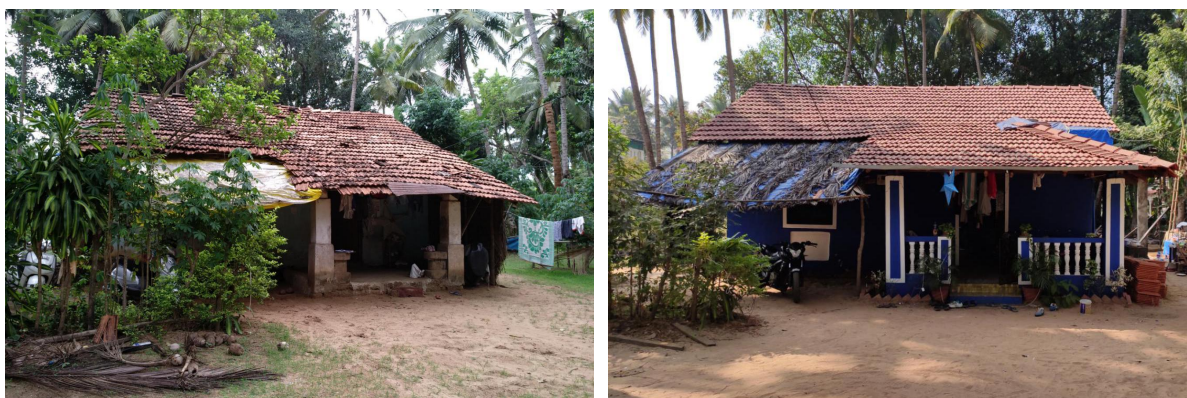
However, as it is a cultural norm to beautify one's house when a family member is getting married, renovations are seen even if ownership is not yet obtained. Survey no. 1 ('Region A') is a good example. The house was renovated in 2019, before a wedding in the family. (Refer images in '4.2. Locations of buildings surveyed and case-studies', Survey no. 1.)

Image 141 and Image 142: House renovated on before wedding celebrations.

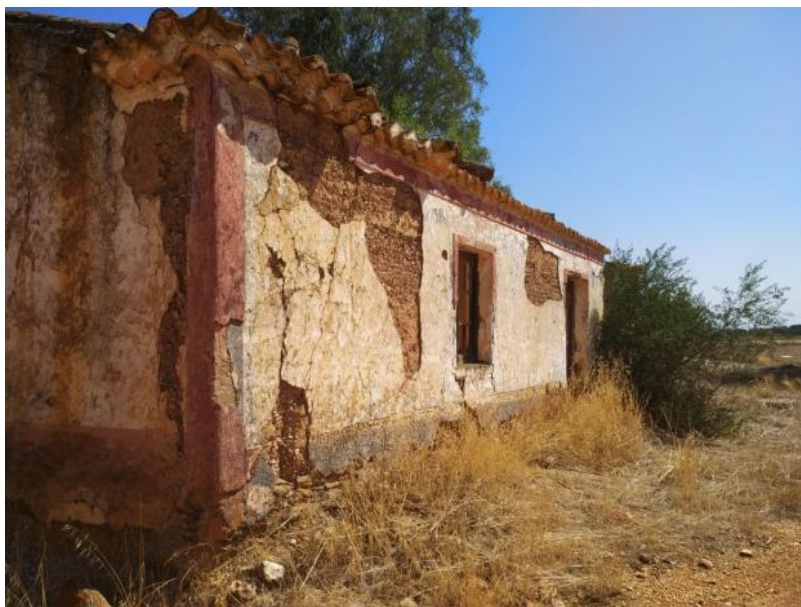
Image 152: The traditional blue colour was later over-painted by reddish-pink shade. Beja, Alentejo, 2018.

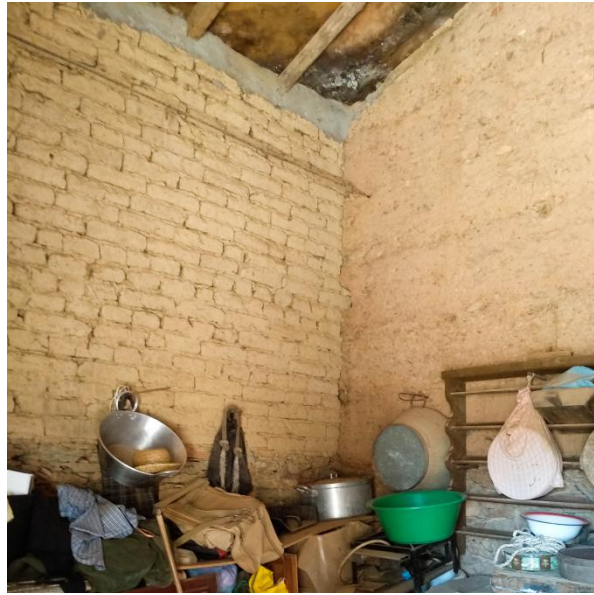
Distinct characteristics: Interior walls are in adobe-bricks.

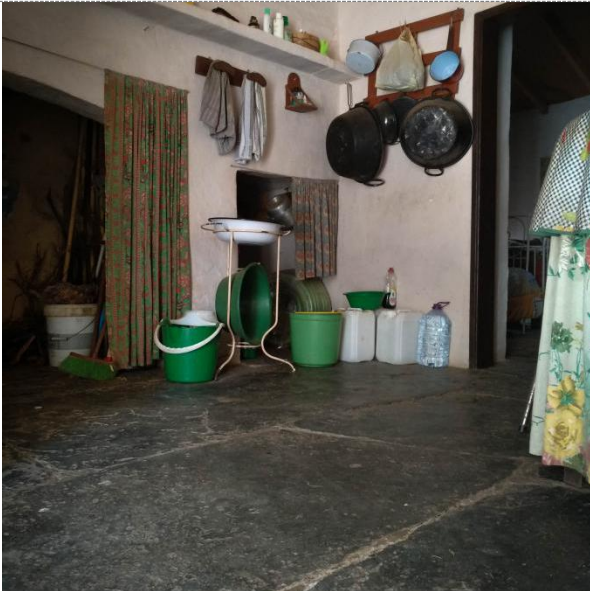
Flooring: Stones were commonly used as floor tiles in the kitchen because they are easy to clean.

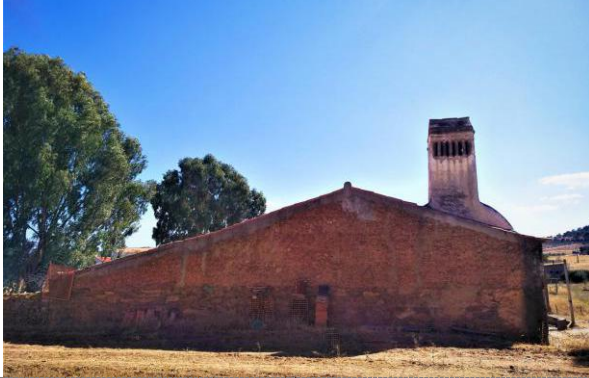
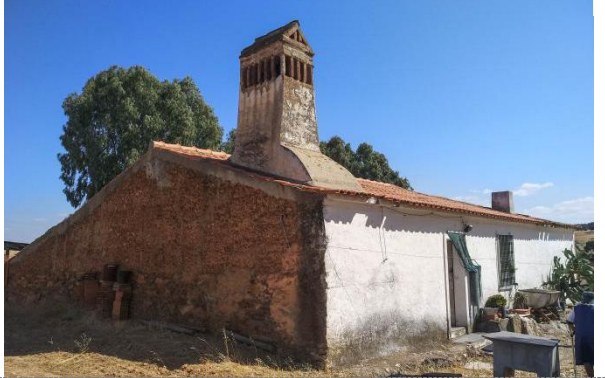
In 2018

The roof of the lean-to has fallen. The wooden part of the east wall is now covered with panels and shutters.

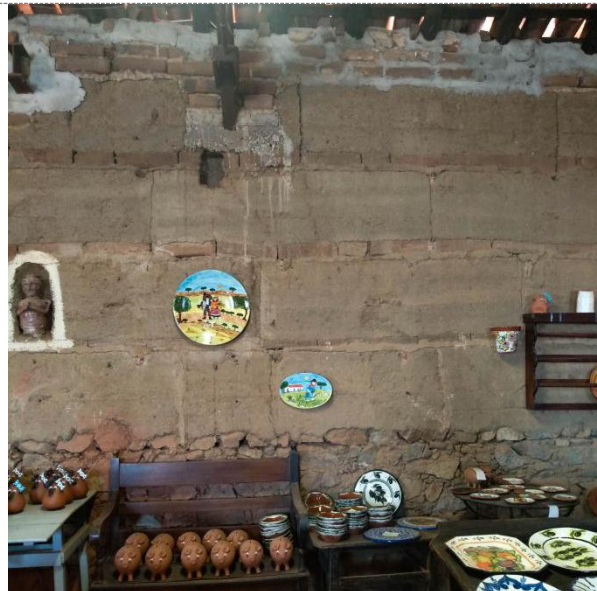
Distinct characteristics: Between each rammed-earth 'lift', there is mortar and fired-bricks. The brick-layers differ in sizes depending on the bricks' dimensions.

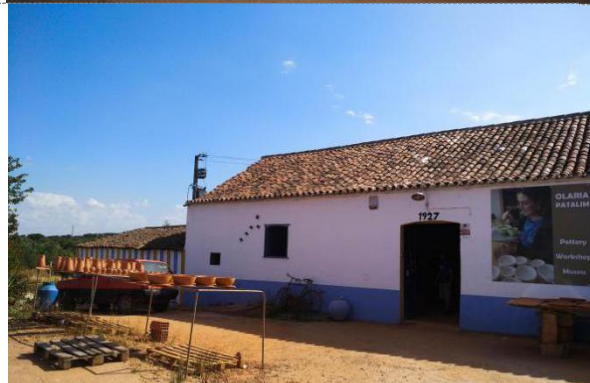
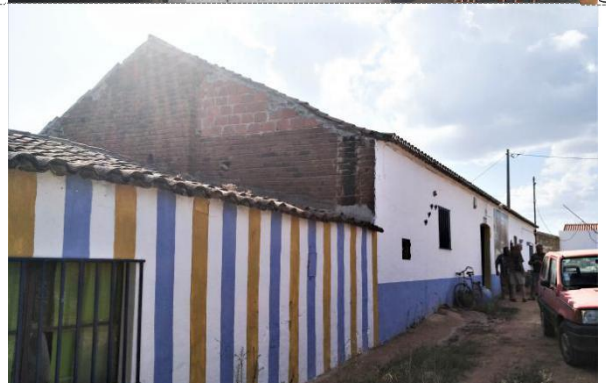
In 2018

Roof replaced, workers' quarters converted into an atelier, chimney torn-down and east gable wall partly reconstructed, facade walls repainted in white, blue and yellow.

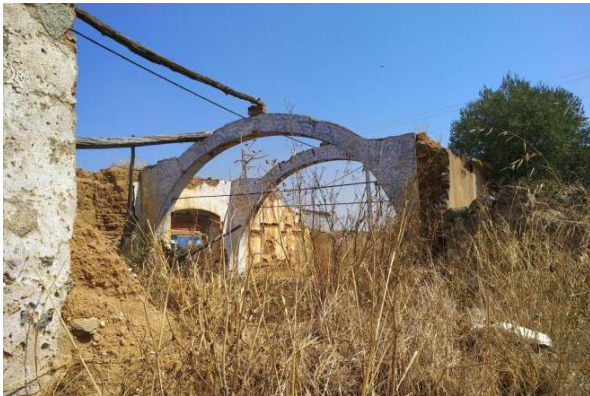
Distinct architectural details: Arches on the interior.  
Maintenance and repairs: Ties between arches.

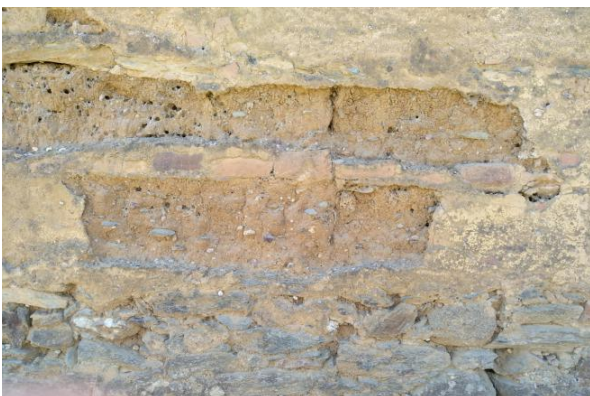
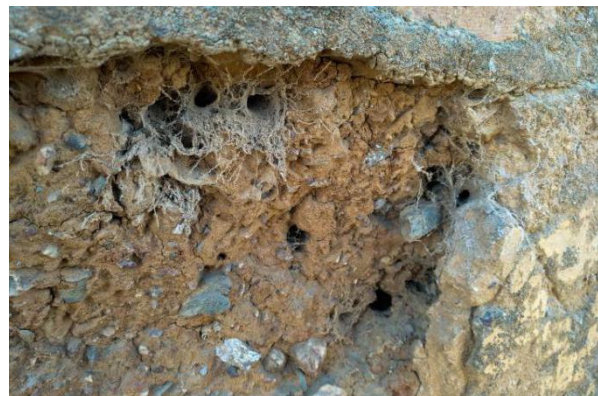
Damages incurred / problems faced: Mason-bee holes.

**Observations:** Walls and roof in ruins, cracks on walls, falling plasters, mason-bee holes, damaged fire-bricks (probably not part of the original construction), vegetation in and around the building.

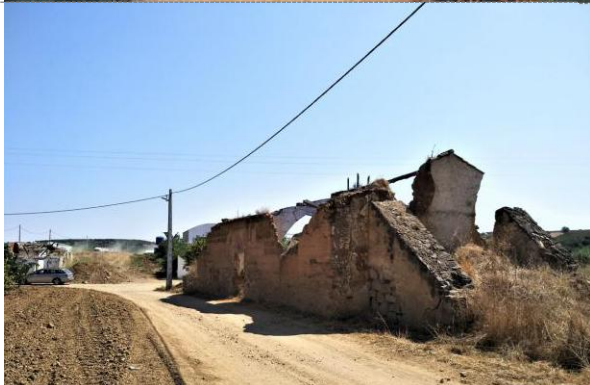
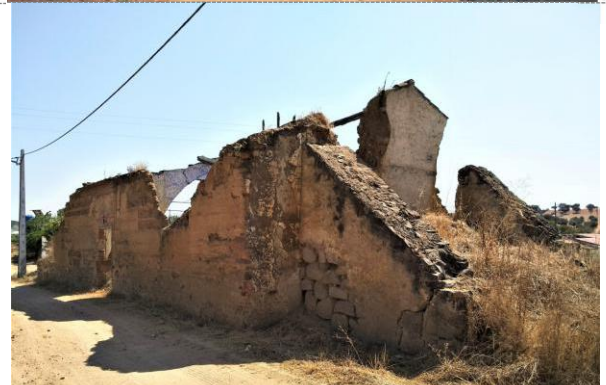
In 2018

Roof has collapsed; walls in ruins; blue daubs or design on interior plaster, especially on arches.

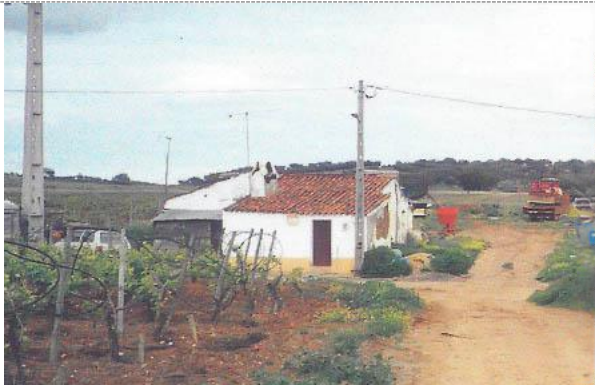
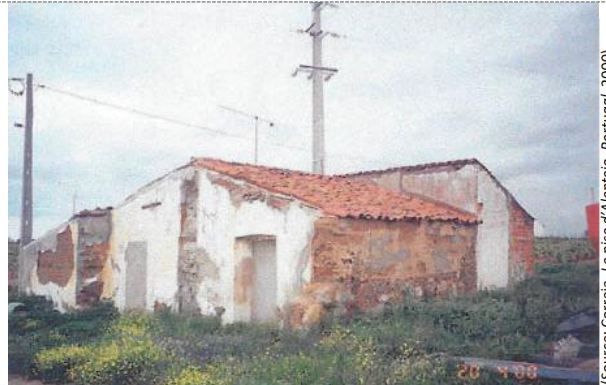
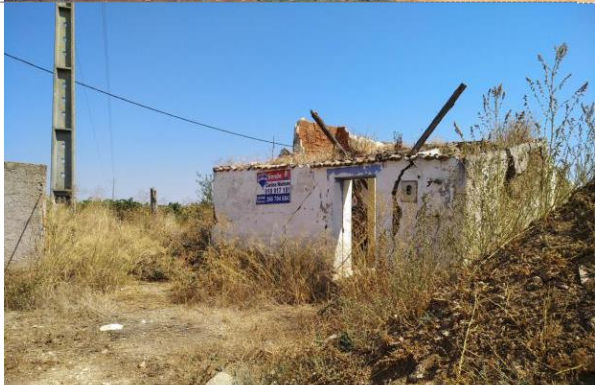
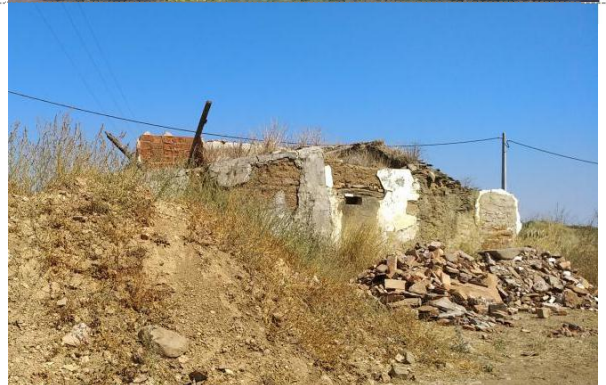
The house is in ruins. The chimney and roof have fallen, walls are cracked and broken, there are debris and abandoned cars around the house. Wall extended in brick along east facade. Wall-bases repainted in blue (records from 2000 show yellow), door border also painted.

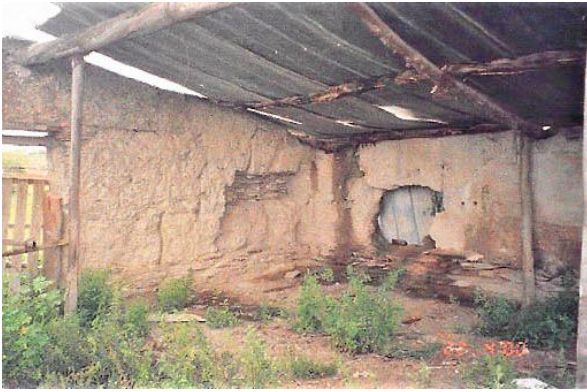
Interior view.

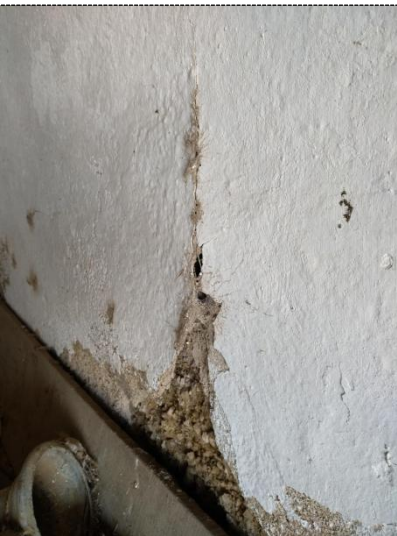
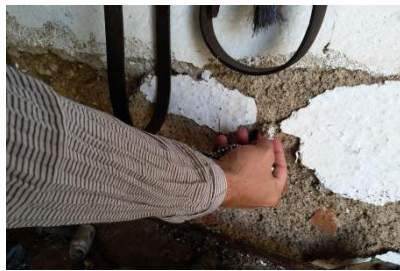
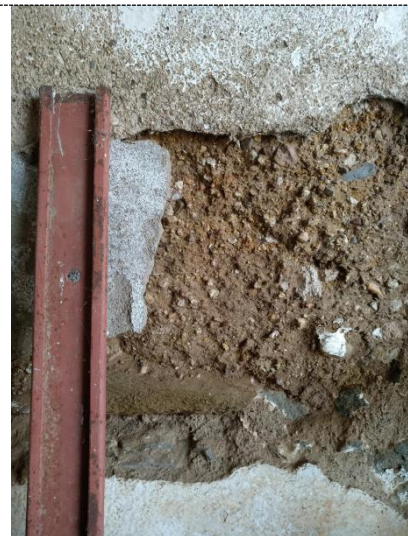
Damages incurred / problems faced: Warping, cracking and fallen plaster.

The roof gets damaged frequently because it is big, thus causing the winds to easily affect its stability. In November 2005, a strong storm brought down the whole chimney and created an opening in the roof.

**Observations:** Warping, cracking and fallen plaster. Some floor-tiles chipped-off.

**Periodic interventions:** Every year, the roof had to be reworked on because the winds would cause the tiles to dislocate. The woodwork needed repairs too. Roof-tiles and wood in the roof's framework was replaced as and when needed. These repairs were done between the months of May and September, when it was dry and least likely to rain. Earlier, walls were whitewashed every year.

**Repairs:** The roof has been repaired many times.

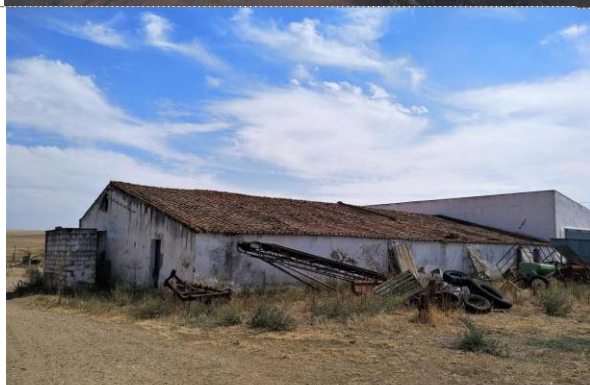
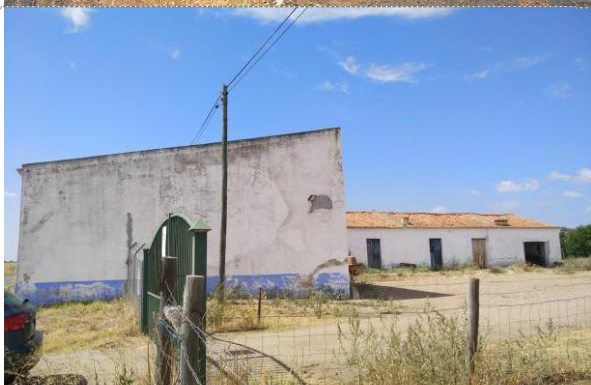
In 2018

Chimney no longer there, roof repaired, blue paint along wall-bases on front facades.

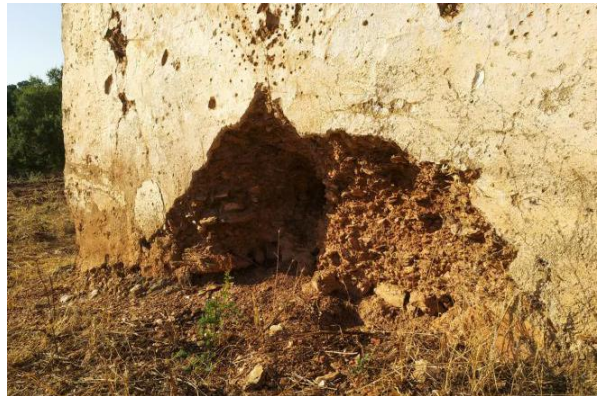
Damages incurred / problems faced: Holes in walls especially where there is lime-based plaster.

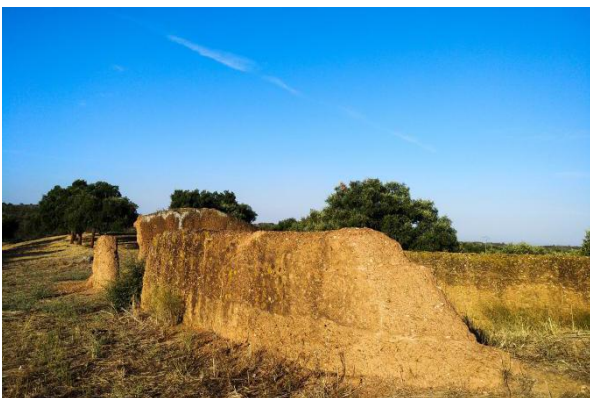
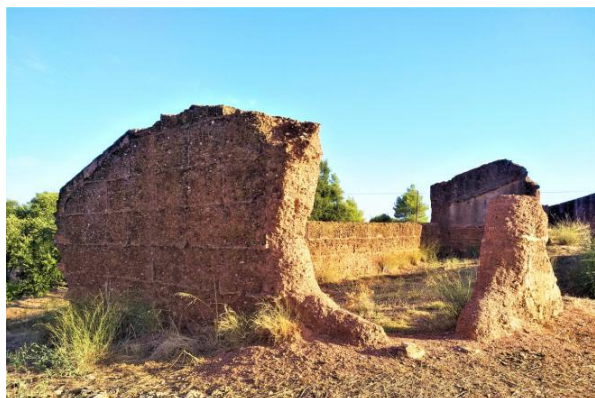
Damages incurred / problems faced: Wall damages got worse with time as the building has not had a roof for many years, some parts of the walls have fallen, vegetation in and around the structure.

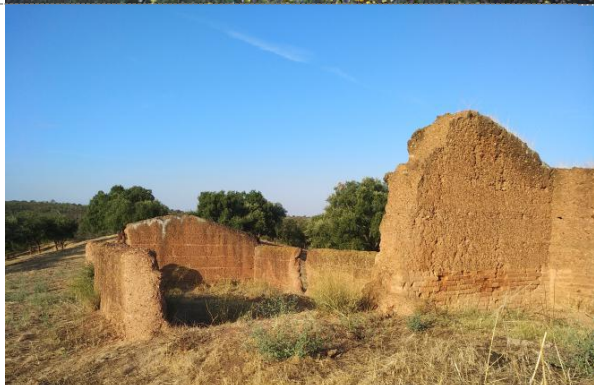
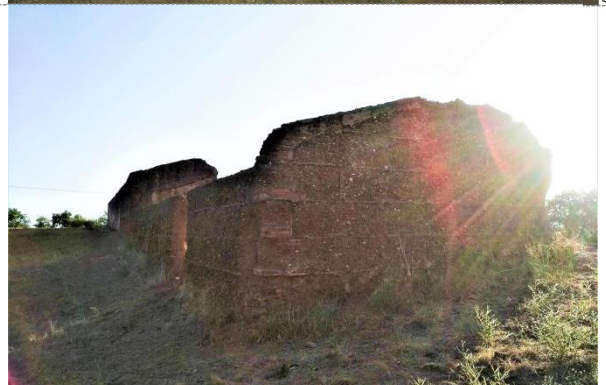
In 2018

Parts of rammed-earth walls have fallen.

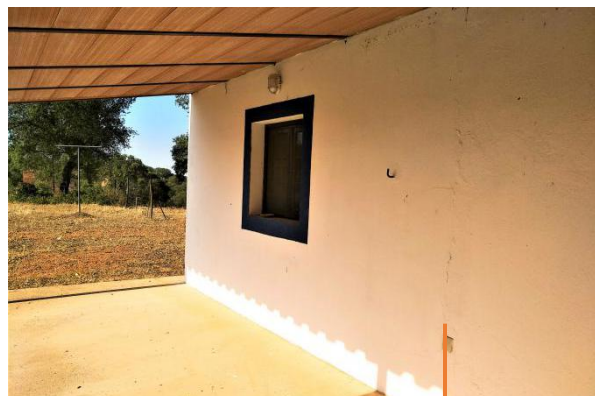
Damages incurred / problems faced: There is a vertical crack along the front facade; it demarcates the new extension.
